# GEOTUBES ALONG THE GULF SHORELINE OF THE UPPER TEXAS COAST: OBSERVATIONS DURING 2001

**A Report of the Texas Coastal Coordination Council pursuant to National Oceanic  
and Atmospheric Administration Award No. NA97OZ0179  
GLO Contract Number 01-597 R**

**Bureau of Economic Geology  
Scott W. Tinker, Director  
The University of Texas at Austin  
Austin, Texas 78713-8924**

**March 2002**

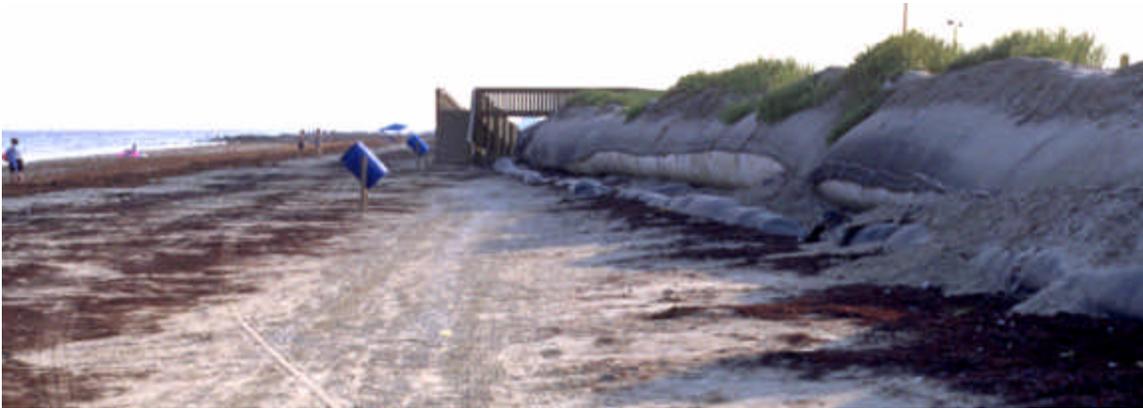
**Figure 7. Example of fully exposed geotube front and scour apron at the Dellanera project on Galveston Island, July 18, 2001.**

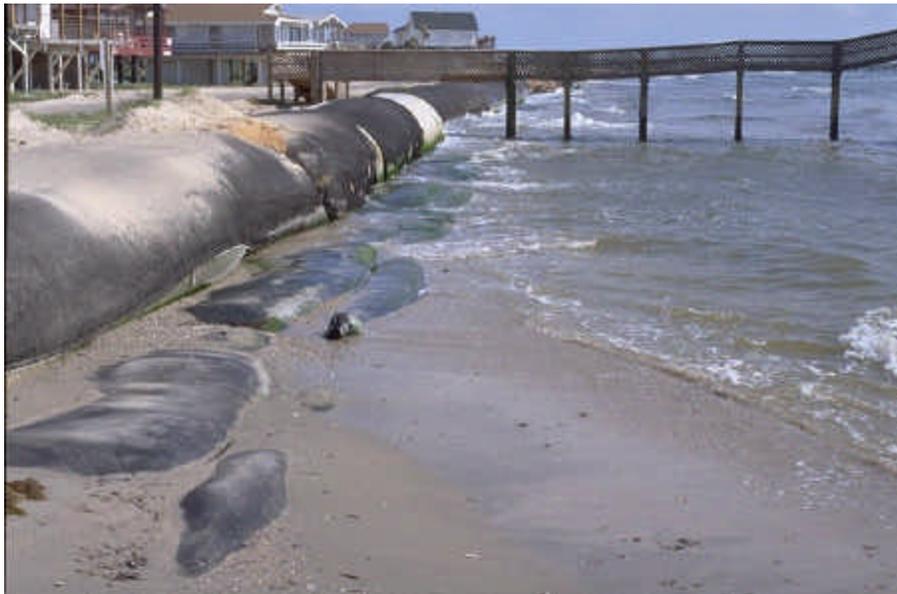
**Figure 14. Treasure Island middle geotube on July 19, 2001. Except for a short piece in the foreground this section was completely destroyed in November 2001. Note exposed scour apron and damaged UV shroud.**

In July there were no beaches in front of the Treasure Island middle project (Fig. 14), most of the south project, and the southern part of the north project; the bases of the geotubes were at the MHHW line (Plate 3). By November the remaining beach in front of the north geotube was eroded allowing direct wave attack on the tube. This shoreline is under the influence of San Luis Pass and has historically undergone dramatic shoreline retreat and advance in response to changes in the sand supply, tidal channels, and offshore shoals. The shoreline along the Treasure Island development is currently in a retreat phase, and the geotubes cannot prevent this natural shoreline adjustment.

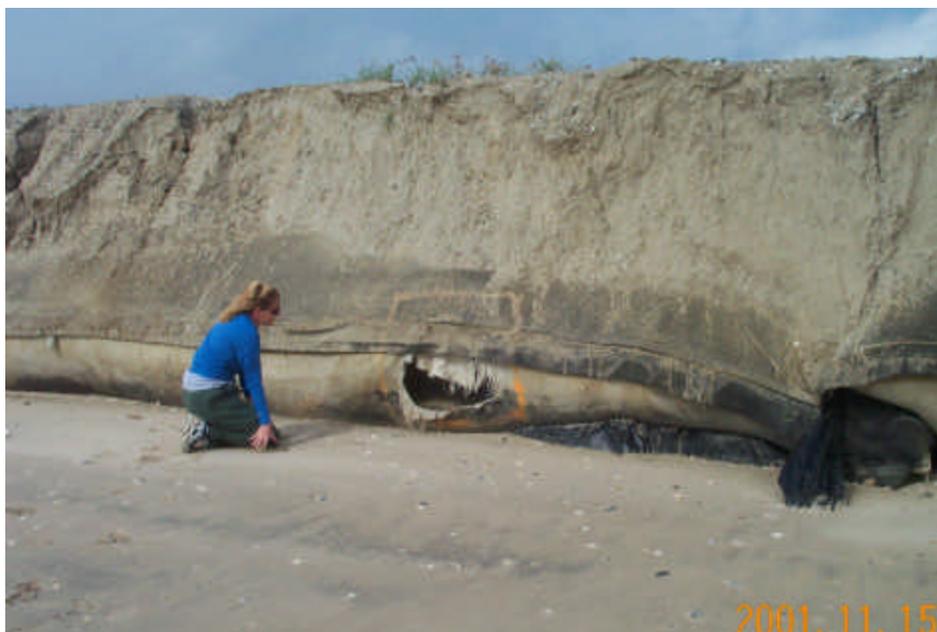
**Figure 15. Puncture in Gilchrist West geotube on November 15, 2001.**

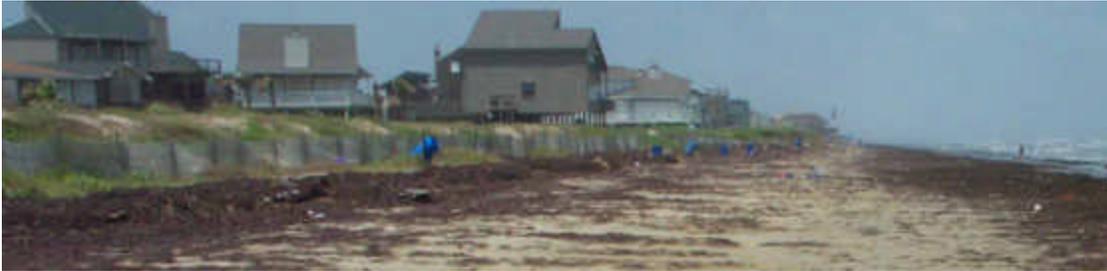
**Figure 16. Pirates Beach geotube at GAL01 profile location (see figure 6 for location). This geotube remained covered and vegetated following Tropical Storm Allison. Note sand fence and lack of coppice mound subenvironment.**

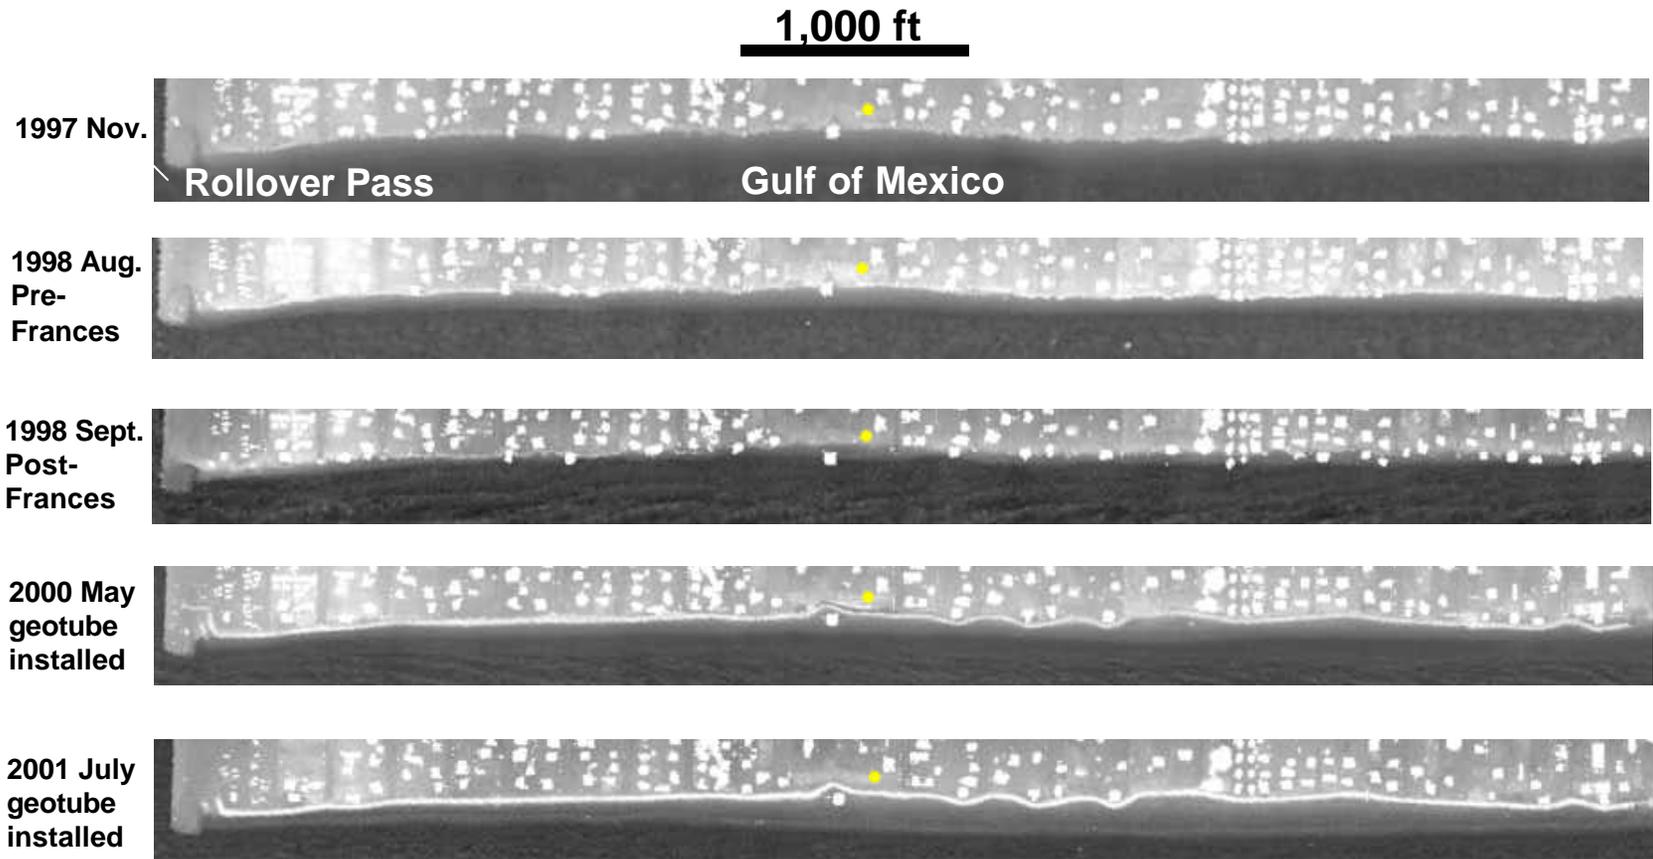
Figure 17. Lidar topographic images of Gilchrist East project. Dark areas are low elevation, lighter higher elevation. Geotube was present during the 2000 and 2001 surveys. Note how geotube was routed seaward of some houses and the overall geomorphic impact of the project.

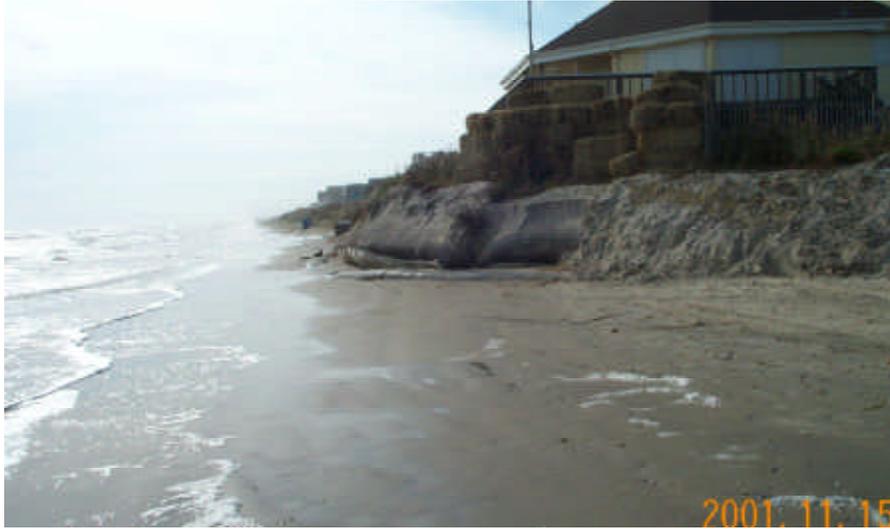
**Figure 18. Pirates Beach geotube on November 15, 2001. Geotube at this location was routed seaward of the house causing a particularly narrow beach and difficulty in maintaining a sand cover on the geotube. Water level was about 2.0 ft (0.61 m) above mean sea level.**

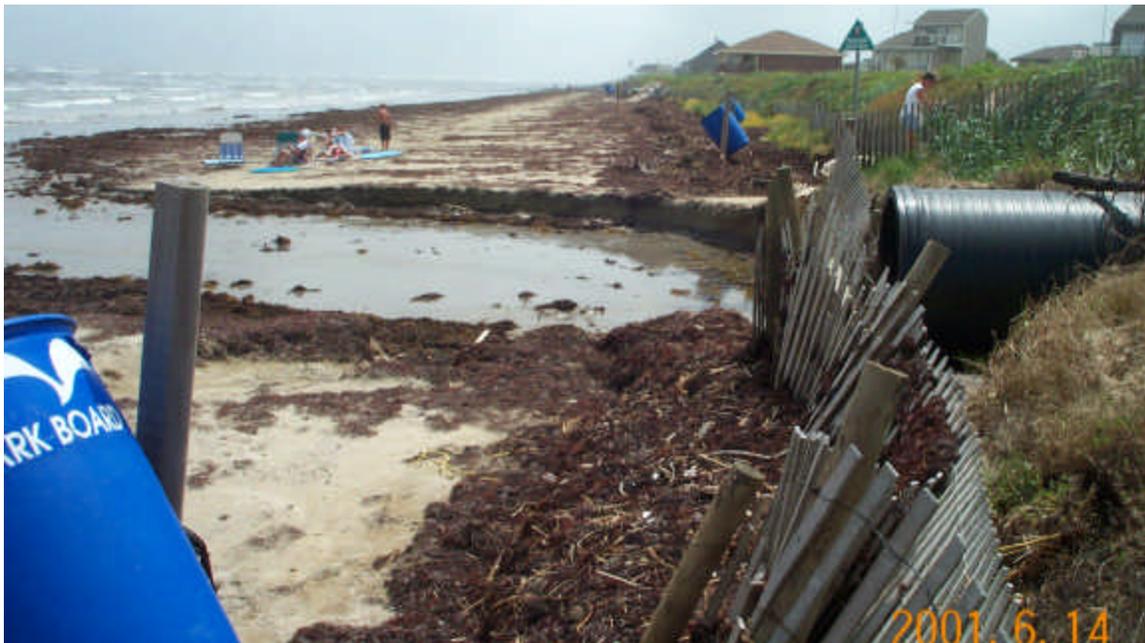
**Figure 19. Pirates Beach geotube project on June 14, 2001 after Tropical Storm Allison. Rainfall runoff from Allison flowed through the black street drainage pipe beneath the geotube on the right and eroded this channel in the beach.**

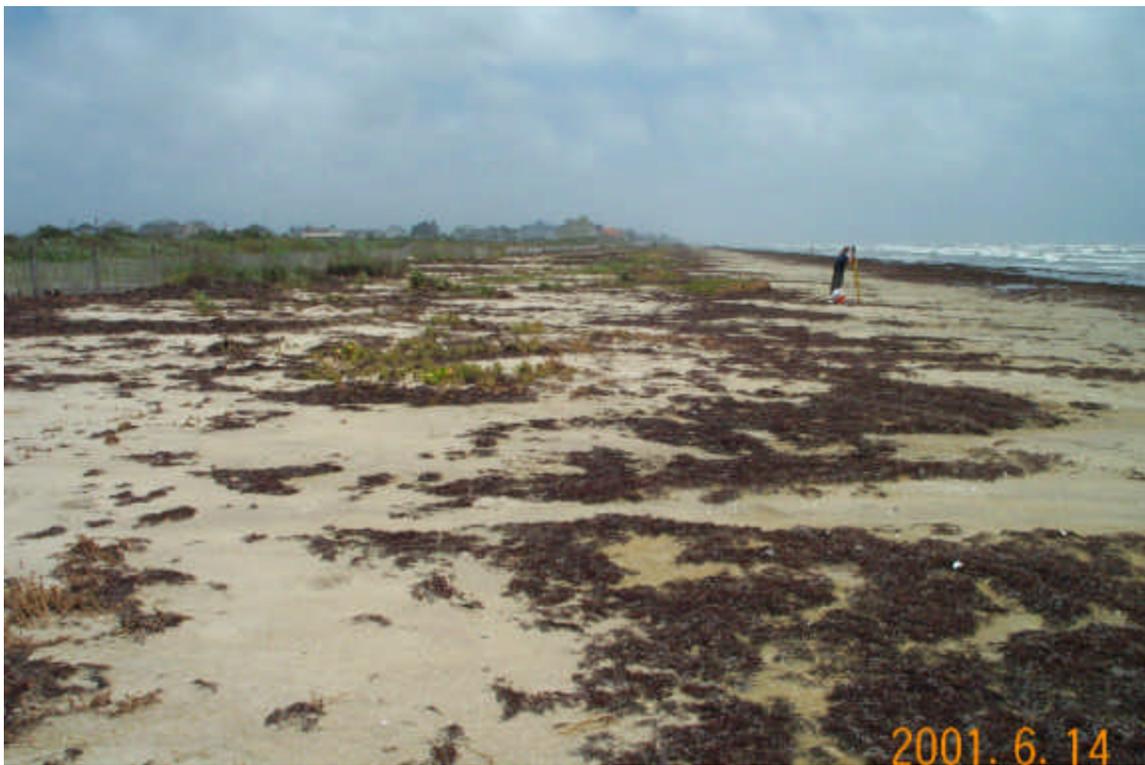
**Figure 20. Coppice mounds at BEG02 profile location in Galveston Island State Park on June 14, 2001 (see figure 6 for location). This subenvironment of wind-blown sand and sparse vegetation was eroded but survived Tropical Storm Allison.**
