Geotubes for Temporary Erosion Control and Storm-Surge Protection along the Gulf of Mexico Shoreline of Texas

James C. Gibeaut, Tiffany L. Hepner, Rachel Waldinger, John R. Andrews, Rebecca C. Smyth, and Roberto Gutierrez

BUREAU OF ECONOMIC GEOLOGY, JOHN A. AND KATHERINE G. JACKSON SCHOOL OF GEOSCIENCES, THE UNIVERSITY OF TEXAS AT AUSTIN

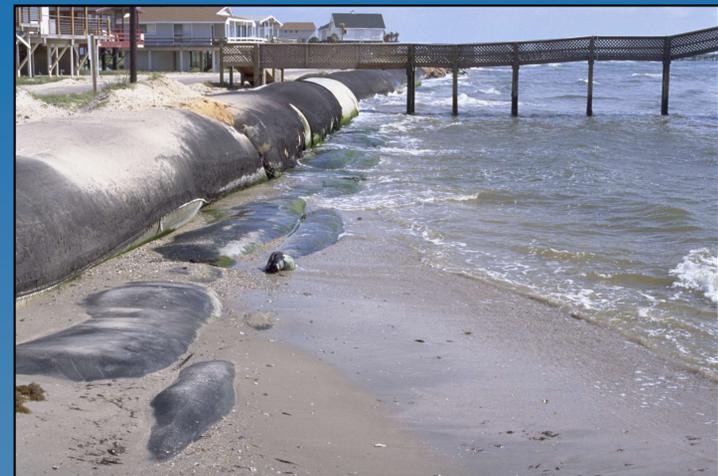
Exposed geotube on July 19, 2001 in the Treasure Island project. This section was destroyed four months later in November, 2001 during slightly elevated (1 ft.) water level and wave conditions. Note exposed scour apron and damaged UV shroud.

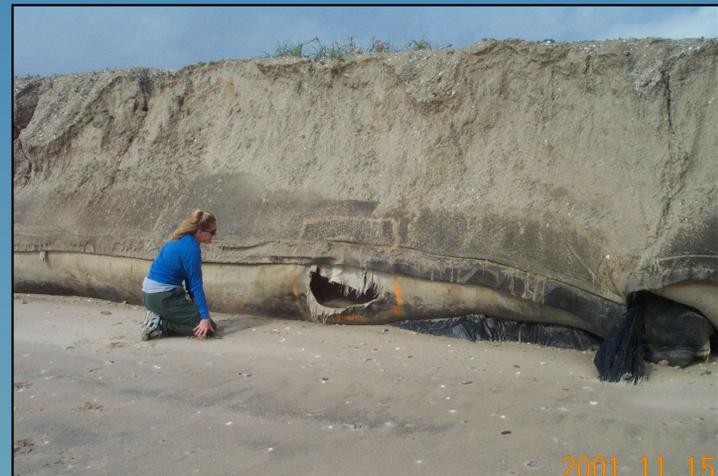
Puncture in Gilchrist West geotube on November 15, 2001.

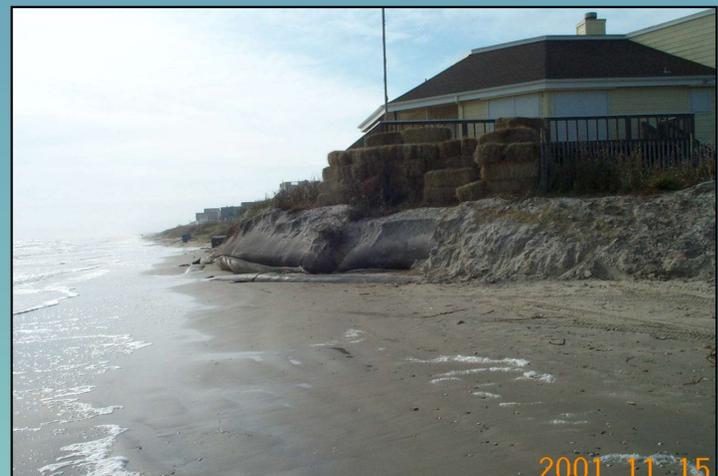
Pirates Beach geotube on November 15, 2001. Geotube at this location was routed seaward of the house, creating a particularly narrow beach and difficulty in maintaining a sand cover on the geotube. Water level was about 2.0 ft (0.61 m) above mean sea level.

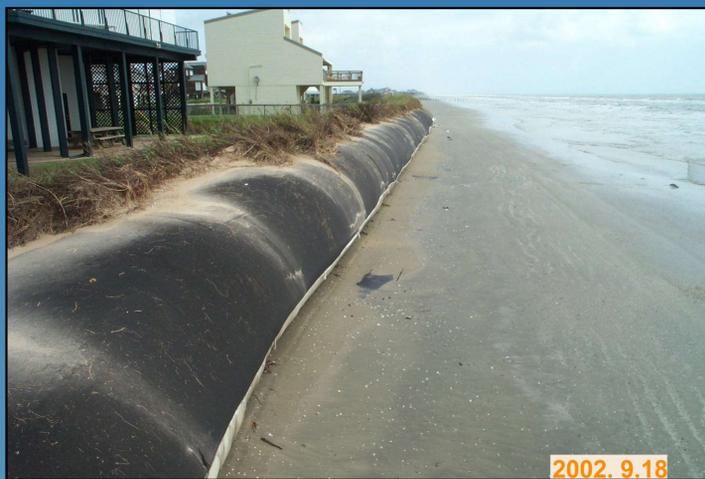
Pirates Beach geotube at GAL02 profile location on September 18, 2002. This geotube was uncovered following Tropical Storm Fay. Note lack of coppice-mound subenvironment when compared with the GLO06 profile location.

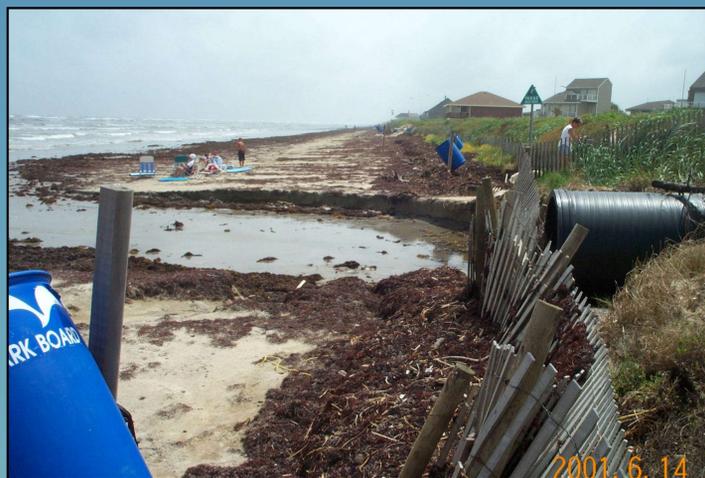
Pirates Beach geotube project on June 14, 2001, after Tropical Storm Allison. Rainfall runoff from Allison flowed through the black street-drainage pipe beneath the geotube on the right and eroded this channel in the beach.

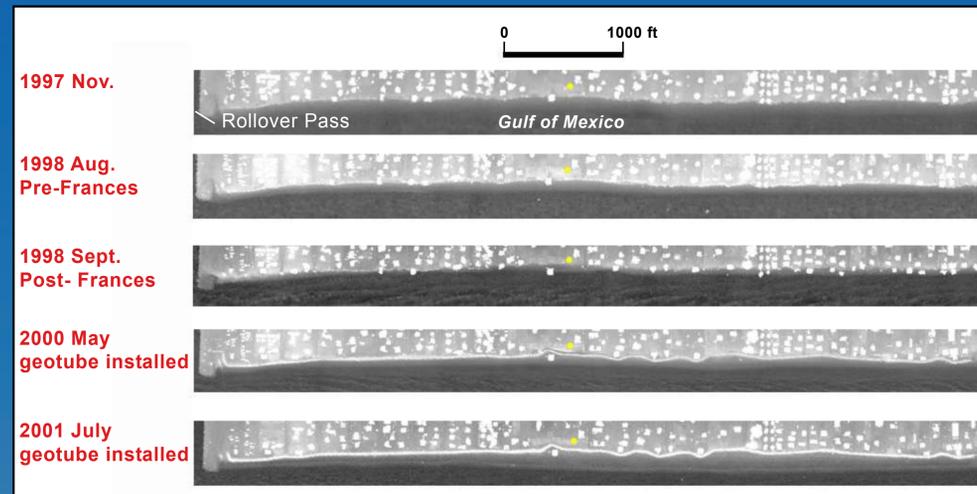
Lidar topographic images of Gilchrist East project. Dark areas are low elevation, lighter higher elevation. Geotube was present during the 2000 and 2001 surveys. Note the overall geomorphic impact of the project and how the geotube was routed around some houses.

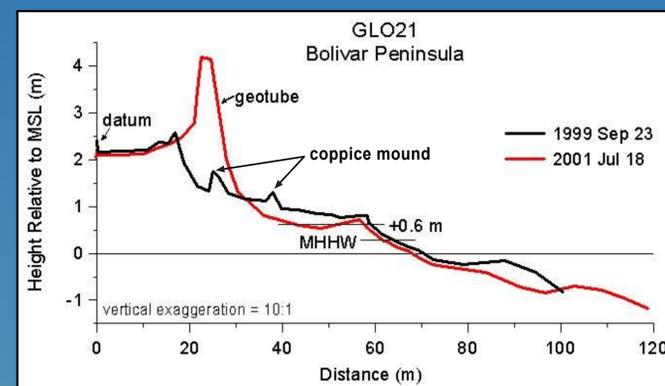
Beach profiles at a location in the Gilchrist West project area before and after geotube installation. Note coppice-mound subenvironment before geotube installation and the unnatural morphology of the geotube.
