EPA/OSHA JOINT CHEMICAL ACCIDENT INVESTIGATION REPORT

**Shell Chemical Company
Deer Park, Texas**

Shell Chemical Company, Deer Park, TX, June 22, 1997

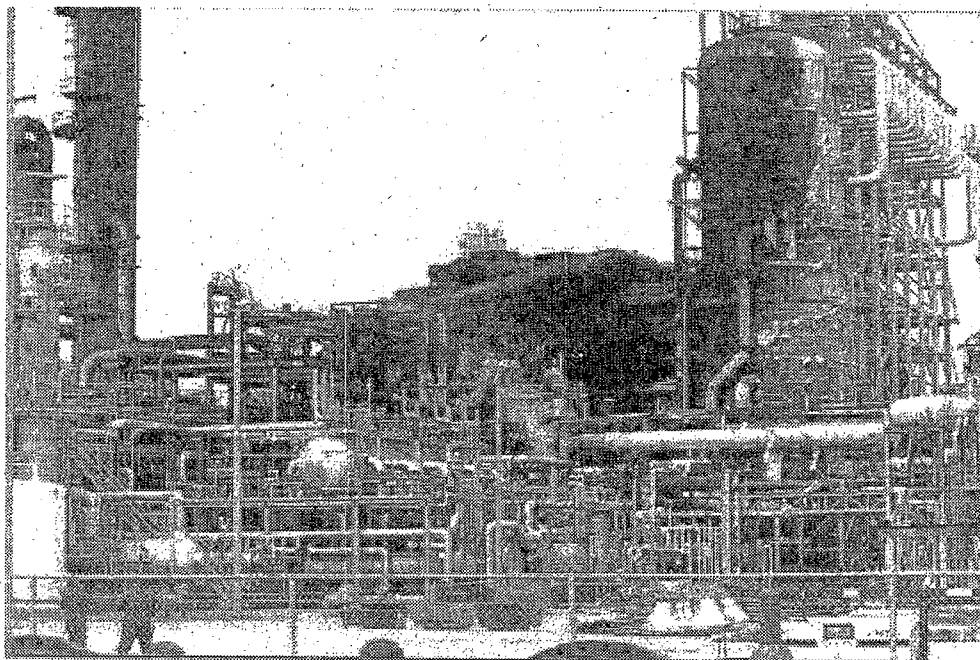
Figure E-1: Photograph of the damage resulting from the explosion and fire at Shell Olefins Plant Number 3 (view from west of blast area). Note the heavy structural damage in the rear center of the photograph.

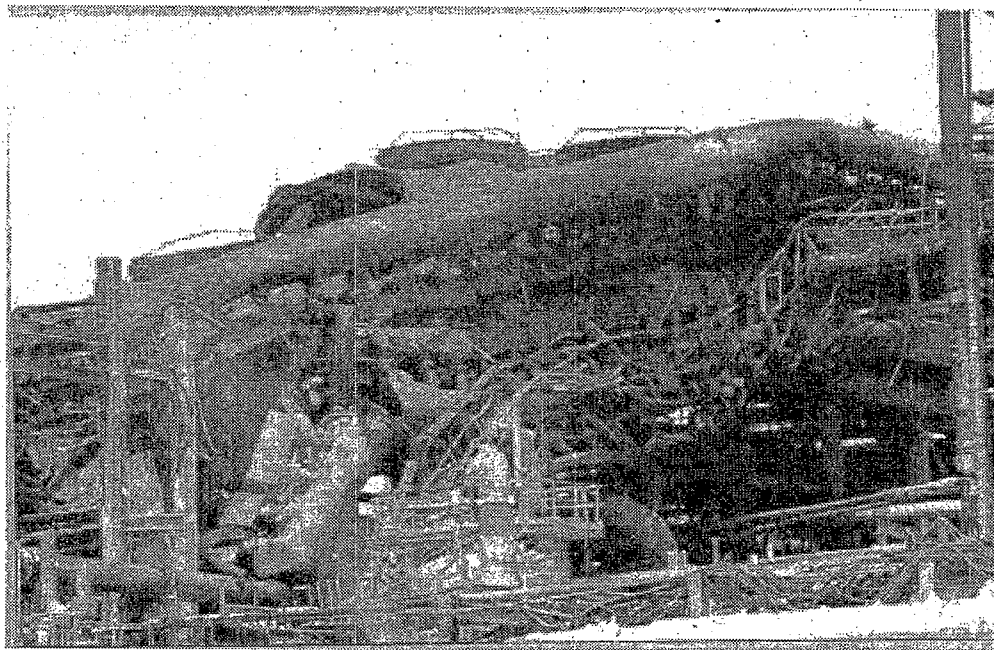
Figure E-2: Close-up of OP-III damage. The structure supporting the overhead cooling fans melted due to the intense heat of the fire and collapsed on top of the pipe rack.

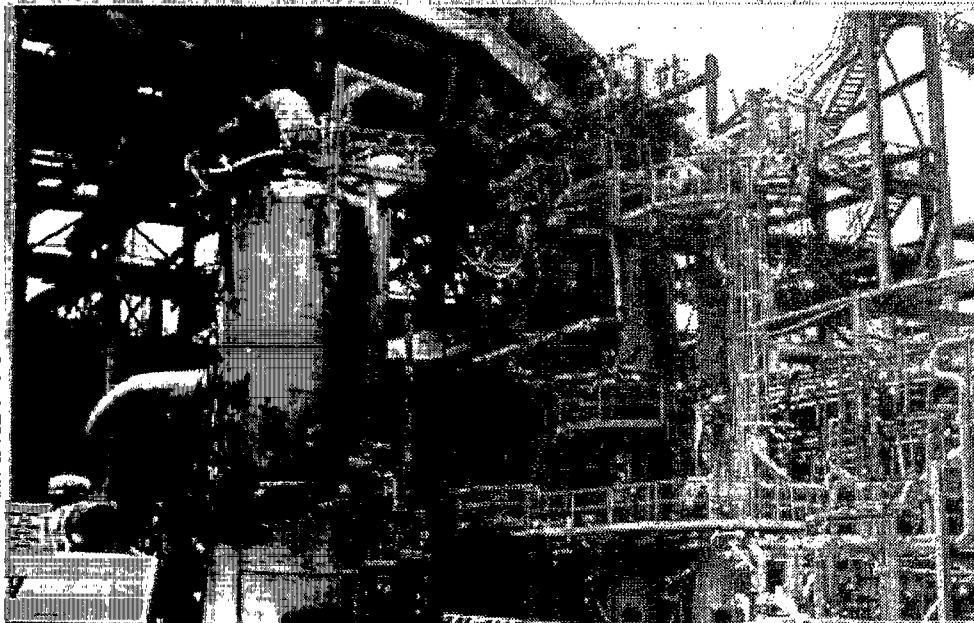
Figure E-3: Photograph of explosion and fire damage at OP-III as seen from the north side of the blast zone.

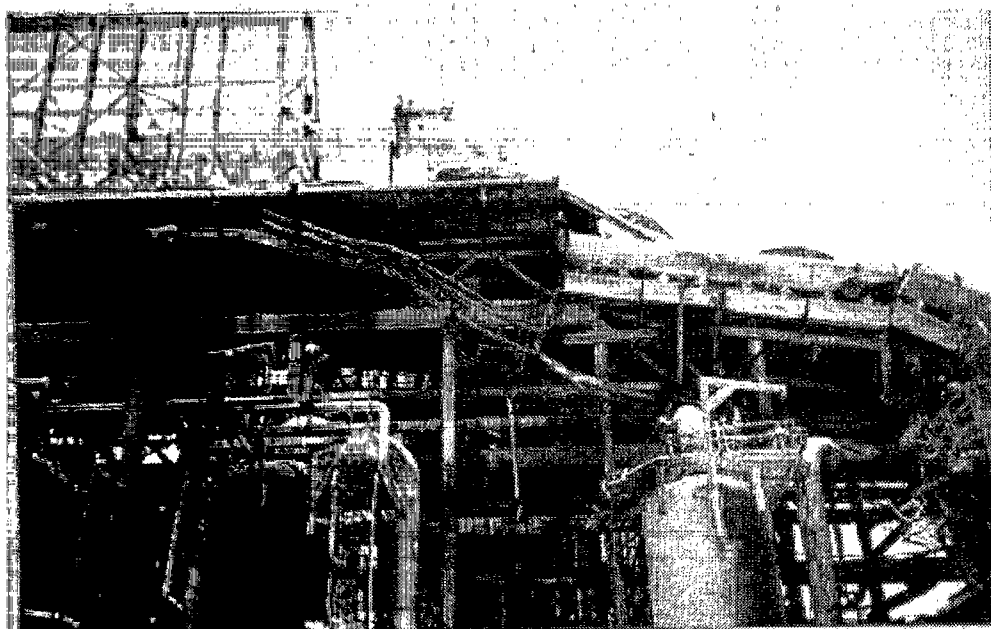
Figure E-4: Photograph of explosion and fire damage at OP-III as seen from north side of pipe rack, looking upward.

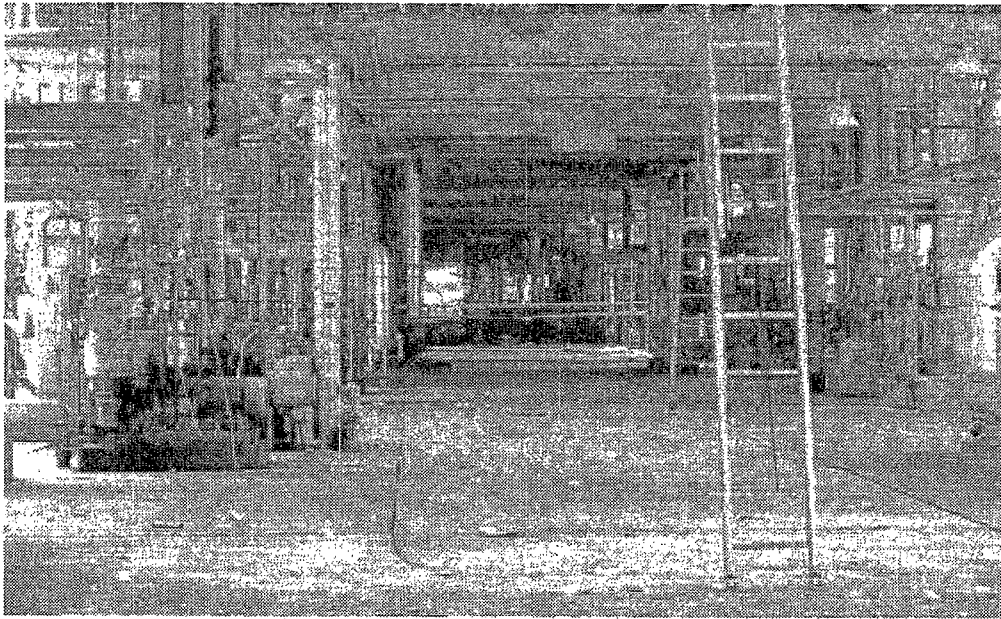
Figure E-5: Photograph looking down pipe alley (passable area underneath pipe rack) where explosion occurred.

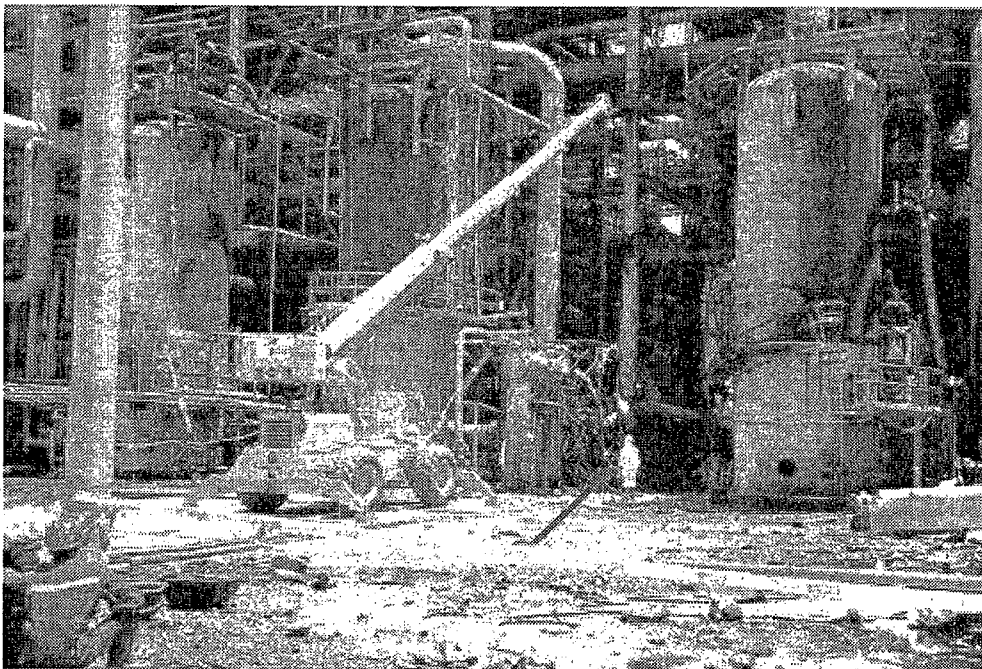
Figure E-6: Photograph of explosion and fire damage in the area of the PGC fifth stage suction and discharge drums (viewed from the north). The man in the lower center provides a reference to the scale of the surrounding structures. The failed check valve was located behind the drum to the man's right.

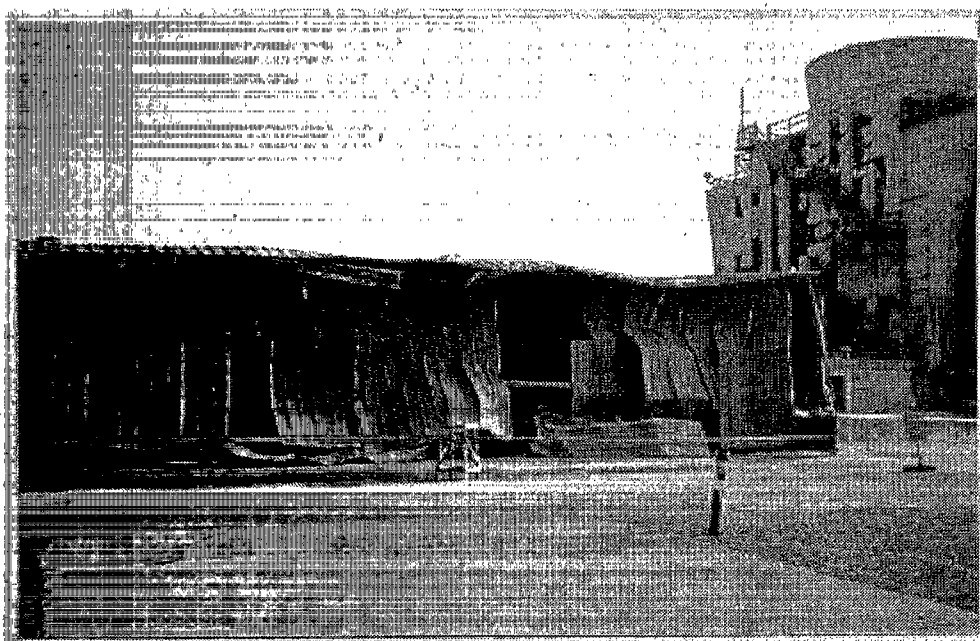
Figure E-7: Photograph of blast damage to buildings and structures in the vicinity of the explosion. Note the buckled metal walls of the storage building in the center and the panels missing from the cooling tower on the right. These buildings were located approximately 500 feet north of the blast center.

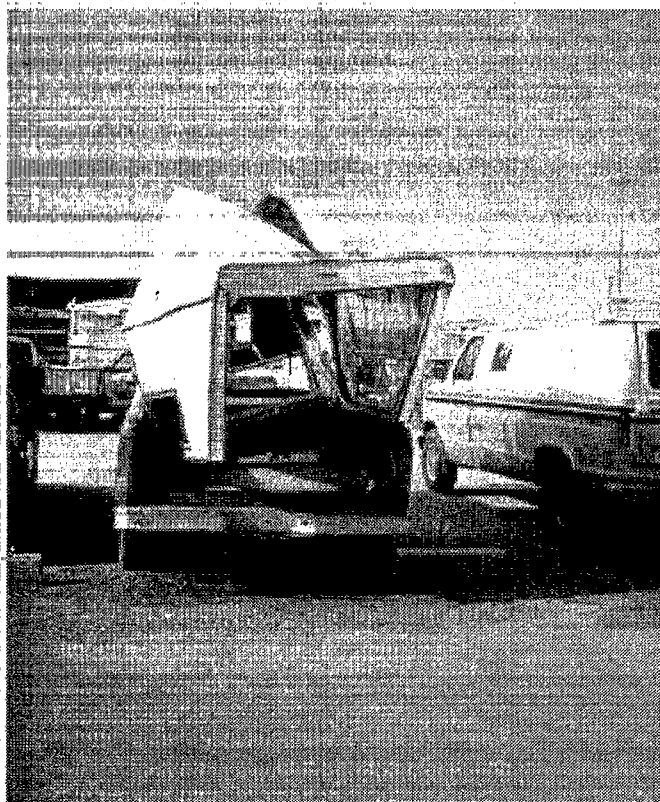
Figure E-8: Photograph of damage to a pickup truck parked near the blast site. Most automobiles parked in this company lot during the accident suffered damage.

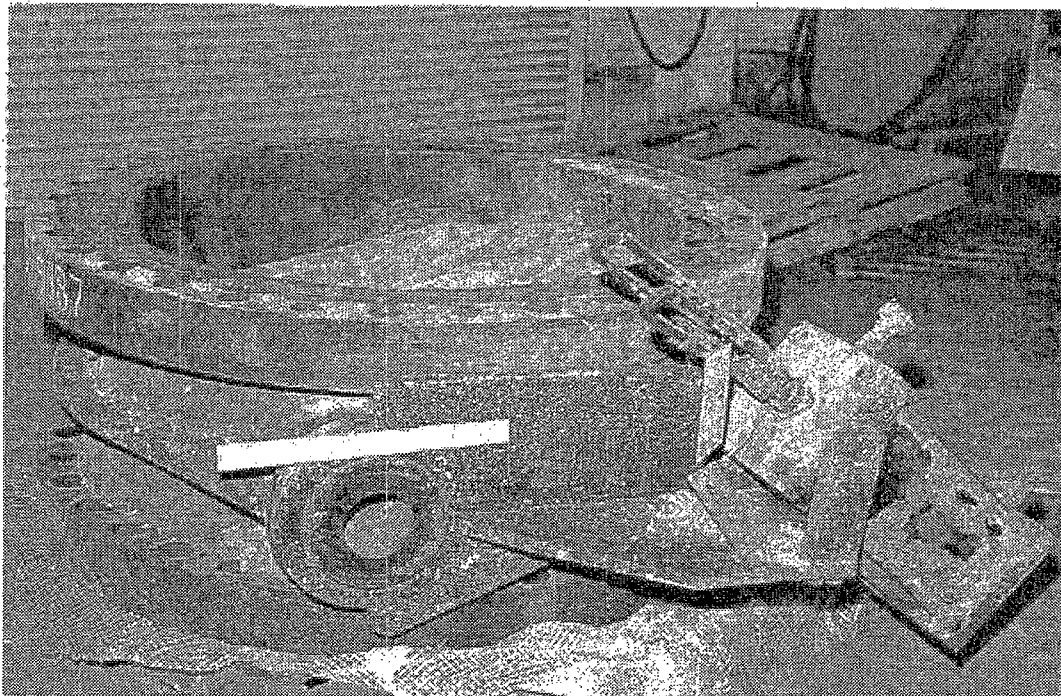
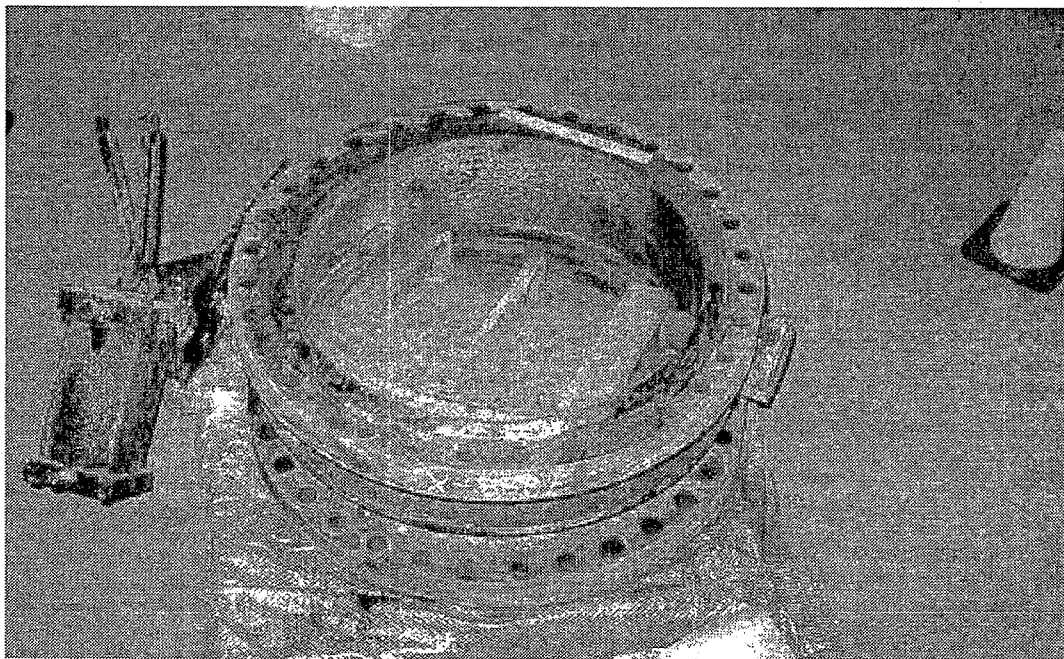
Figures E-9 and E-10: Photographs of two views of the disassembled subject 36" Clow check valve. The pneumatic actuator assembly can be seen in both views. In the lower photograph, the hole directly below the 12-inch ruler formerly contained the valve's drive shaft. This is where the shaft blow-out and flammable gas release occurred.

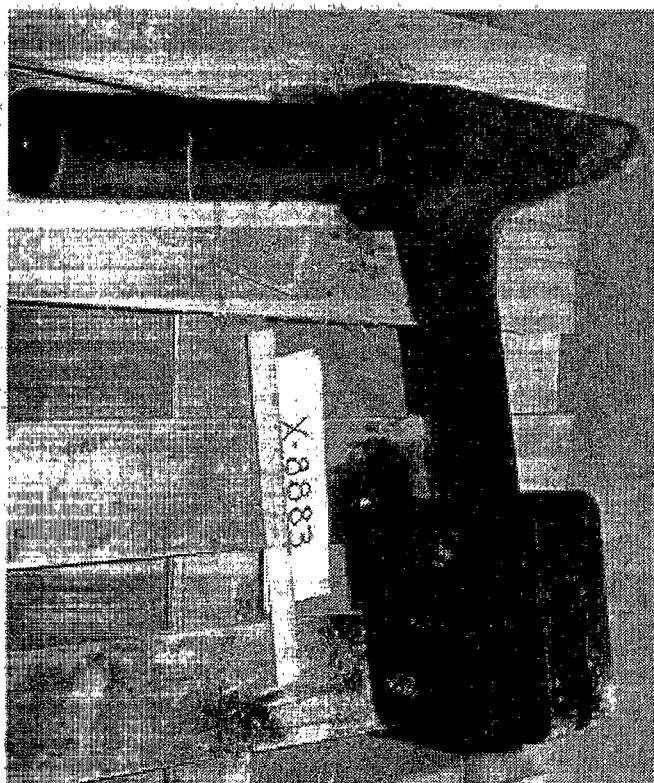
Figure E-11: Photograph shows the drive shaft and counterweight that were ejected from the 36" Clow check valve.

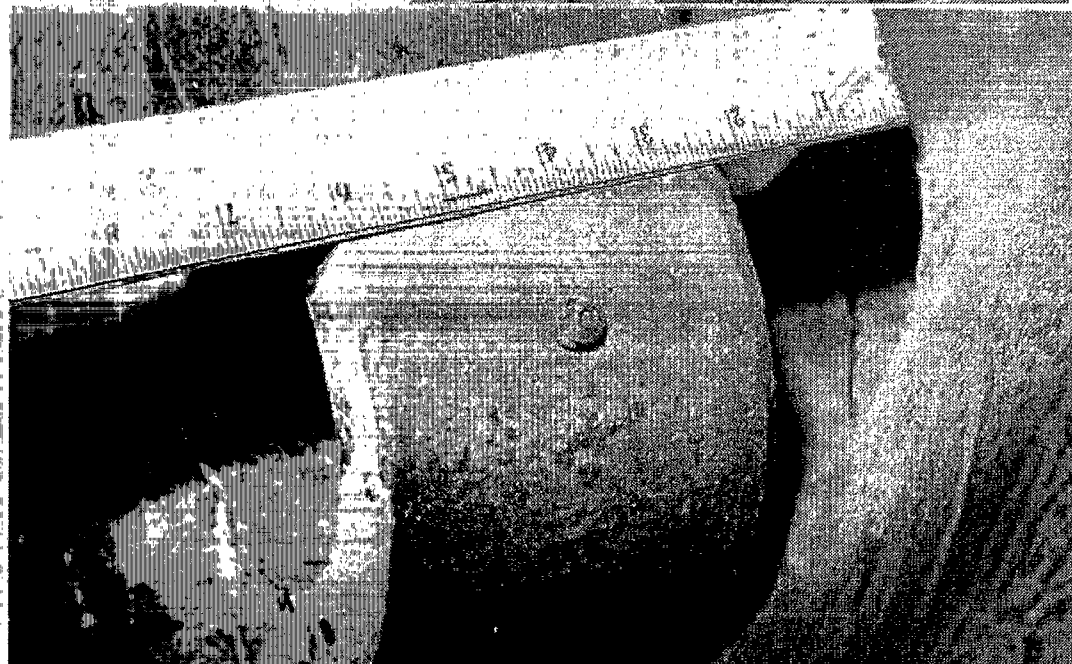
Figure E-12: Photograph shows the head of the machine screw protruding from the portion of the fractured pin. The pin is shown extended slightly out from the surface of the flange, or disk "ear", from which the valve shaft was ejected.

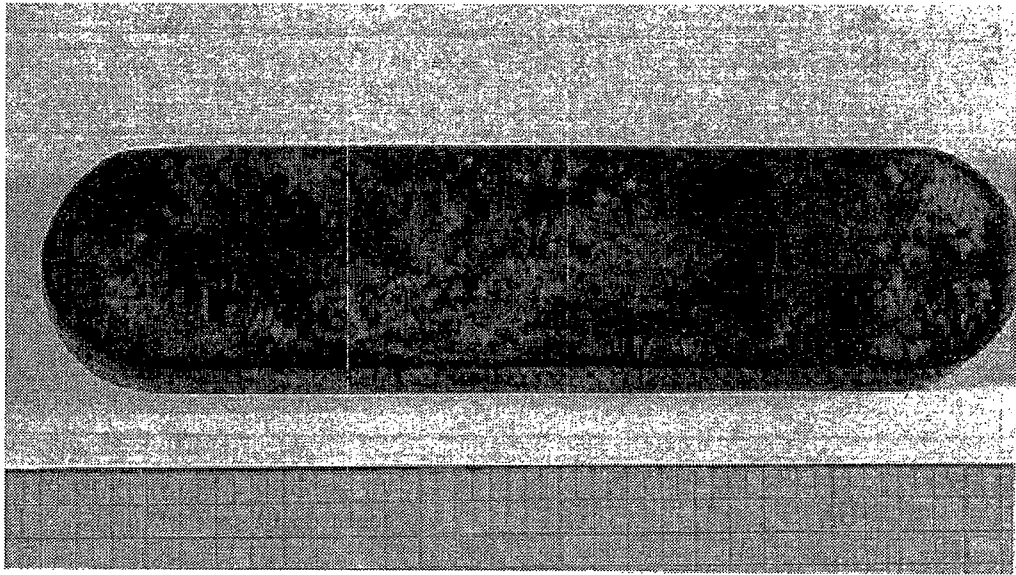
Figure E-13: Photograph shows the metal key intended to help mechanically connect the drive shaft to the valve disk.

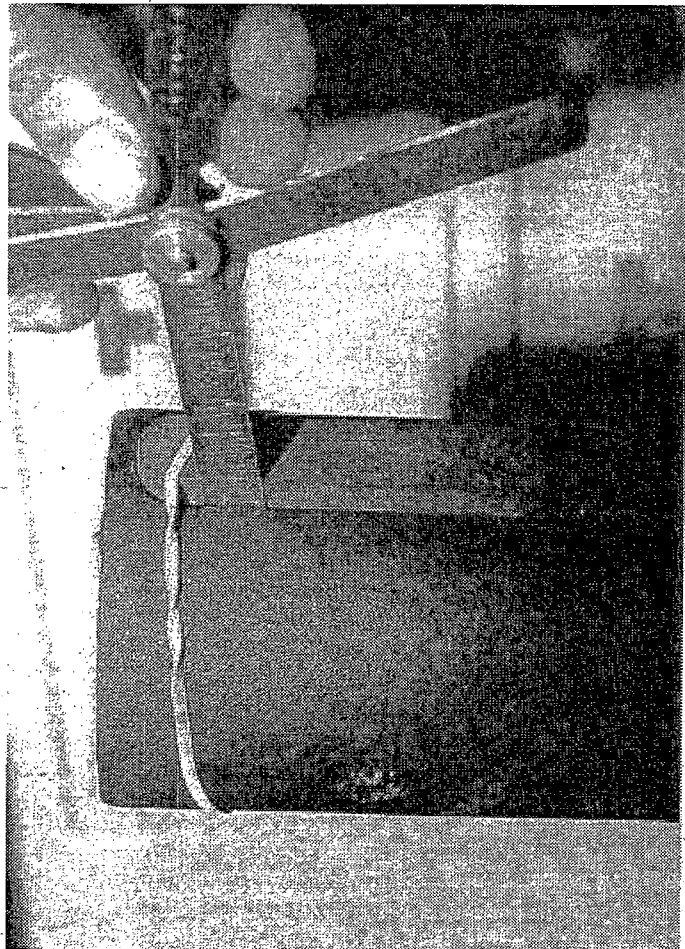
Figure E-14: Photograph depicts the measured looseness of the key within its machined slot, or keyway. The key was intended to transfer torque between the shaft and the valve disk, but the key's loose fit forced the much smaller dowel pin to transfer virtually all drive shaft torque. The key eventually fell out of its slot as the drive shaft moved outward after the dowel pin fractured.

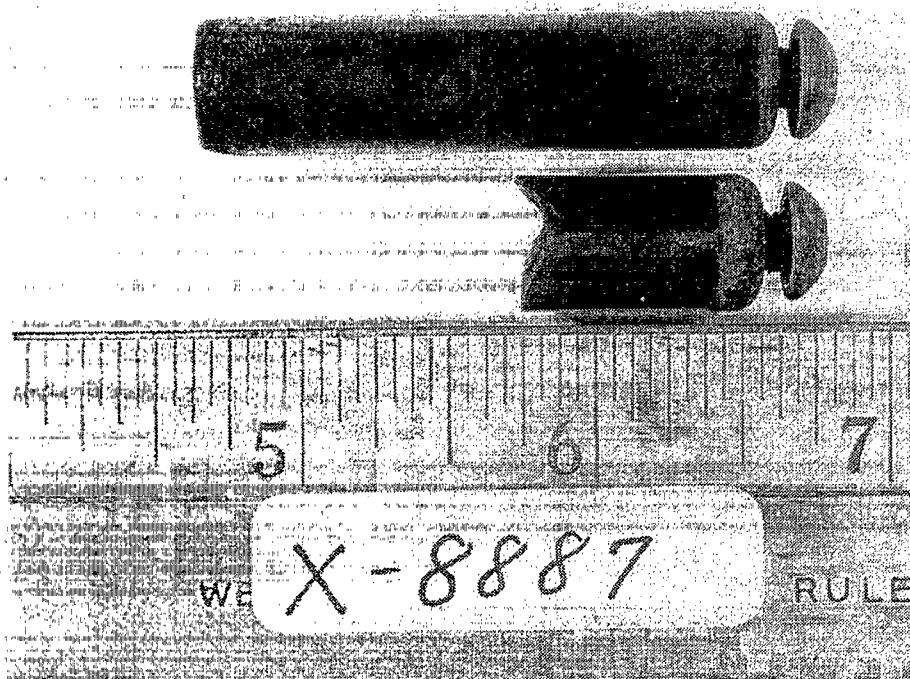
Figure E-15:

Photograph shows the general configuration of the intact dowel pin removed from the idler shaft, and a portion of the fractured pin. Both pins exhibit the threaded machine screws, which were placed in holes drilled in the center of each pin to allow later pin removal.

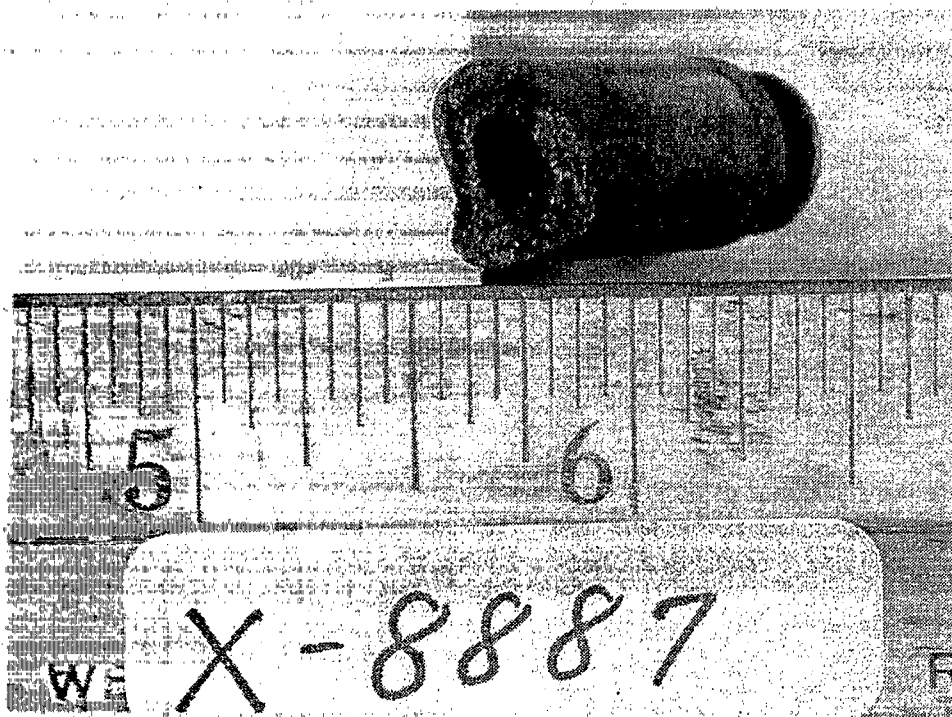
Figure E-16:

Perspective view of the fractured dowel pin showing the fracture face extending through the drilled hole within the center of the pin.

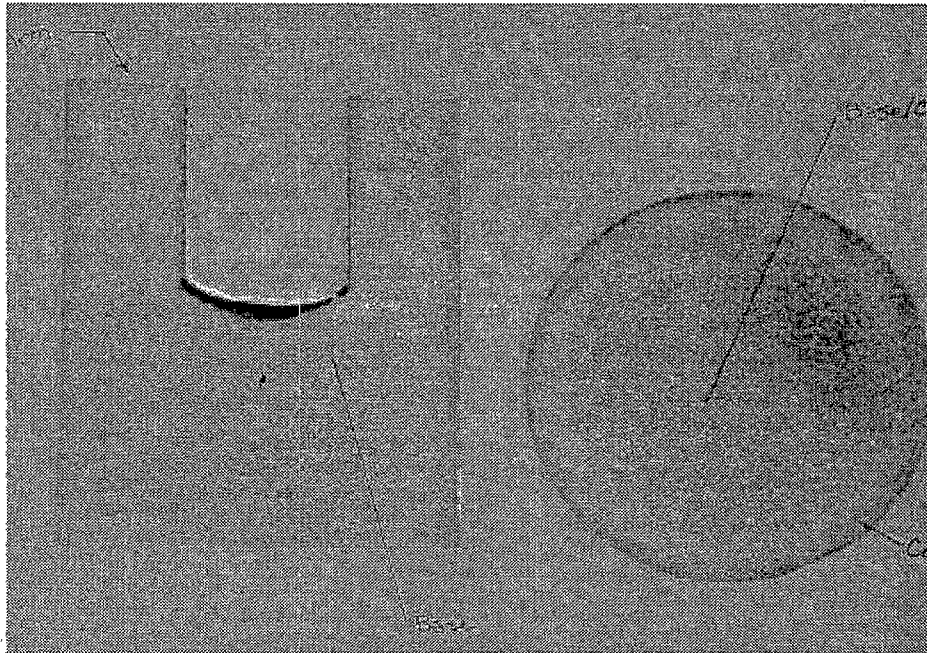
Figure E-17: Views of the longitudinal and transverse cross-sections taken through the intact dowel pin showing the carburized case at both the outside diameter of the pin and within the drilled hole.

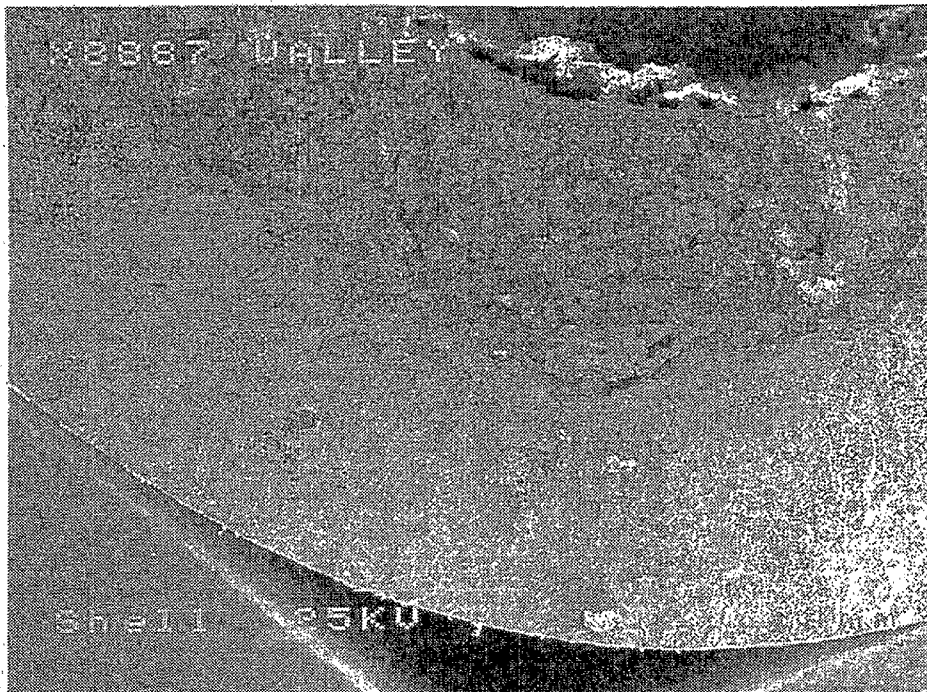
Figure E-18: 25X magnification fractograph displaying a portion of the fracture face of the dowel pin which broke in the service of the 36" Clow check valve.

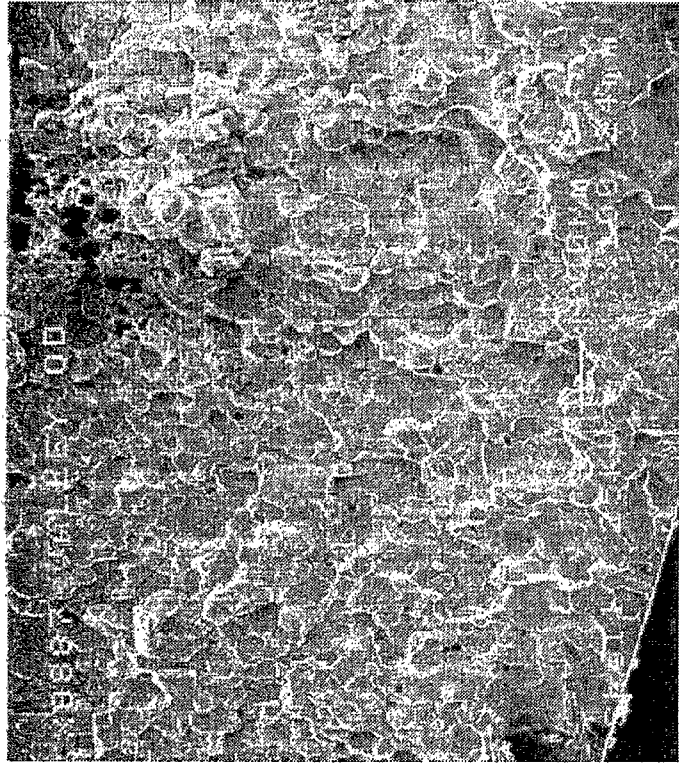
Figure E-19: 100X magnification scanning electron microscope (SEM) fractograph depicting the intergranular fracture at the carburized surface of the dowel pin.

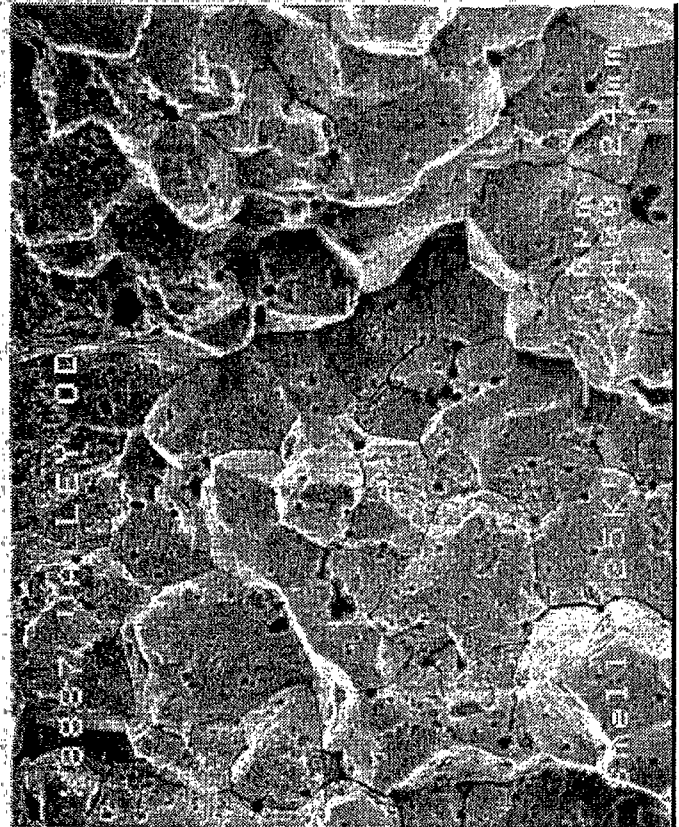
Figure E-20: 400X magnification SEM fractograph of the dowel pin shows details of the intergranular “rock candy” fracture surface at the outside diameter of the dowel pin, a characteristic of hydrogen embrittlement failure mode.

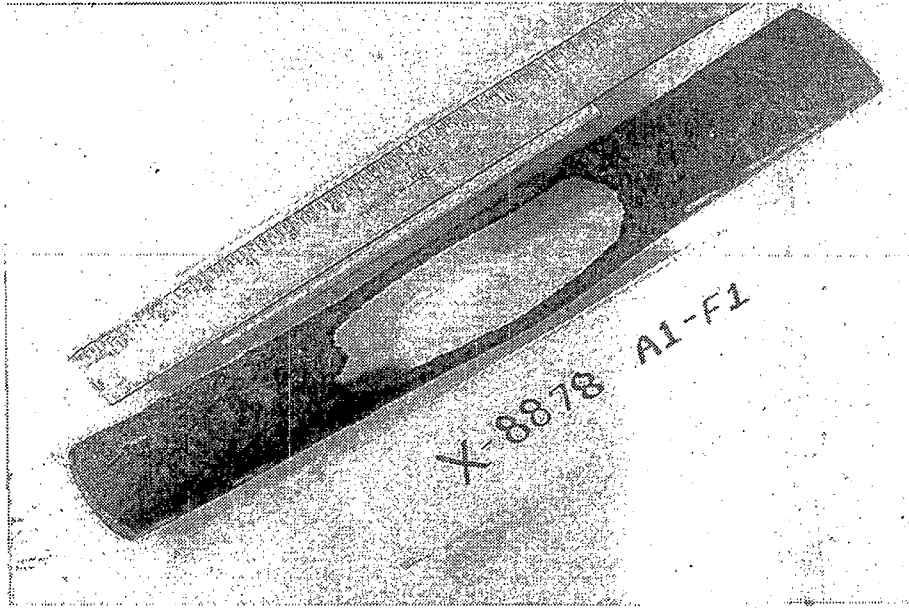
Figure E-21: A view of pipe section X-8878, one of four pipe sections removed from OP-III in addition to the Clow check valve for laboratory analysis as possible sources of the initial flammable gas leak.

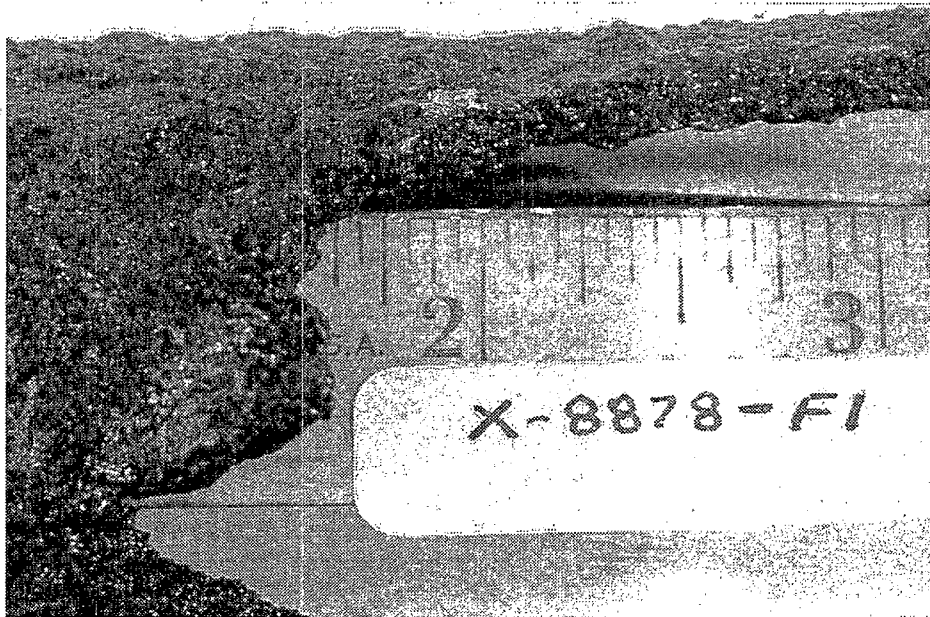
Figure E-22: At higher magnification, this macrograph shows the high temperature oxidation and fire damage around the opening in the pipe section. Laboratory analysis of this and each of the other three pipe sections revealed similar fire-induced failure modes, indicating that none were the likely source of the initial flammable gas leak.
