***Beach and
Vegetation-Line Changes
at Galveston Island, Texas:
Erosion, Deposition, and Recovery
from Hurricane Alicia***

***Robert A. Morton
Jeffrey G. Paine***

***Bureau of Economic Geology
W. L. Fisher, Director
The University of Texas at Austin
Austin, Texas 78713***

Geological Circular 85-5

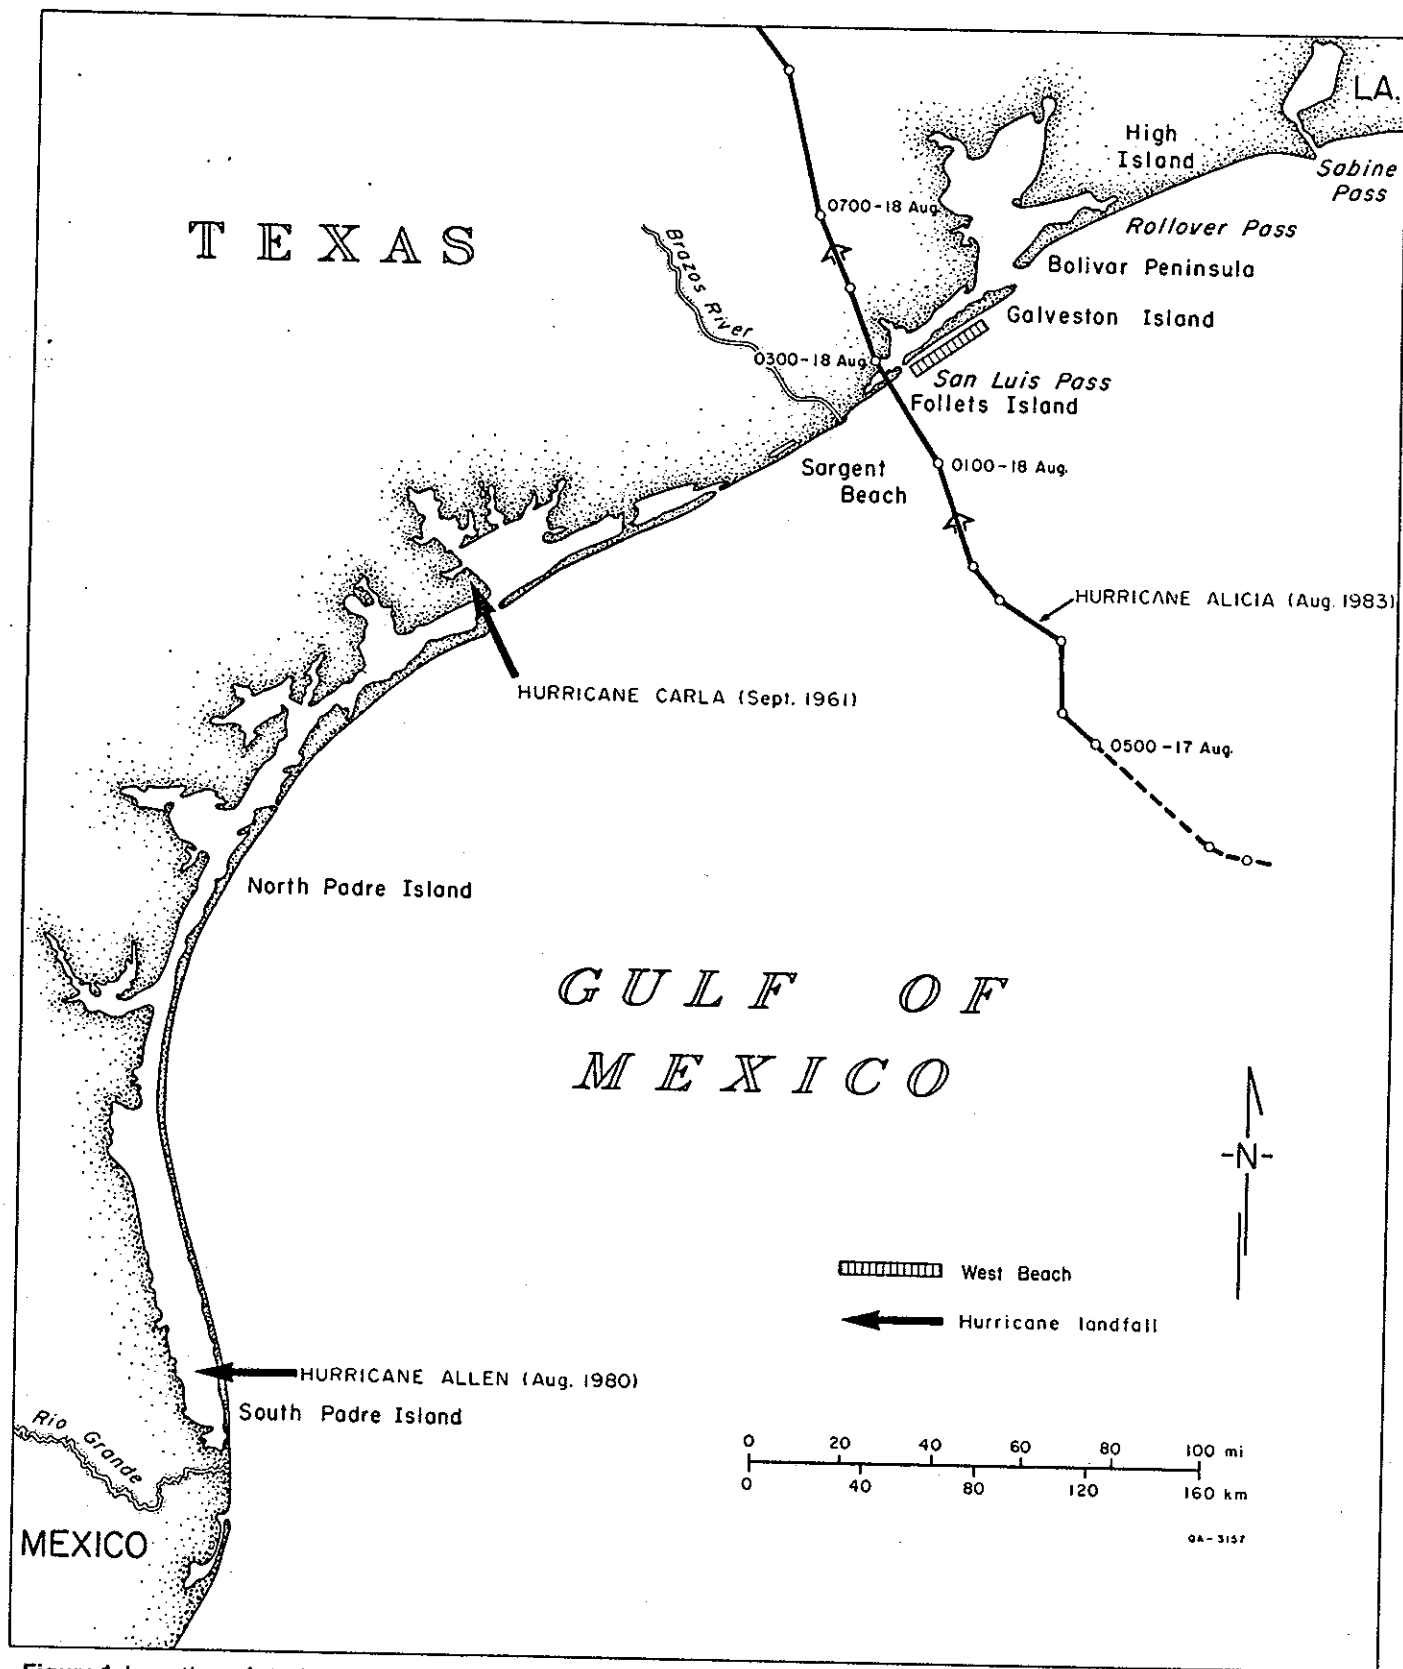
Figure 1. Location of study area (West Beach), geographic features, and sites of recent hurricane landfall along the Texas Gulf Coast.

On August 18, 1983, Hurricane Alicia crossed the upper Texas Gulf Coast (fig. 1), causing unsurpassed economic losses. Alicia was neither the first storm to strike Galveston Island (appendix A) nor the first to emphasize the hazards of building on a barrier island. The 1900 hurricane was larger and more deadly than Alicia, but Alicia was the first Texas storm in recent history that damaged or destroyed much of the beachfront property in its path. Strong winds, waves, and currents devastated residential and commercial buildings while reshaping the island's sandy surface. As a result of the widespread destruction, the nation's attention was briefly turned to the dramatic beach changes and attendant legal issues that confronted the State and littoral property-owners.

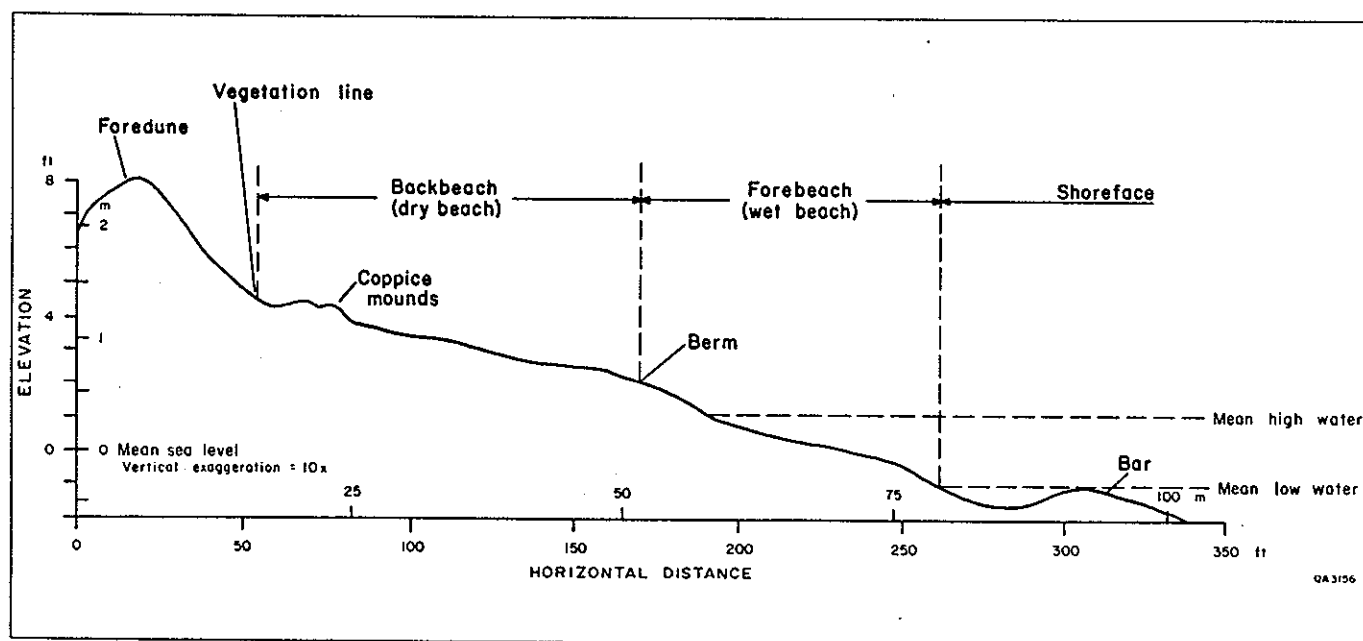
Figure 2. Generalized pre-storm profile of West Beach showing morphological subdivisions of the beach and related tidal and physiographic boundaries.

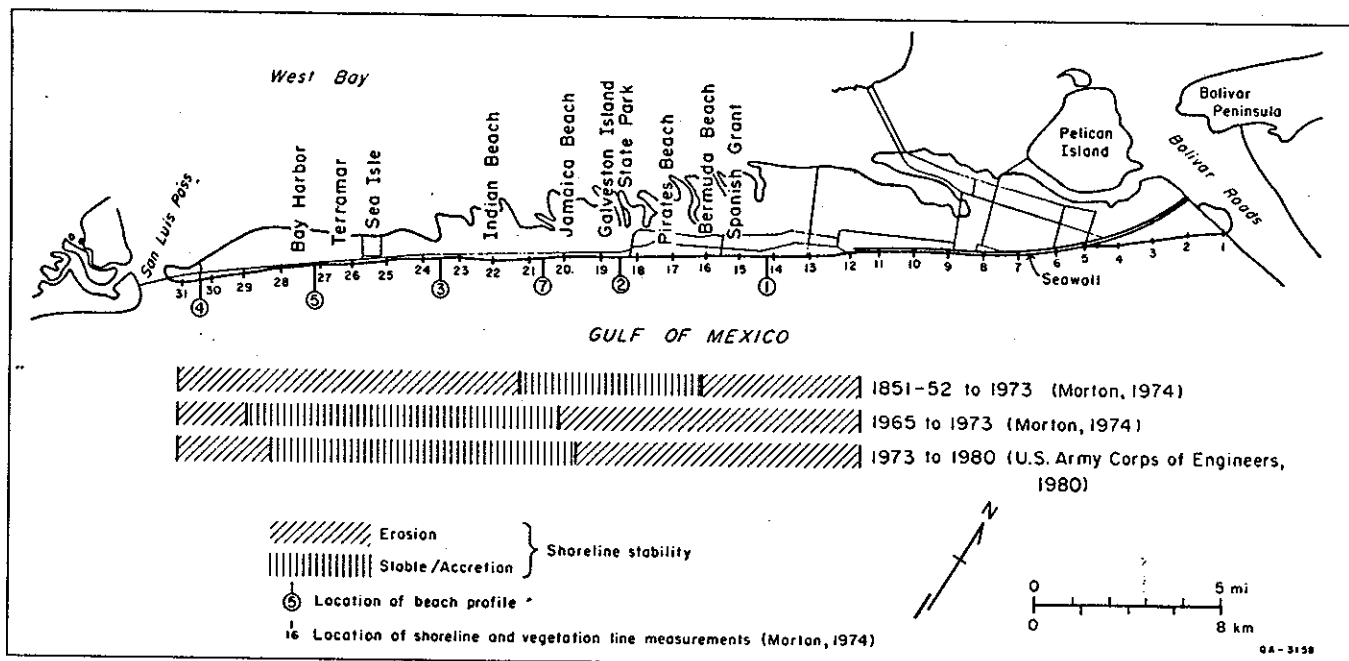
Figure 3. Measuring stations, beach-profile sites, subdivisions, and stability of Gulf shoreline, Galveston Island. Numbered measuring stations (appendix C) spaced approximately 5,000 ft apart; intermediate stations, spaced approximately 1,250 ft apart, are not shown here but are included in appendix C.

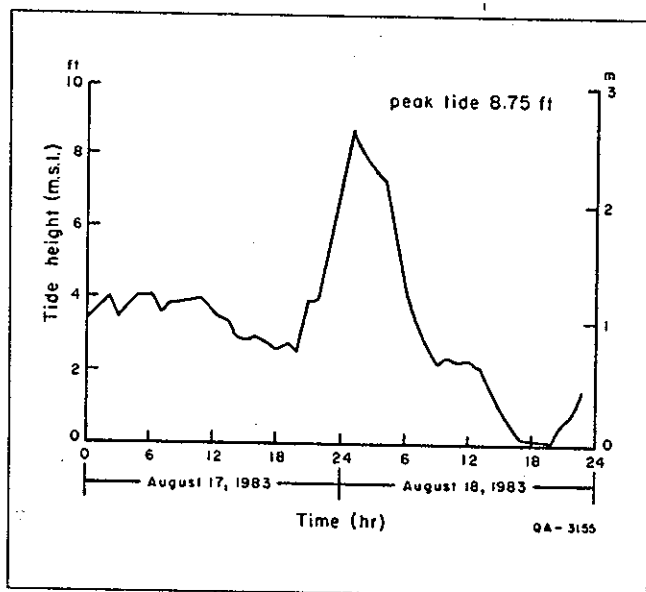
Figure 4. Gulf tidal elevations at Pleasure Pier, Galveston Island, during Hurricane Alicia. Data from National Ocean Service.

Counterclockwise air circulation of northern hemisphere hurricanes increases water levels to the right of the storm's path. Because the center of Alicia passed southwest of Galveston, the island was subjected to higher tides and sustained more damage than other coastal areas. Predictions of tides 12 ft above normal near landfall were accurate; a still-water elevation of 12.7 ft above m.s.l. was measured at San Luis Pass, and water elevations of 6.5 to 11.0 ft above m.s.l. were measured along the gulf side of Galveston Island (U.S. Army Corps of Engineers, 1983a). Flood elevations (fig. 4) were generally lower west of the storm (5 to 9 ft above m.s.l. along most of Follets Island) and farther from the center (7 to 9 ft above m.s.l. along Bolivar Peninsula).

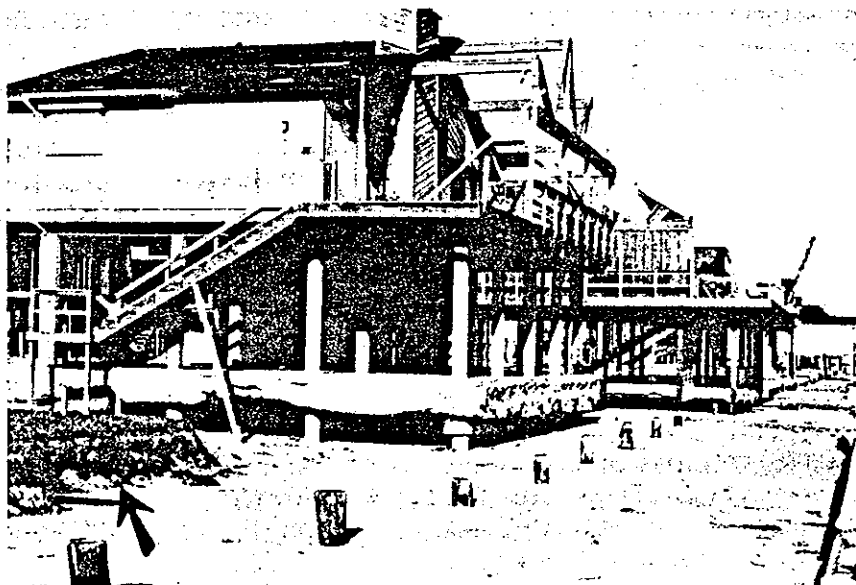
Figure 5. Undermined beach home landward of failed bulkhead, Sea Isle subdivision. Erosional escarpment visible at lower left (see arrow).

allowed normal high tides to reach farther inland than they did before the storm. Indeed, many West Beach structures that were landward of the continuous vegetation line before the storm were on the beach and within reach of normal tides after the storm (fig. 5).

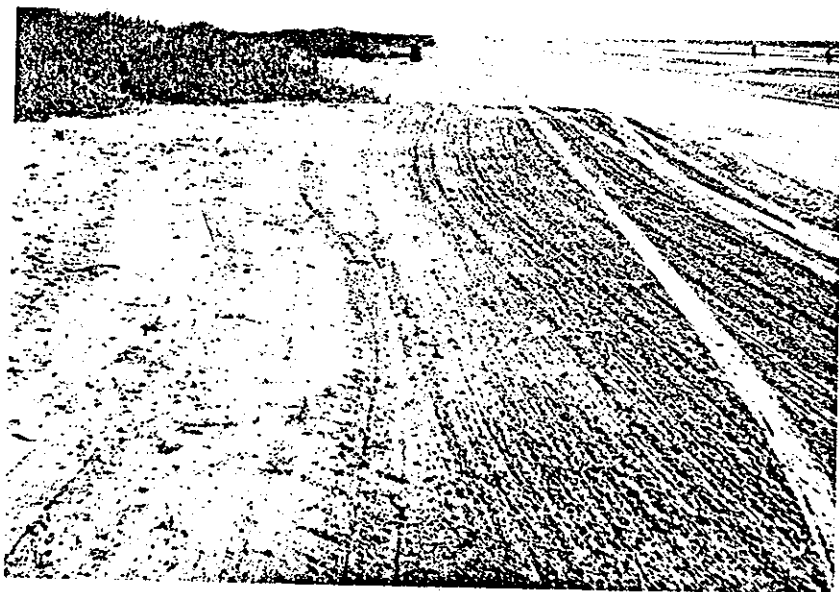
Figure 6a. Pre-Alicia vegetation line, West Beach.

The boundary on or near the beach that is consistent regardless of the tide or season is the vegetation line (figs. 6a and 6b). Like the shoreline, it is also a dynamic boundary; however, it changes imperceptibly from day to day under normal conditions. Under extreme conditions, such as during a hurricane, it can move rapidly landward tens or hundreds of feet as a result of beach erosion. In the aftermath of a hurricane, several years may pass as coastal processes gradually increase backbeach

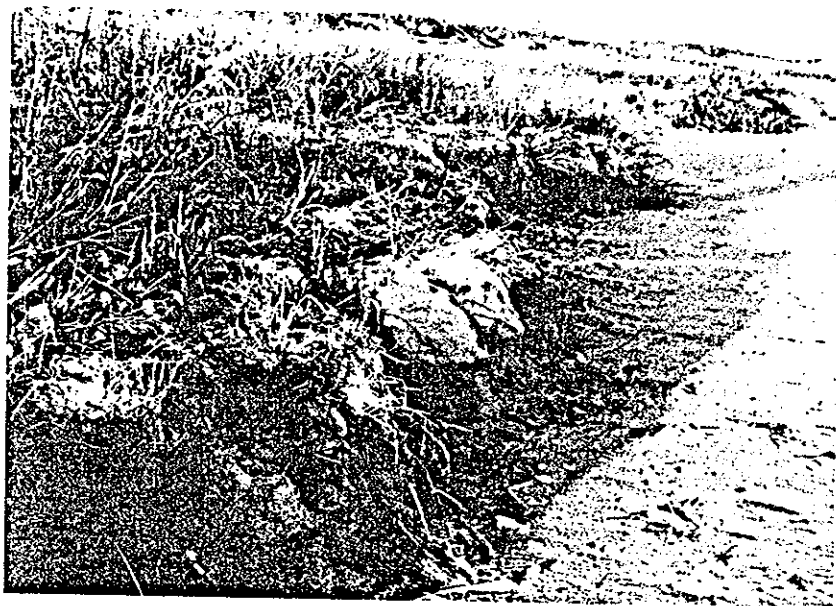
Figure 6b. Post-Alicia erosional escarpment and vegetation line, West Beach. Shoreline to right of area shown.

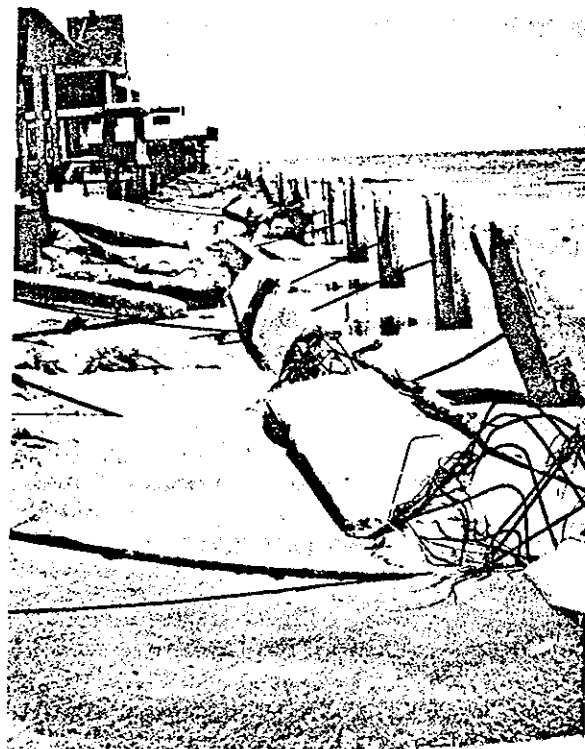
Figure 8. Remnants of a reinforced concrete bulkhead destroyed by Hurricane Alicia, Sea Isle subdivision.

24.75 and 25.00 and fig. 8), although destroyed by the storm, reduced vegetation-line retreat by 75 to 100 ft compared with adjacent unbulkheaded parts of the development, and by 20 to 50 ft relative to adjacent natural areas. These bulkheads only reduced vegetation-line retreat and not shoreline erosion; consequently, bulkheaded beaches were generally narrower than adjacent unbulkheaded beaches after the storm.

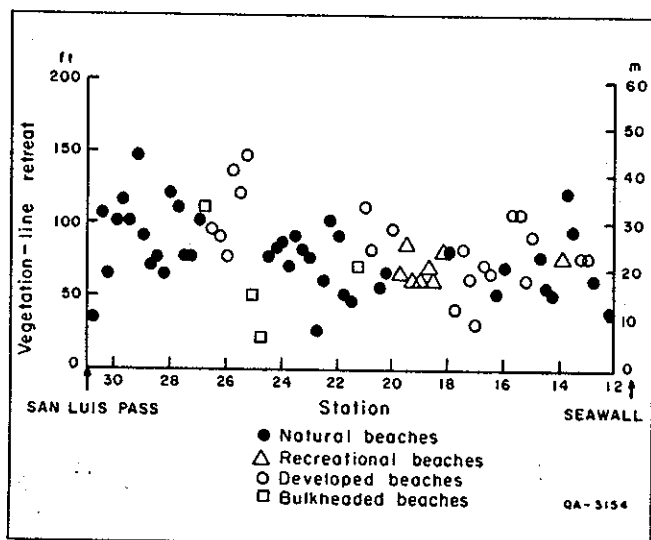
Figure 7. Vegetation-line retreat caused by Hurricane Alicia, West Beach. Station locations shown in figure 3.

Comparison of vegetation lines shown on aerial photographs taken in June 1982 and August 1983 reveals that Hurricane Alicia moved the vegetation line on West Beach landward an average of 78 ft (table 1 and appendix C). Measured vegetation-line retreat ranged from 20 to 145 ft and generally decreased away from San Luis Pass (fig. 7). The most retreat (145 ft) was observed both at

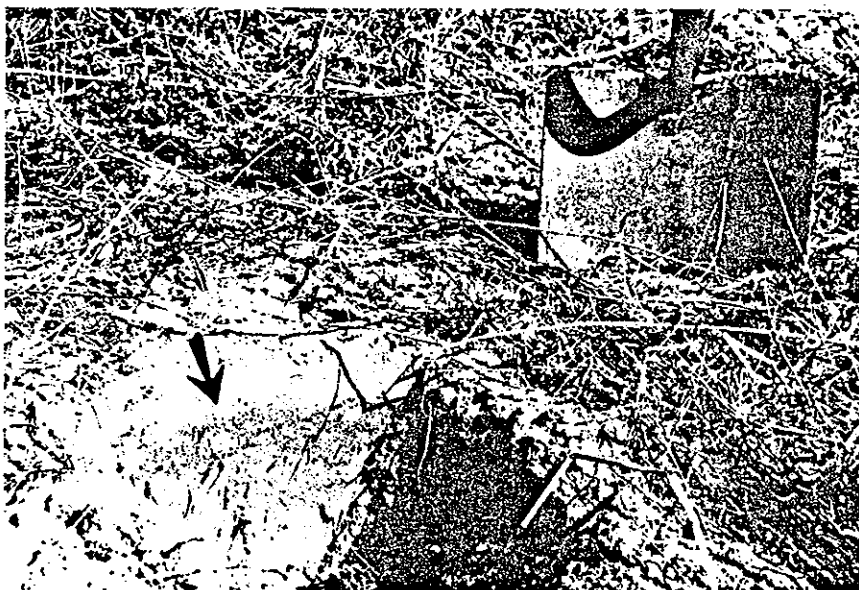
Figure 9. Thin layer of light-colored sand (Alicia washover deposits) covering dark, organic-rich soil zone. Dark zone (see arrow) represents pre-storm ground surface.

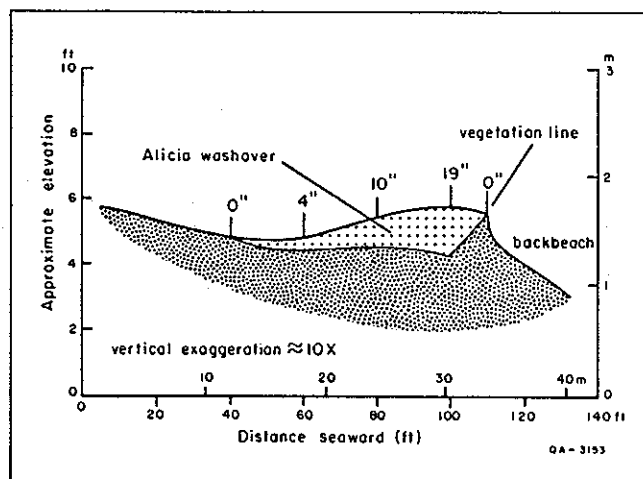
Figure 10. Profile of typical Alicia washover deposit along West Beach. Profile constructed from trenches along profile 3.

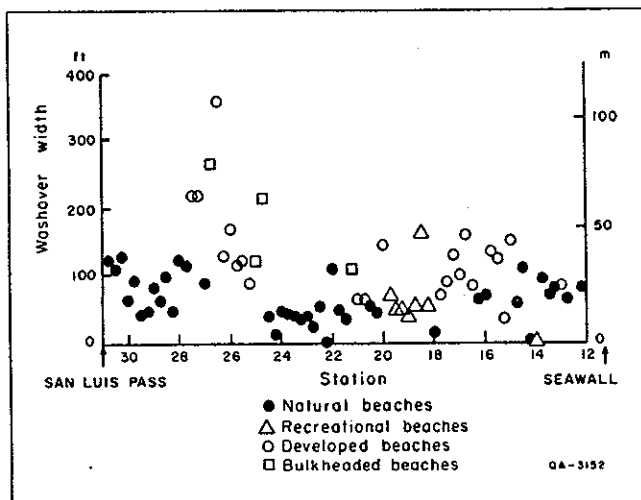
Figure 11. Inland extent of washover deposition from Hurricane Alicia, West Beach. Station locations shown in figure 3.

deposition than did adjacent natural areas (fig. 11). Washover deposits extended landward of the post-storm vegetation line from 30 to 355 ft at measuring points in developed areas, and as much as 1,000 ft in specific areas between measuring points. The widest washover deposits in unbulkheaded developed stations were found at the westernmost subdivisions on Galveston Island; one station in Terramar recorded 355 ft, and two stations in Bay Harbor recorded 215 ft each.

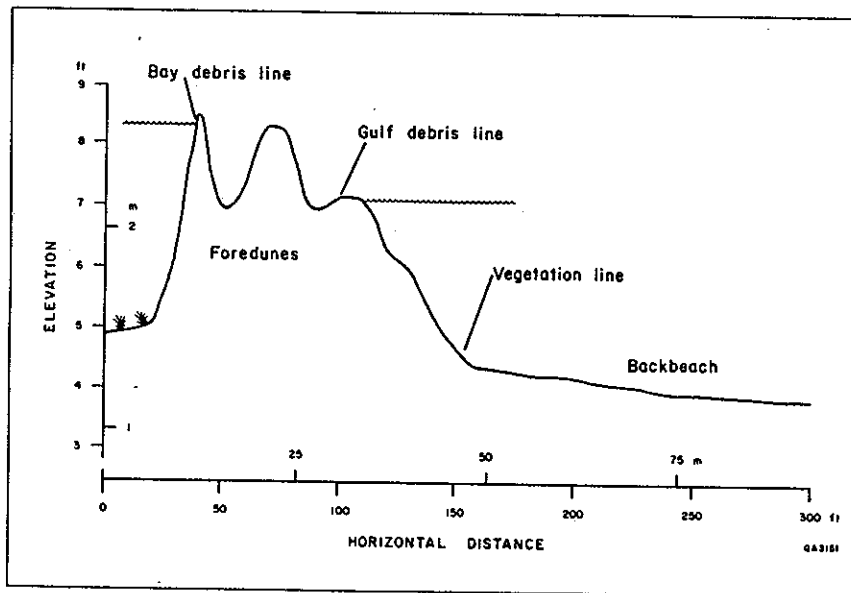
Figure 13. Profile of dune ridge on Follets Island (fig. 1) showing Gulf and bay debris-line elevations. Profile location is adjacent to a large storm-runoff drainage channel.

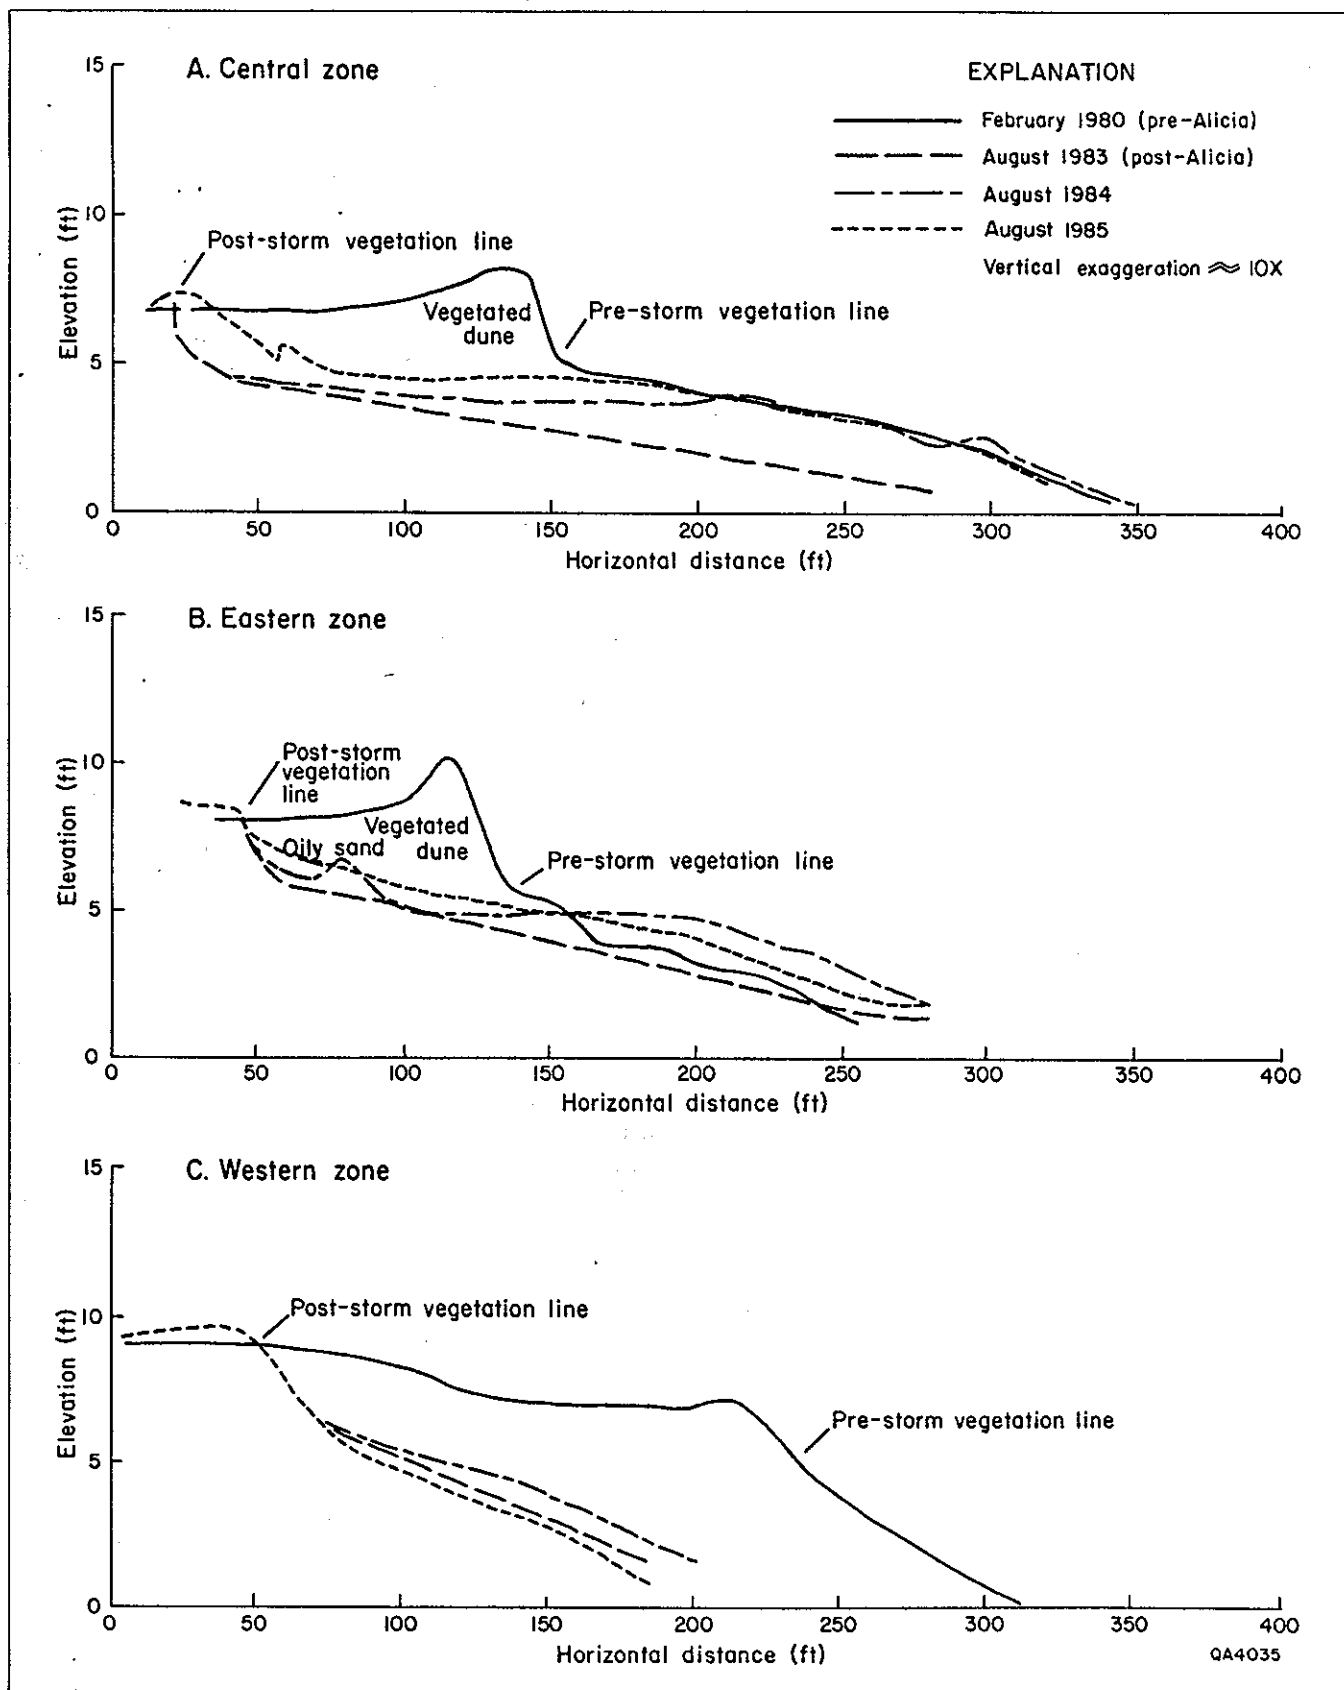
Figure 14. Pre- and post-Alicia beach profiles from (A), the central stable zone of West Beach (profile 3); (B), the eastern erosional zone near West Beach tower base (profile 1); and (C), the western erosional zone near San Luis Pass (profile 4). February 1980 profiles by U.S. Army Corps of Engineers (1980).

Profile 1 depicts an area located about 2 mi southwest of the end of the seawall along an erosional shoreline. Pre- and post-storm profiles (fig. 14B) indicate that the shoreline retreated 50 to 75 ft, whereas the vegetation line moved 75 to 85 ft landward. Consistent recovery was observed at this site during the first post-storm year, and, as at profile 3, the August 1984 shoreline had nearly attained its pre-storm position, but backbeach elevation was several feet below the pre-storm elevation. Some windblown sand was deposited along the base of the erosional escarpment, and some oily sand was dumped on the backbeach during the cleanup of the *Alvenus* oil spill in the summer of 1984. About 59 percent of the sand eroded from the beach near profile 1 during Alicia had returned by August 1984.

Profile 4 is located along the highly erosional shoreline just east of San Luis Pass and is closest to the site of Alicia's landfall. Here Alicia caused about 100 ft of shoreline erosion and about 150 ft of vegetation-line retreat. The recovery profiles are strikingly different from those farther east along the island (fig. 14C). In the western zone, little sand returned to the beach during the first post-storm year; during the period most favorable for beach recovery (May to August 1984), the shoreline accreted only about 15 ft. Slight recovery occurred between August 1983 and February 1984 (amounting to a little more than 6 percent of the total amount eroded), but erosion between February and May 1984 removed more sand than was deposited in the previous period and left the shoreline near its post-Alicia position. Minor accretion between May and August 1984 brought the recovery at the end of the first post-storm year to only 7 percent of the total sand eroded.

Slight erosion at profile 4 between August and December 1984 decreased recovery to 6 percent of the volume eroded by Alicia. However, severe erosion between December 1984 and February 1985 removed the equivalent of 15 percent of the sand eroded by Alicia. This winter erosion caused net shoreline retreat and lowered the backbeach as much as 1 ft below its elevation after Alicia. Erosion to the end of the second post-storm year pushed the shoreline farther landward of its post-storm position (fig. 14C).

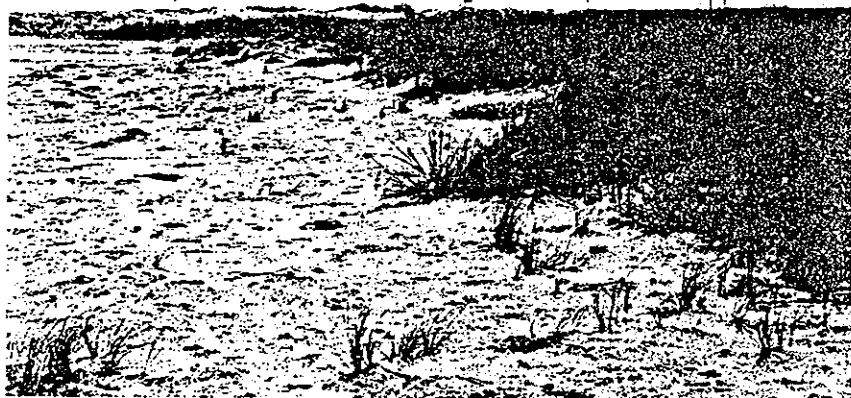
Figure 15. Sprigs of vegetation colonizing the backbeach near Indian Beach.

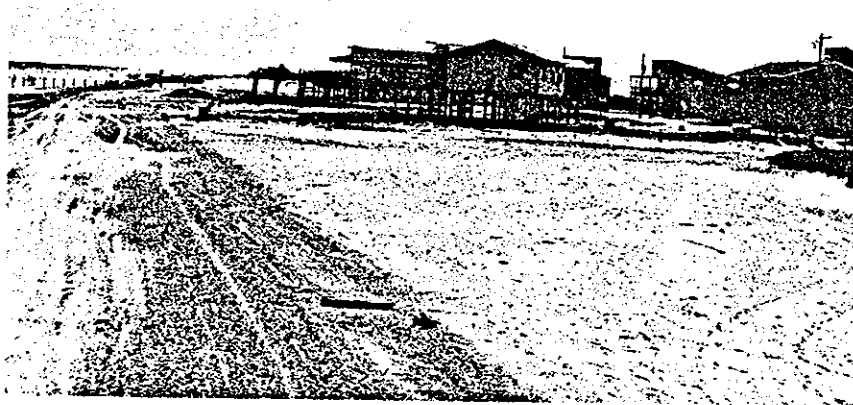
Figure 16. Post-Alicia view of Jamaica Beach subdivision. Fill extends approximately 110 ft seaward of the natural post-storm vegetation line.

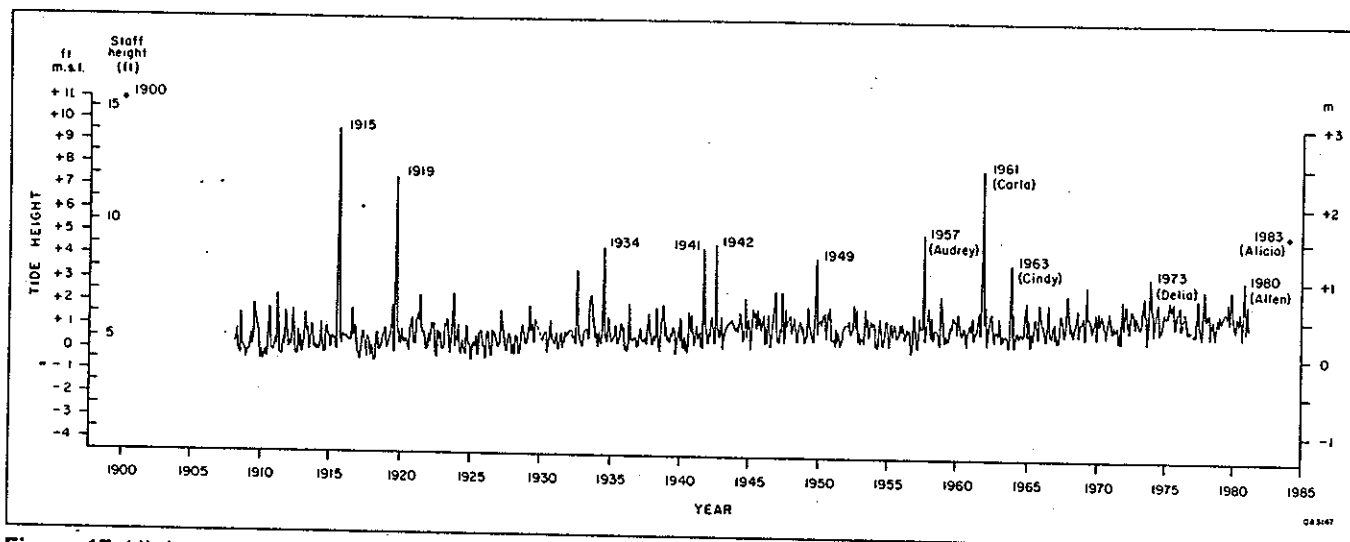
Figure 17. Highest monthly tides observed at Pier 21 on the bay side of Galveston Island, 1908 to 1983. Mean sea level (m.s.l.) calculated from 1960 through 1978 hourly tide heights. Tide heights of earlier storms may not equal heights mentioned in text because of periodic adjustments to mean sea level. Modified from U.S. Army Corps of Engineers (1983b). Data from National Ocean Service.

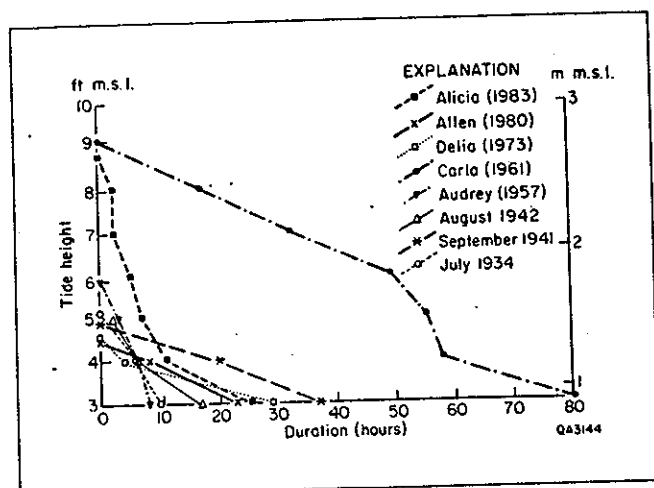
Figure 18. Storm surge height and duration, Galveston Island. Carla (1961) and later storms were recorded at Pleasure Pier (gulf gauge); earlier storms were recorded at Pier 21 (bay gauge). Data from National Ocean Service.

Hurricane Allen washover deposits on West Beach covered approximately 3,570,000 ft². In comparison, Alicia deposits covered 8,599,250 ft² and Carla deposits covered 28,635,000 ft². The more than threefold difference between Alicia and Carla washover deposition was apparently caused by the tremendous difference in surge duration (fig. 18).

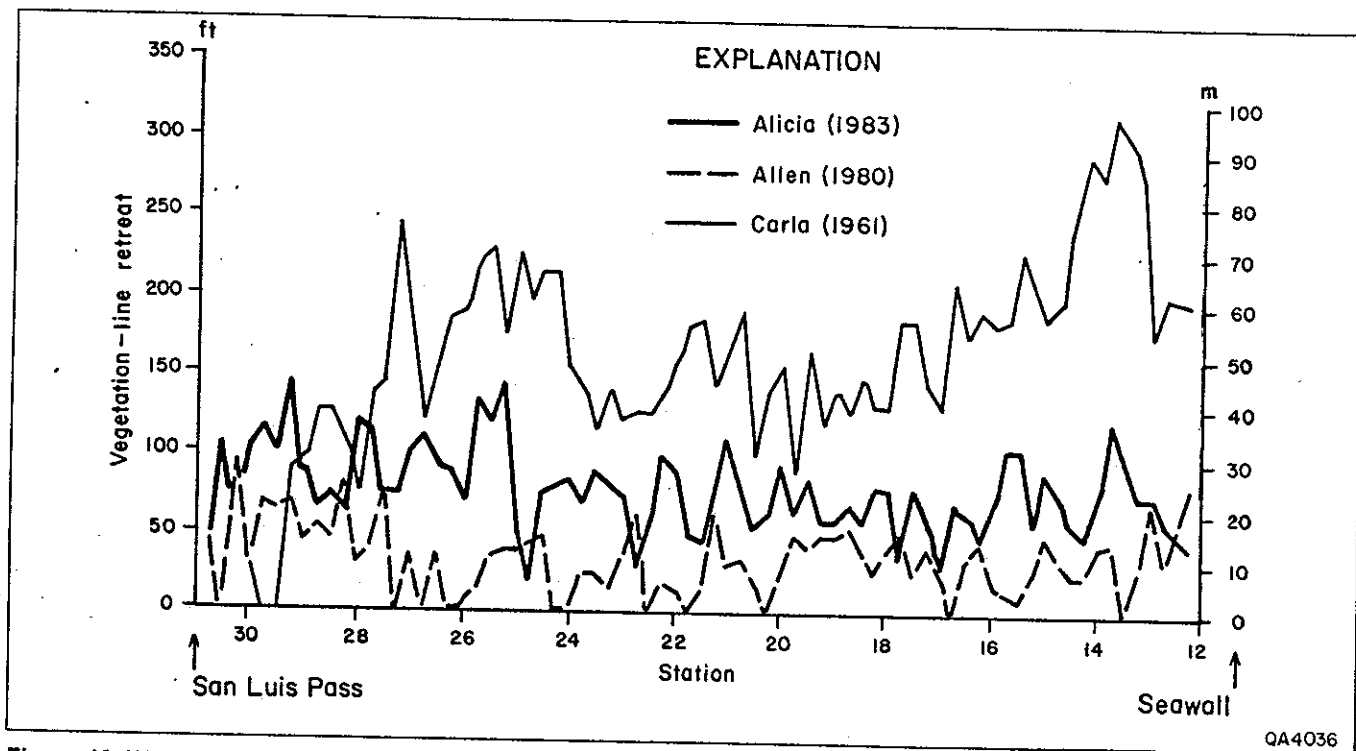
Figure 19. West Beach vegetation-line retreat caused by Hurricanes Carla, Allen, and Alicia. Station locations shown in figure 3.

Vegetation-line retreat along West Beach ranged to as much as 315 ft for Carla, 95 ft for Allen, and 145 ft for Alicia (fig. 19 and appendix C). Carla caused average vegetation-line retreat of 164 ft (table 5), or more than twice that caused by Alicia (78 ft) and almost five times that caused by Allen (34 ft). Areal measurements made from pre- and post-storm photographs also indicate that Carla eroded about twice as much vegetated area as did

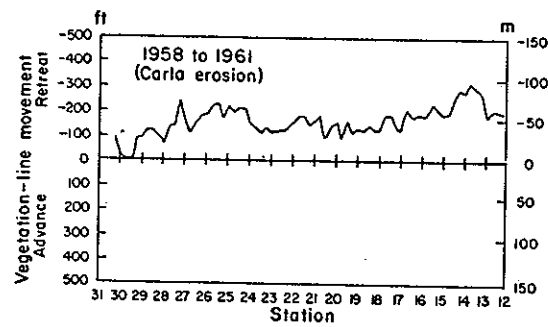
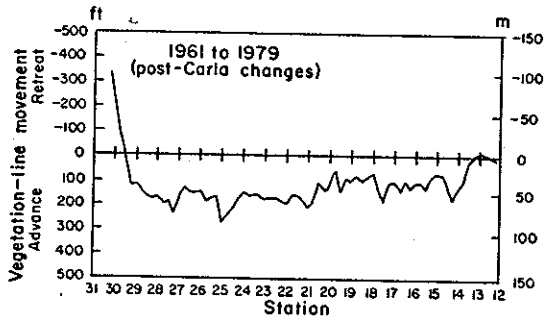
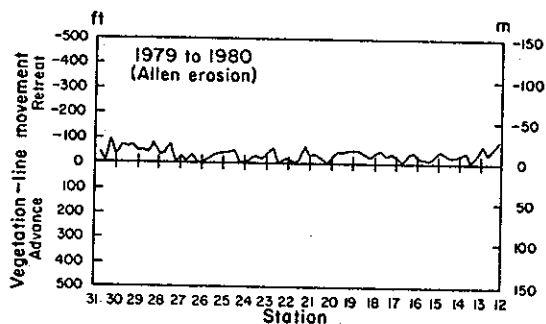
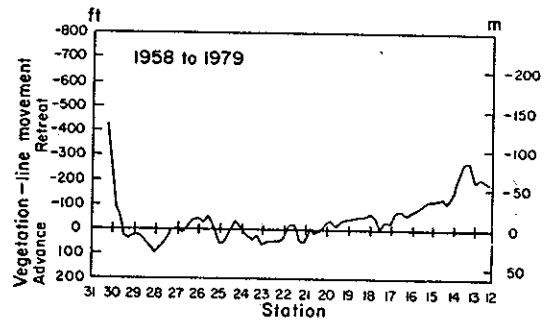
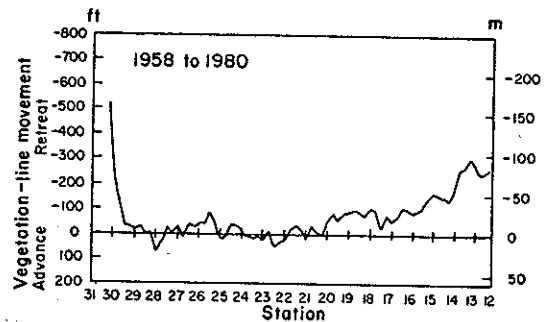
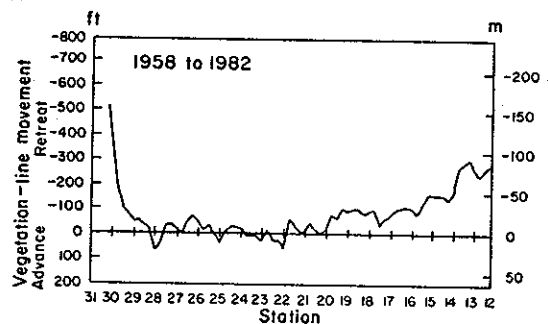
Figure 20. Incremental and cumulative West Beach vegetation-line changes, 1958 to 1983. Left column: vegetation-line changes during Hurricanes Carla, Allen, and Alicia and during intervening recovery periods. Right column: cumulative vegetation-line changes since 1958.

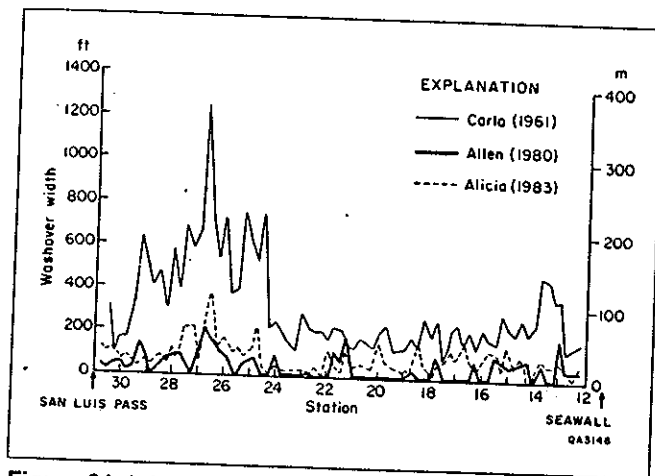
Figure 21. Inland extent of Carla, Allen, and Alicia washover deposition, West Beach. Station locations shown in figure 3.

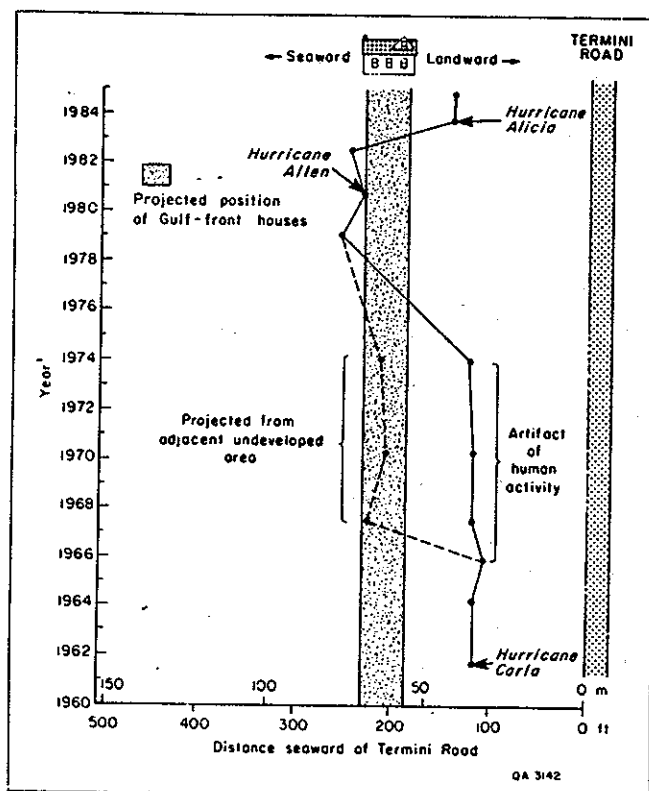
Figure 22. Sequential movement of vegetation line from 1961 to 1985. Profile is within the Sea Isle subdivision (fig. 3). Shading represents the position of Gulf-front houses.

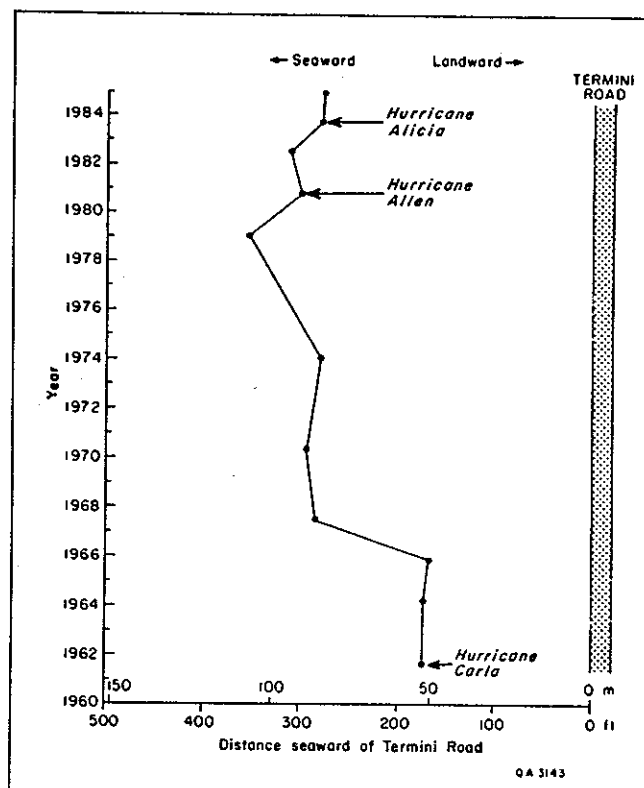
Figure 23. Sequential movement of vegetation line from 1961 to 1985. Profile is within an undeveloped area just east of Sea Isle subdivision (fig. 3).

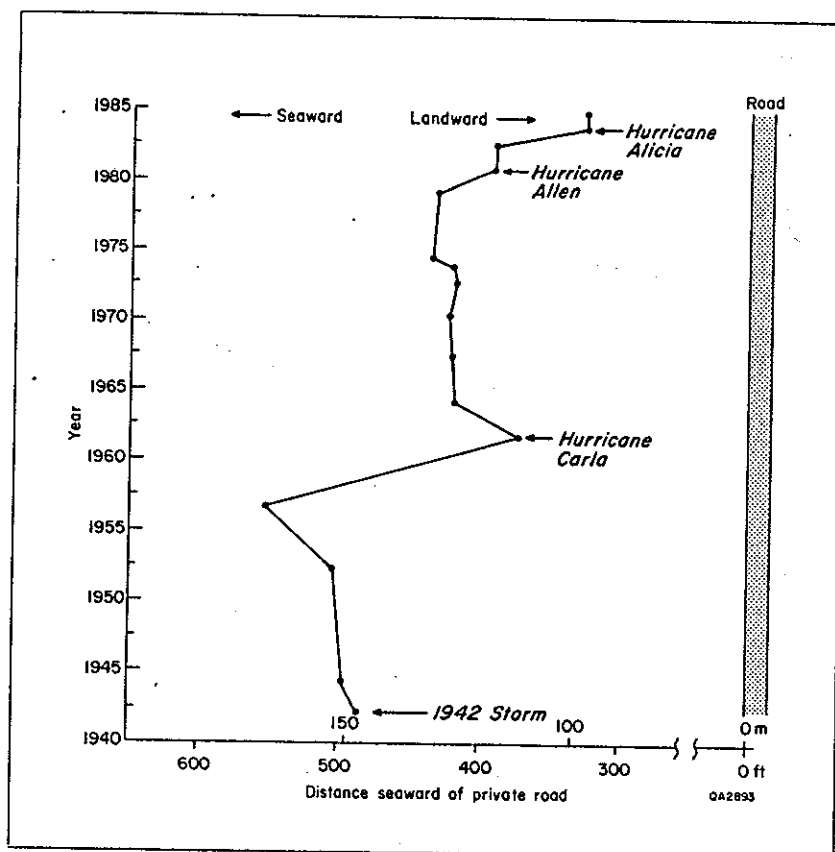
Figure 24. Sequential movement of vegetation line from 1942 to 1985. Profile is within an undeveloped area east of Pirates Beach (fig. 3).
