# **Mathews County Shoreline Management Plan**

**Shoreline Studies Program  
Virginia Institute of Marine Science  
College of William & Mary**

**March 2010**

Special Report in Applied Marine Science and Ocean Engineering No. 417 of the  
Virginia Institute of Marine Science

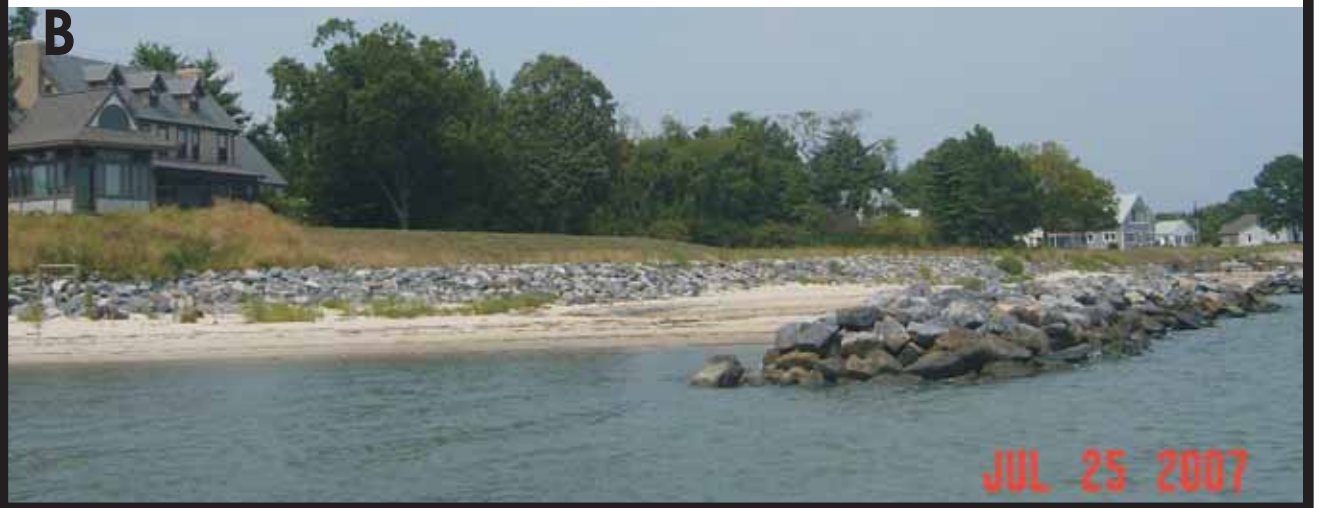
Figure 2-8. A) Breakwaters built on Chesapeake Bay at Festival Beach, Mathews, Virginia and B) breakwaters built on the York River in Gloucester, Virginia.

- 4) Breakwater System: Although single breakwaters can be used, two or more are recommended to address several hundred feet of coast (Figure 2-8). For breakwaters, the level of protection changes with the system dimensions such that larger dimensions generally correspond to bigger fetches and where a beach/dune shoreline is desired.

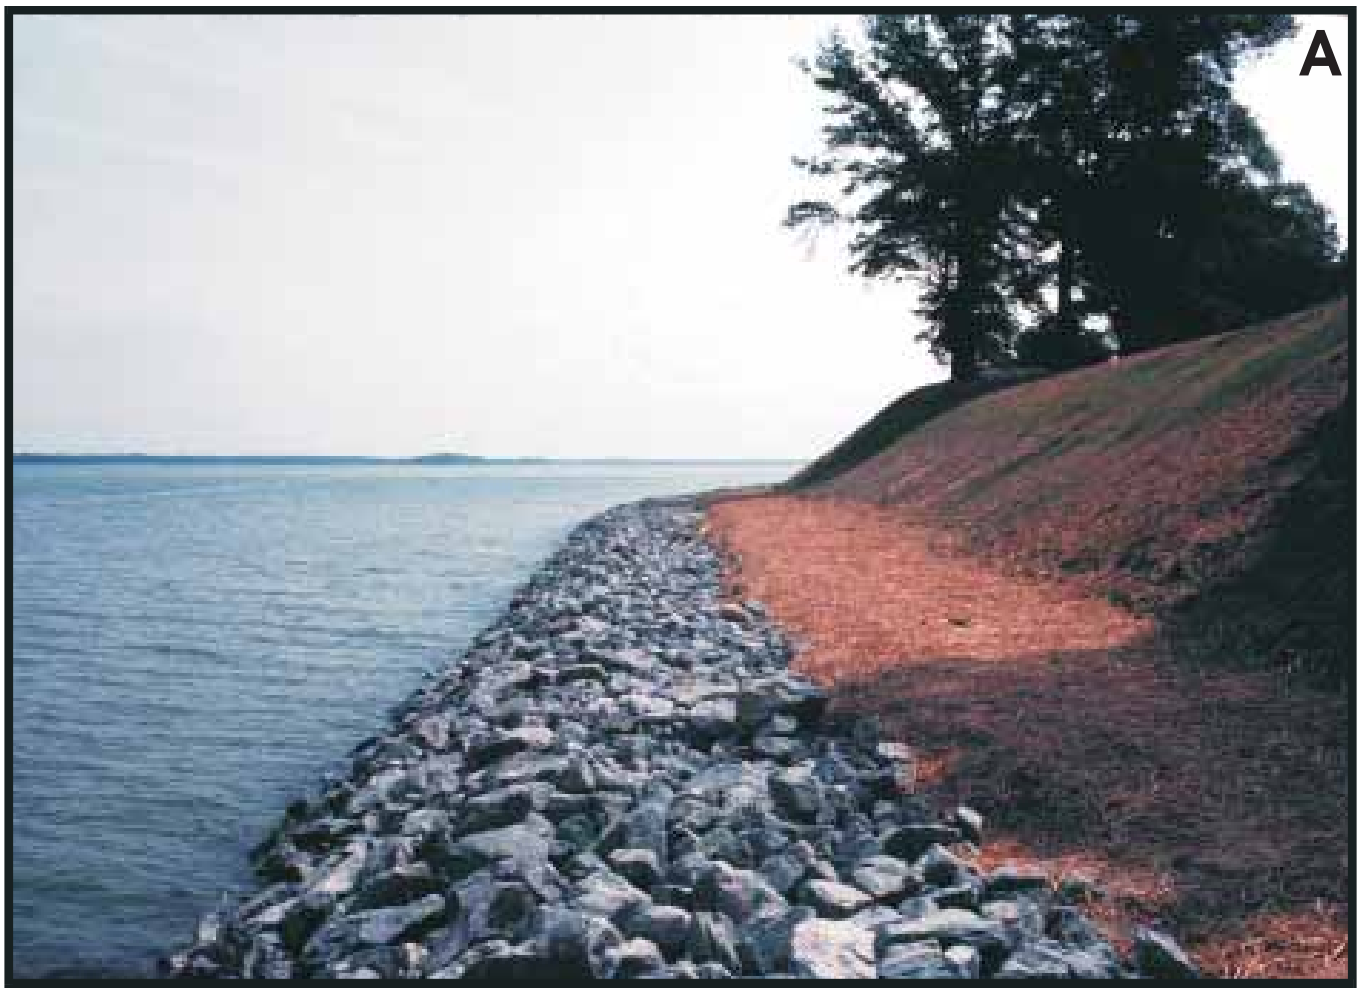
Figure 2-9. A) Stone revetment shortly after construction on the Potomac River, Virginia, and B) cross-section of the elements necessary for proper stone revetment design (Hardaway and Byrne, 1999).

- 5) Revetments: Many bulkheads and revetments exist along the Mathews County coast, some of which are in need of repair or extensions (Figure 2-9). Stone revetments may be the preferred method for shore erosion control along north facing shorelines with high banks and heavy tree cover and other areas where it may be difficult to establish a protective marsh fringe.

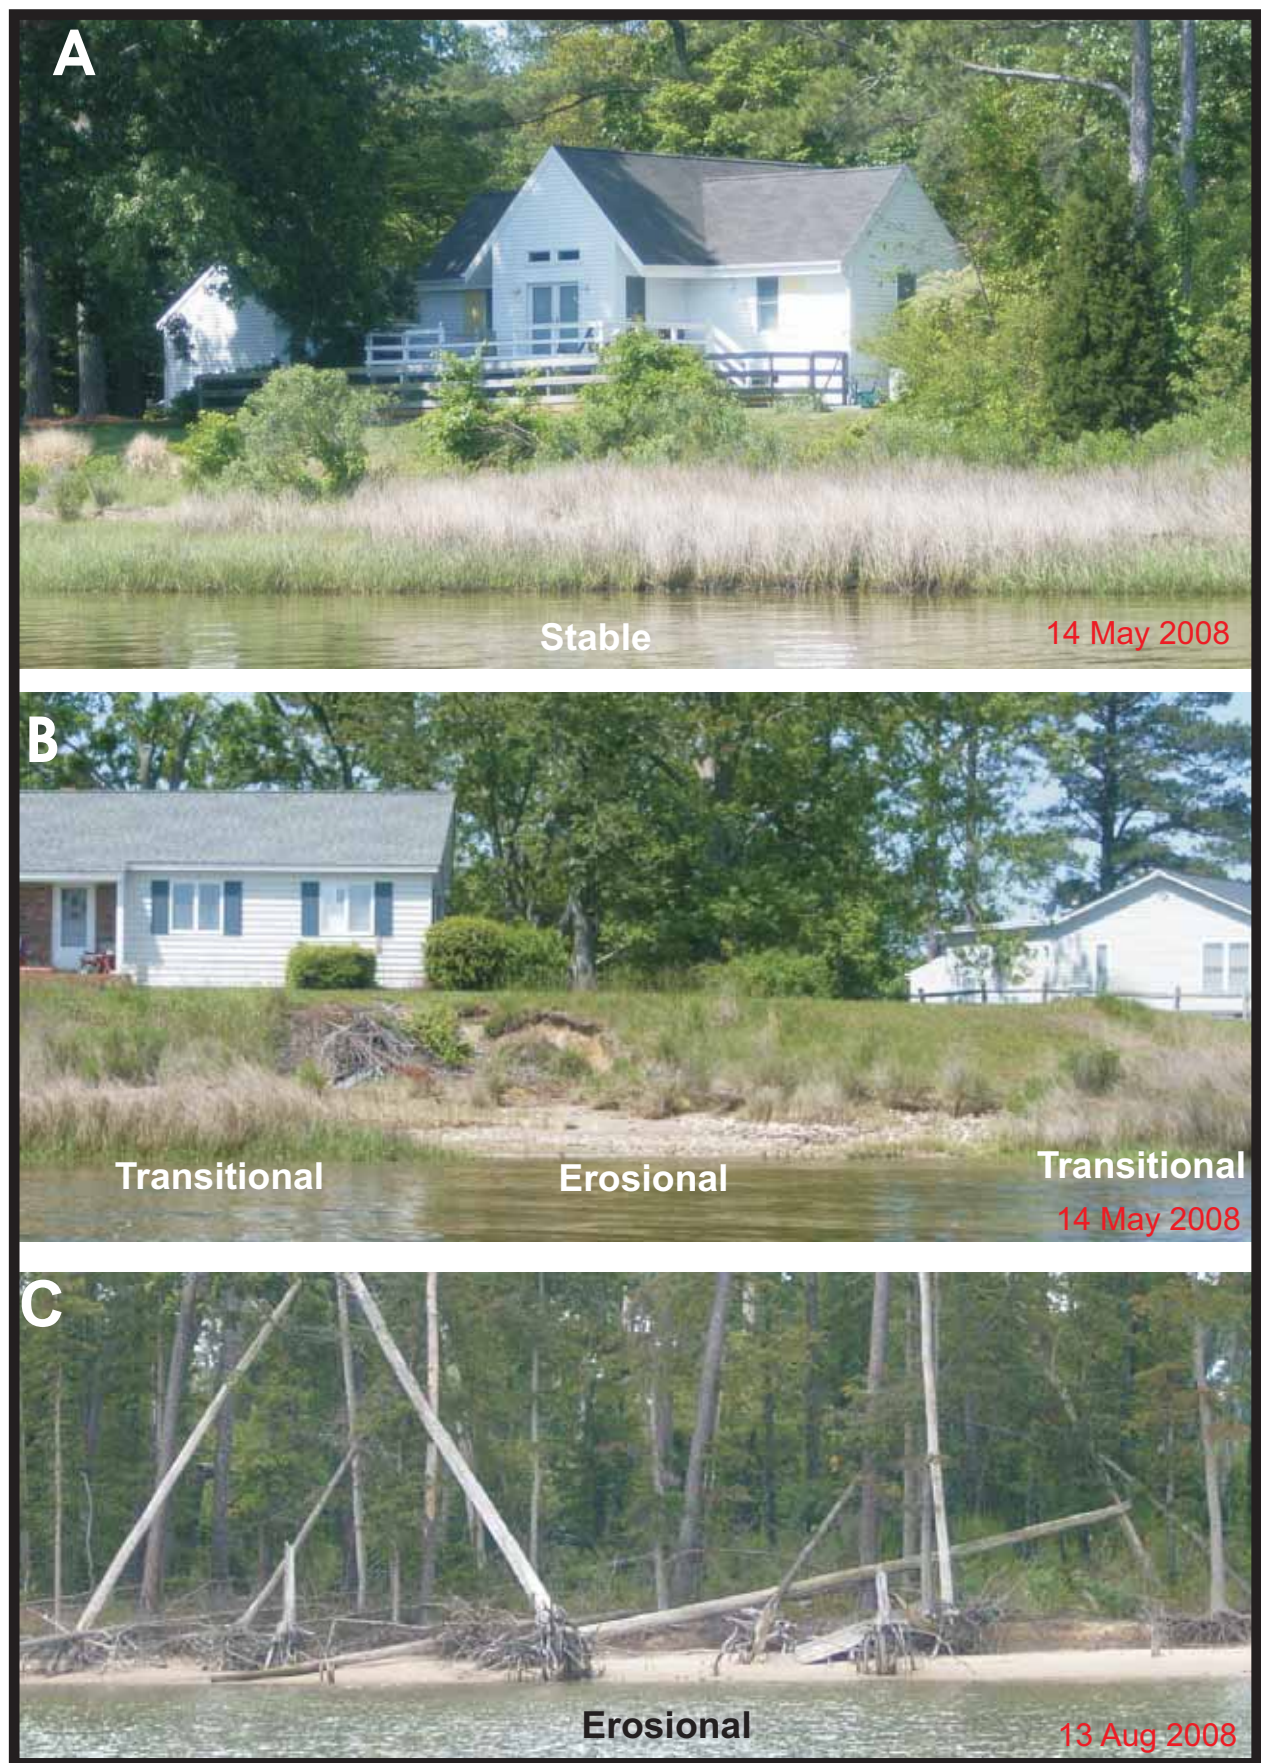
Figure 3-1. These Mathews County shorelines are characterized as A) stable, B) transitional and erosional, and C) erosional.

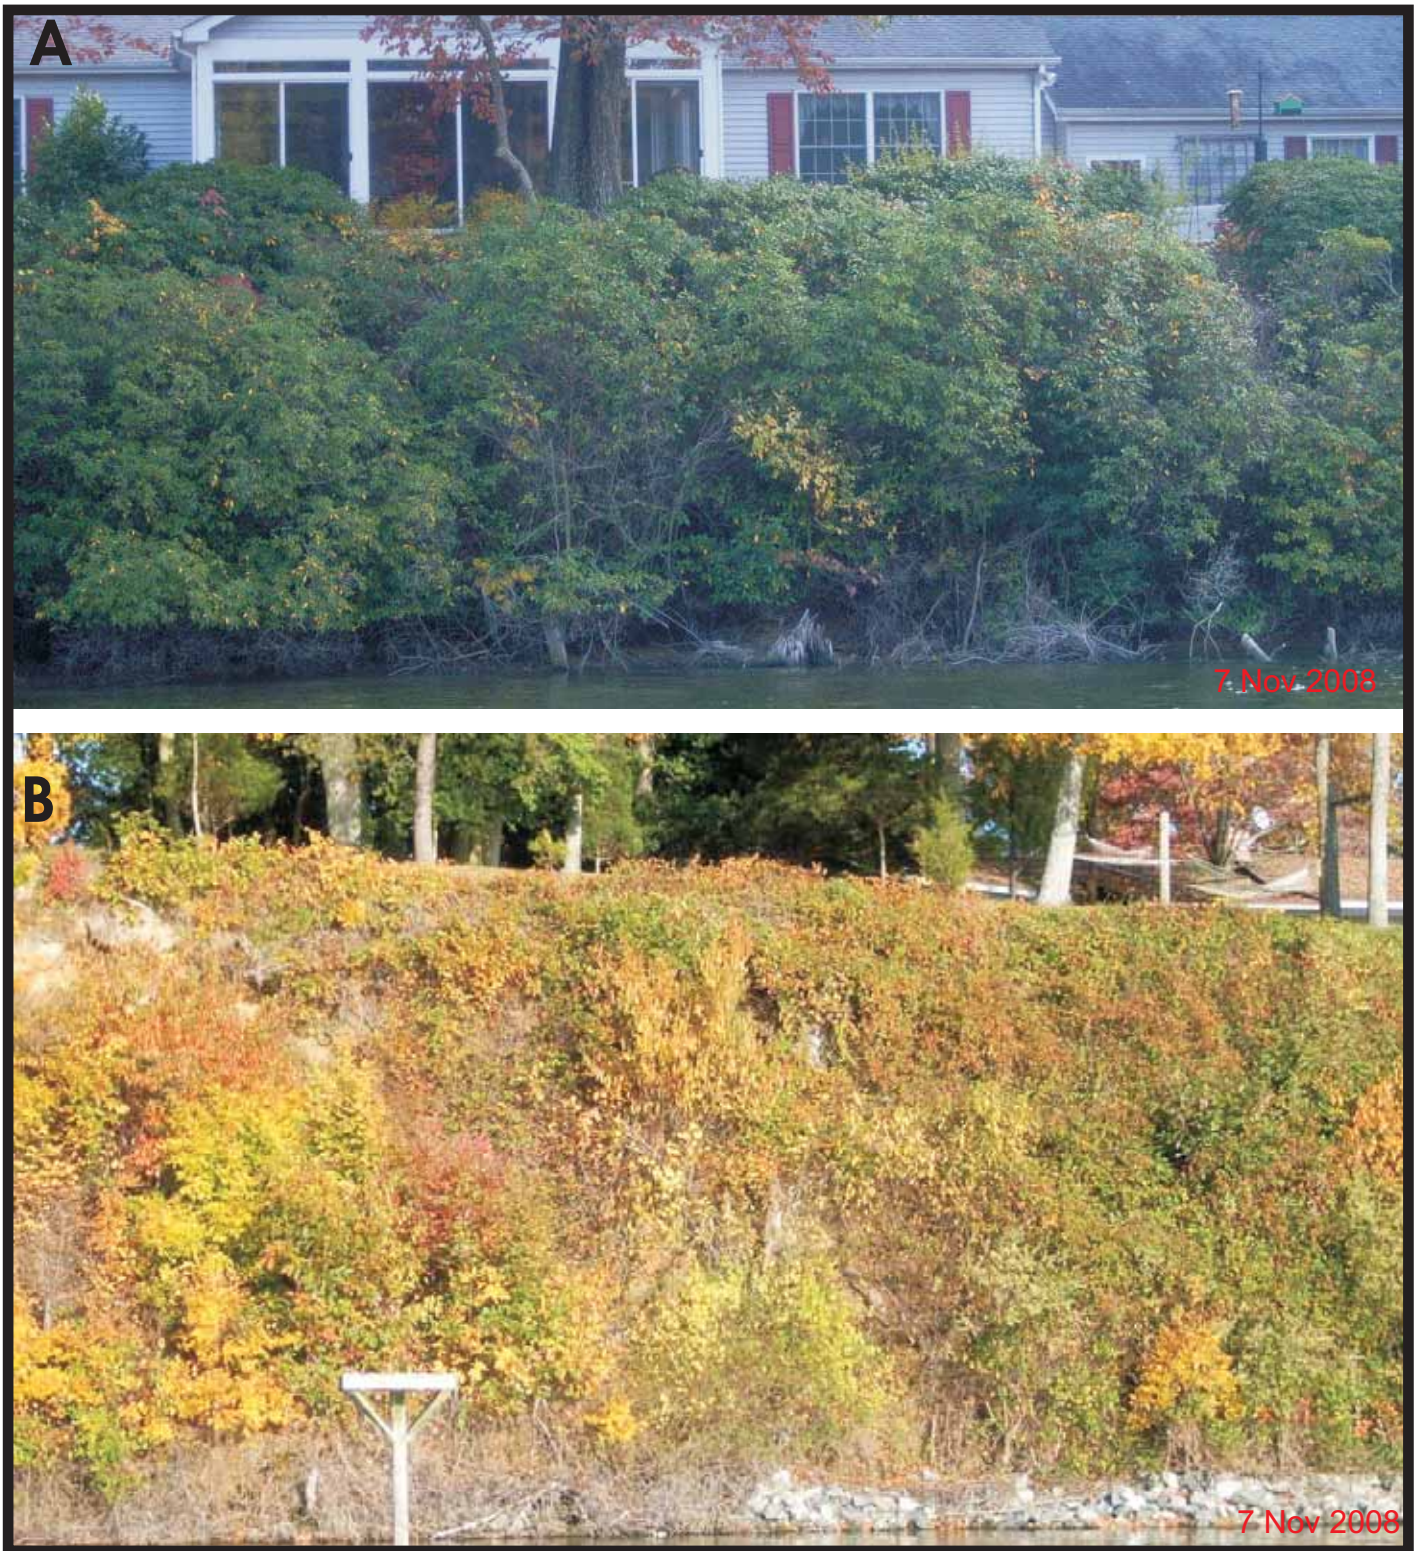
Figure 3-3. These Mathews County shorelines depict base of bank and bank face erosion. A) The dense vegetation as well as lower fetch environment has maintained a stable bank face while the base of the bank shows erosion primarily due to the loss of a vegetated fringe probably due to shading. B) Bare spots on the bank indicate that the sediments on the bank face are unstable. Protecting the base of bank with rock will not stabilize the bank face.

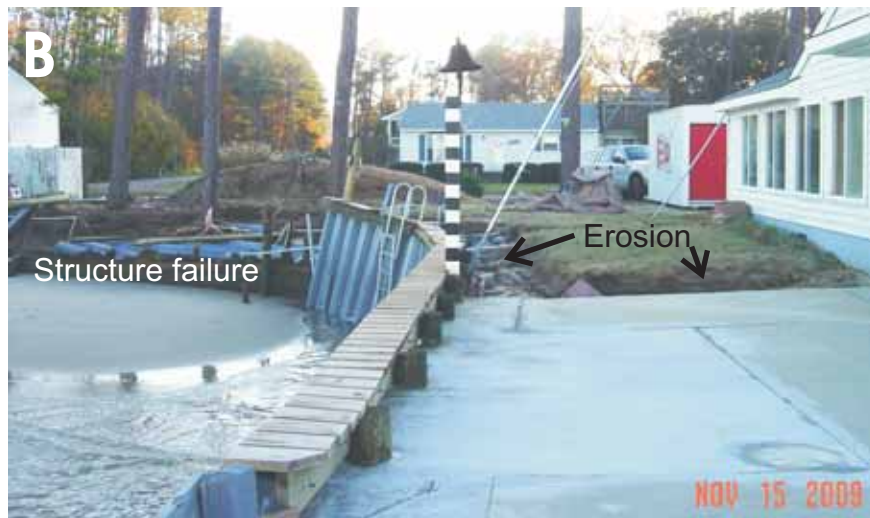
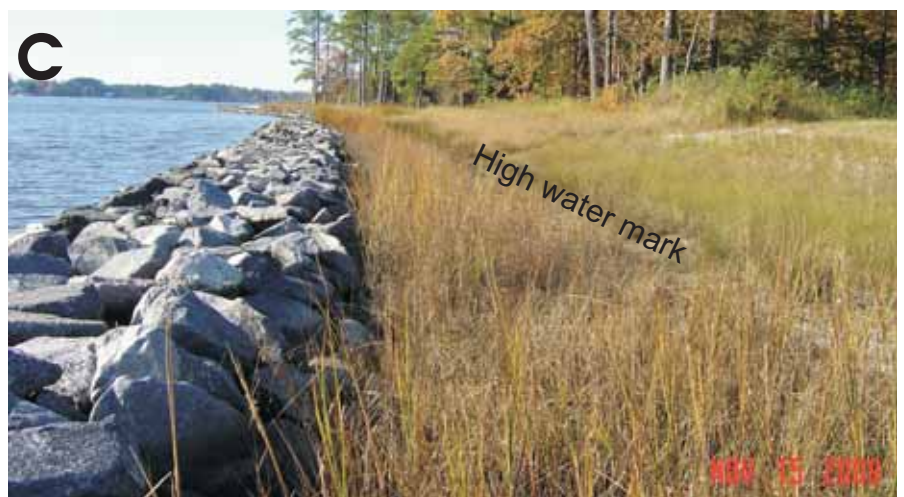
Figure 3-7. Impacts of the Veteran's Day Northeaster along select Mathews County shoreline. A) Profile data taken along the southern end of Bavon Beach showed that the beach had a large amount of erosion. B) Structures along Gwynn's Island failed and the shoreline eroded. C) A sill on the East River had no significant impact from the increased water levels and waves.

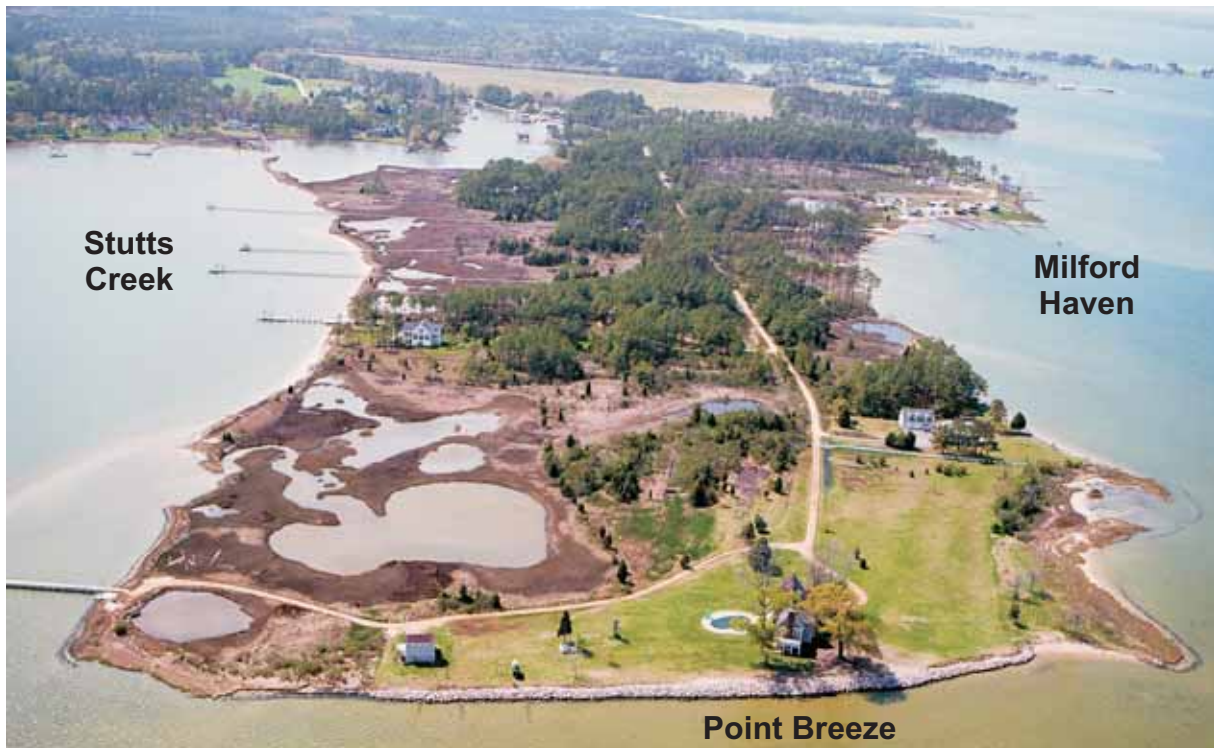
Figure 6-2. Point Breeze in Milford Haven is exposed to open Bay conditions due to the deterioration of Rigby Island. As a result, a stone revetment was constructed to stabilize the shoreline.

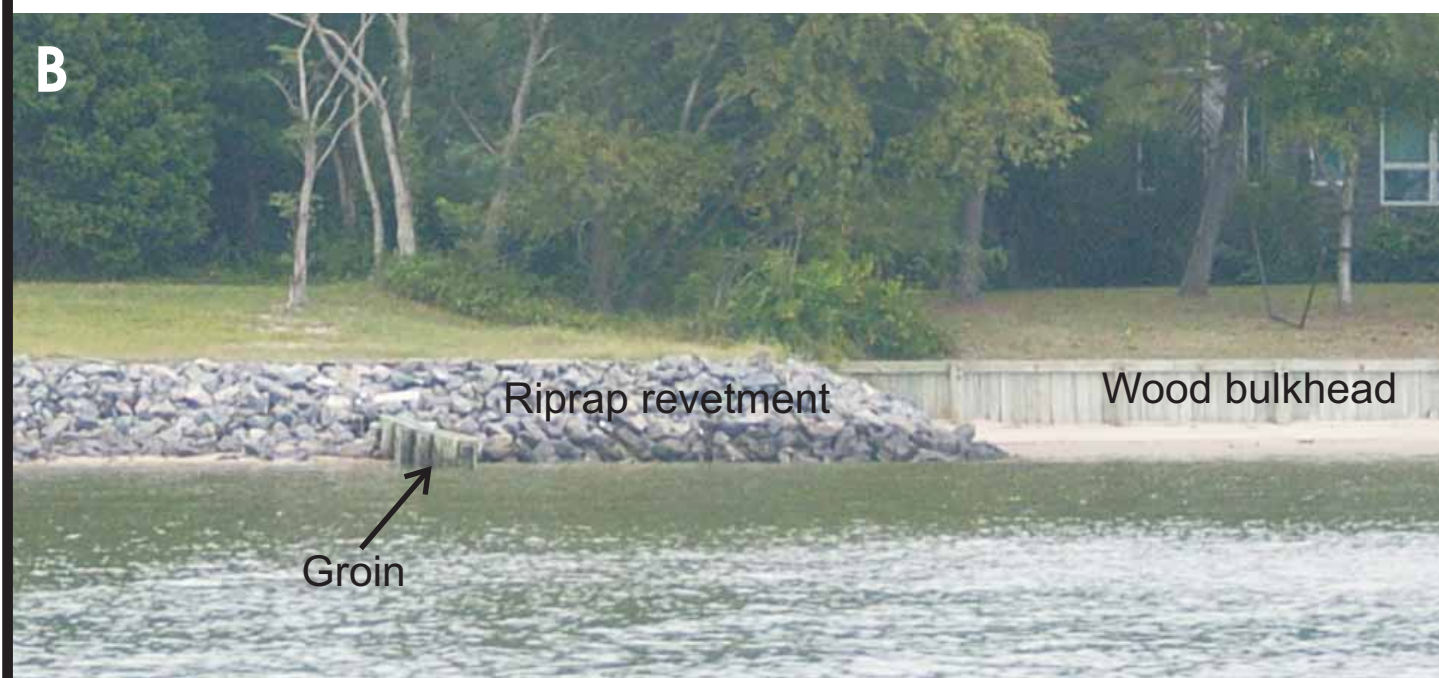
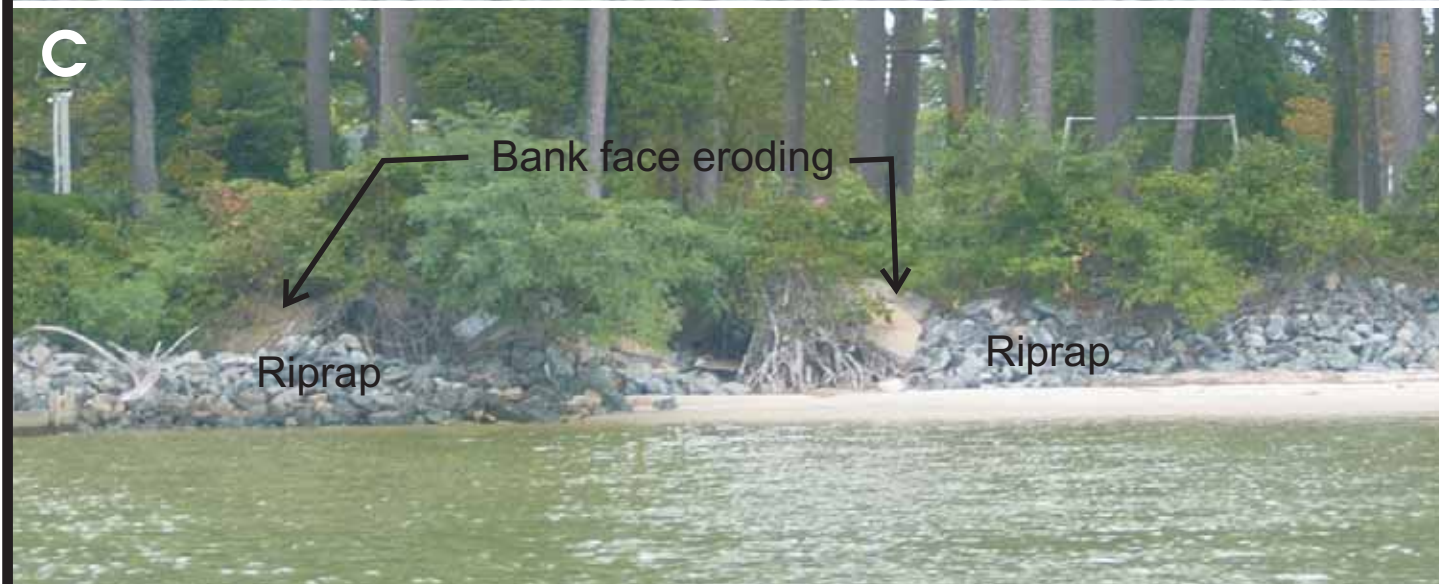
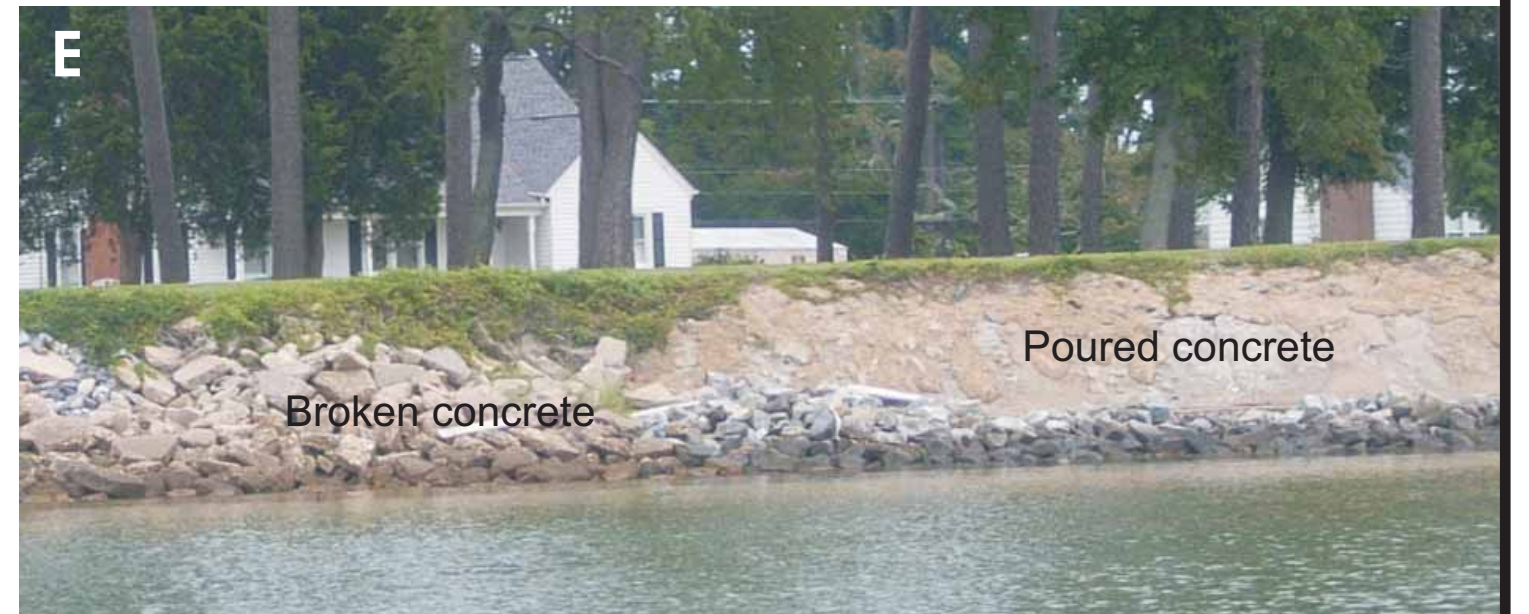
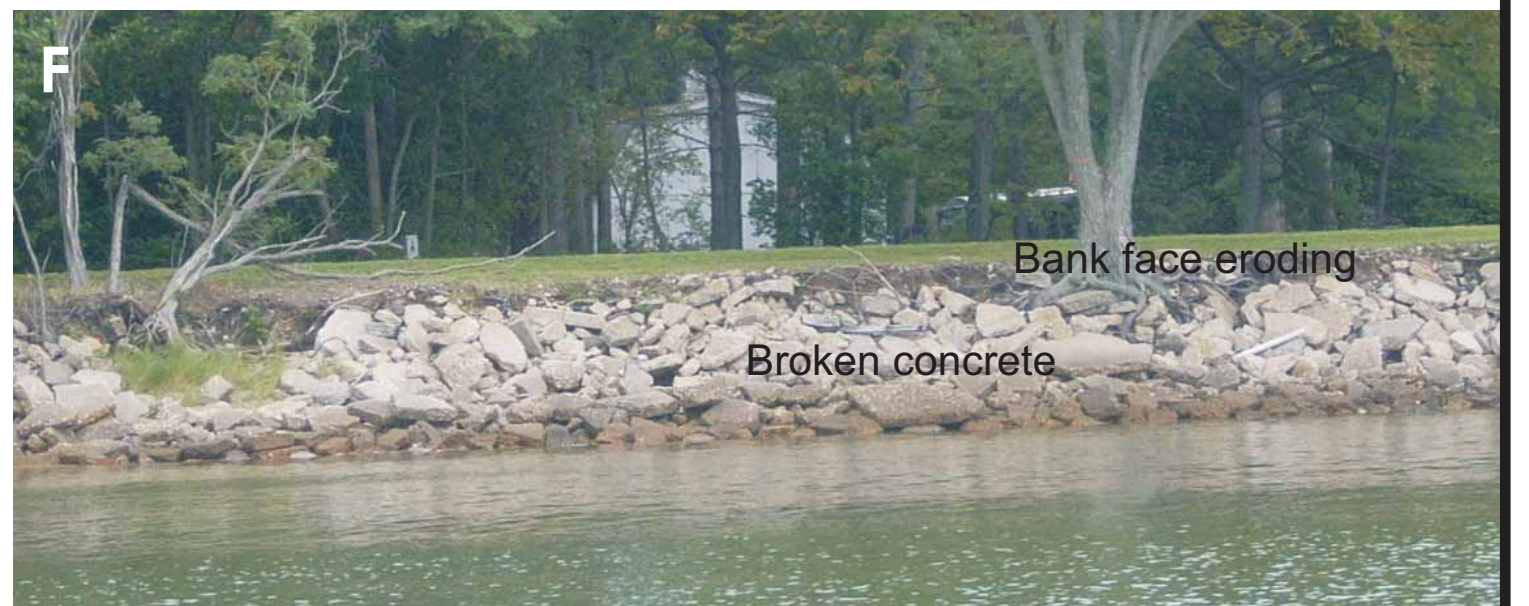
Figure 6-4. The northwest side of Gwynn's Island has many types of structures for shore stabilization A) bulkheads, B) groins and revetments, and C) riprap. In addition, along the main road onto Gwynn's Island broken concrete and poured concrete have been dumped along the shore in order to protect the road.

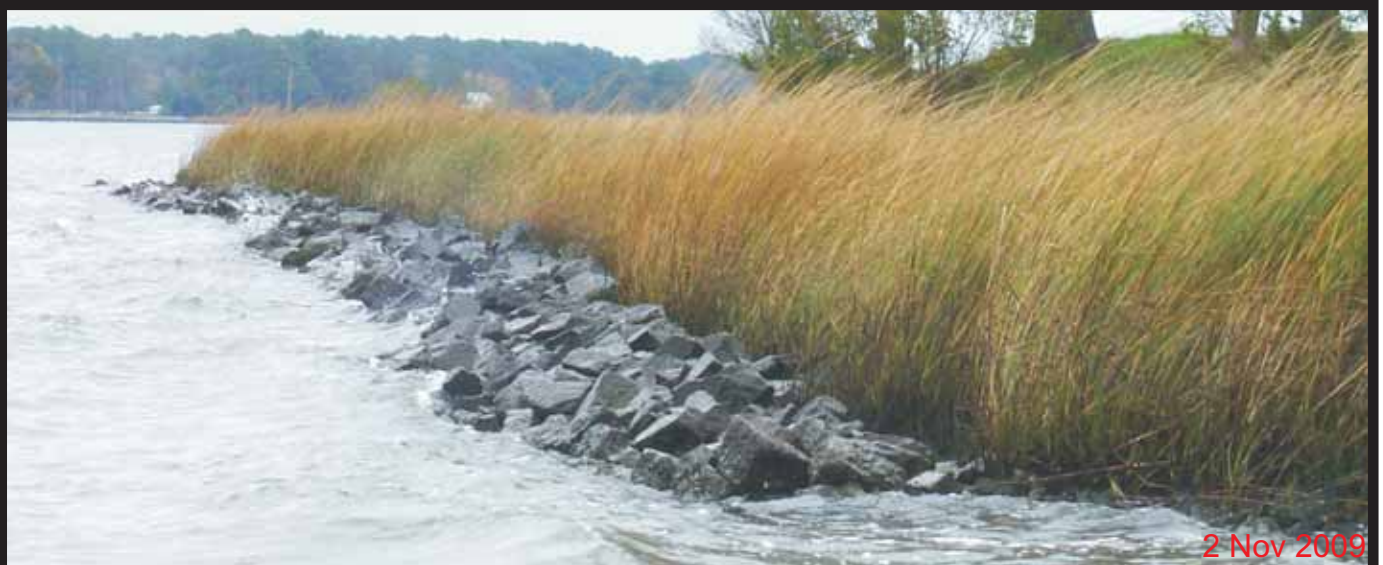
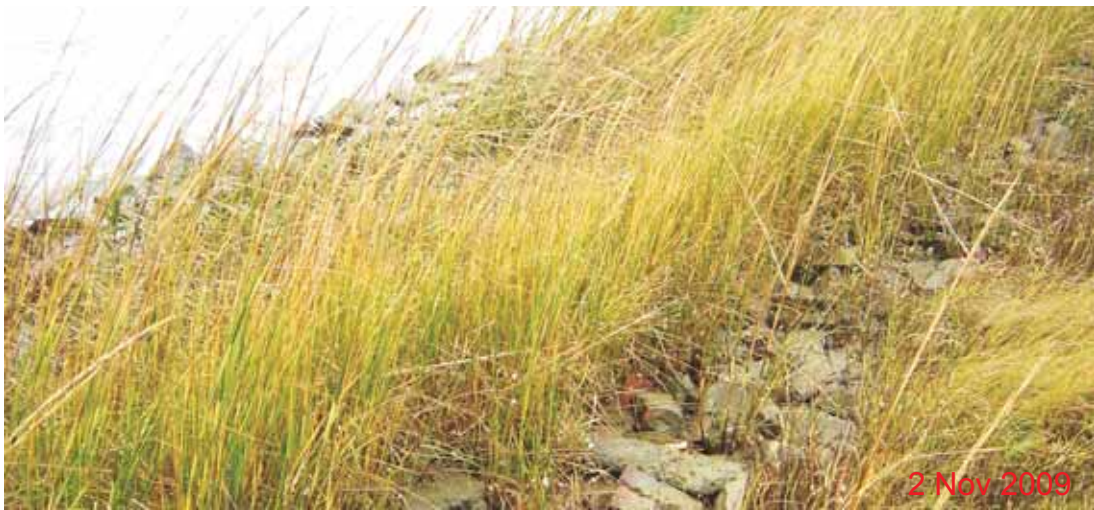
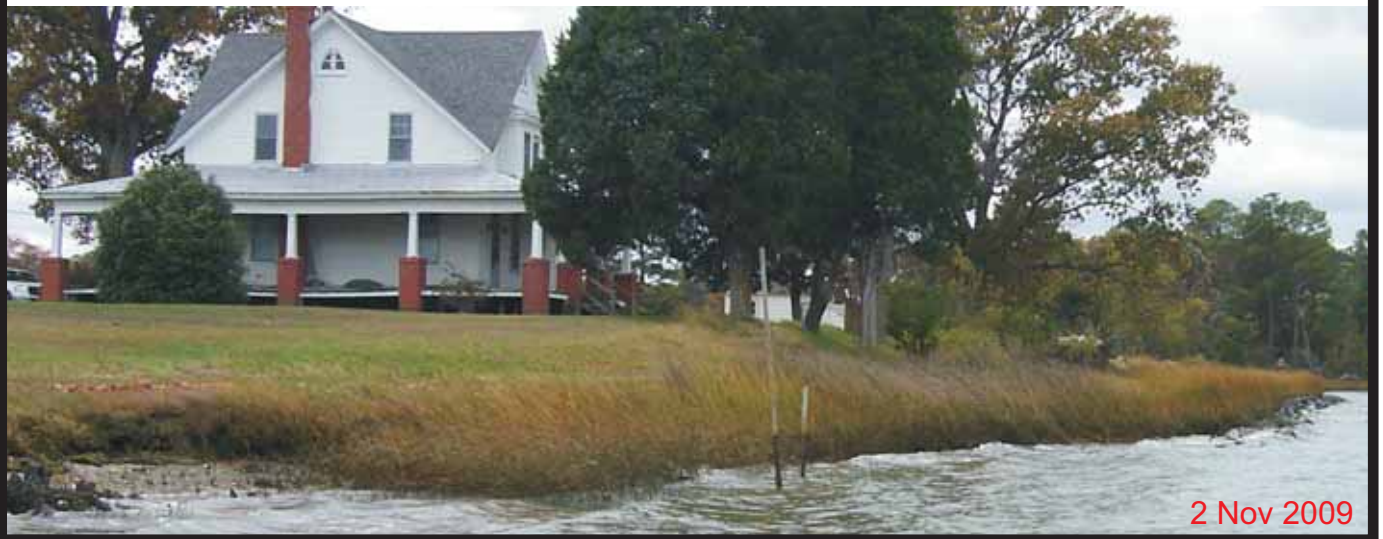
Figure 7-5. “Granddaddy sill” along the East River. Anecdotal evidence suggests this structure was placed along the shore in the late 1800s. Since that time, it has maintained the fringe marsh in front of the upland.
