# Coastal Protection and Development Planning Guidelines for Bermuda

Government of Bermuda,  
Ministry of the Environment

November 2004

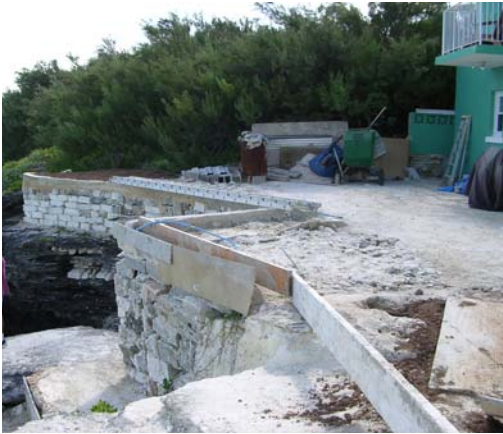
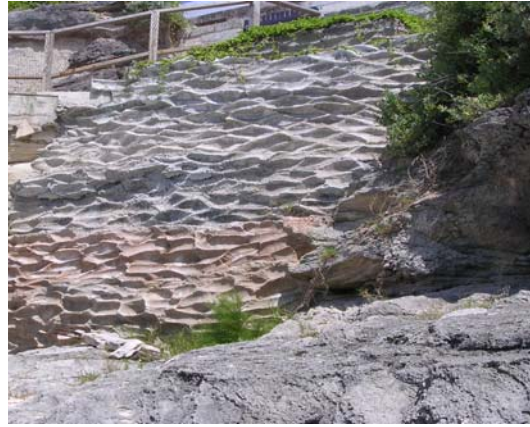
- Reinforced concrete faced with specific patterns; or
- Reinforced concrete faced with Bermuda stone; or

- Where low walls are to be constructed, walls may be made out of unreinforced Bermuda stone, held in place by mortar.

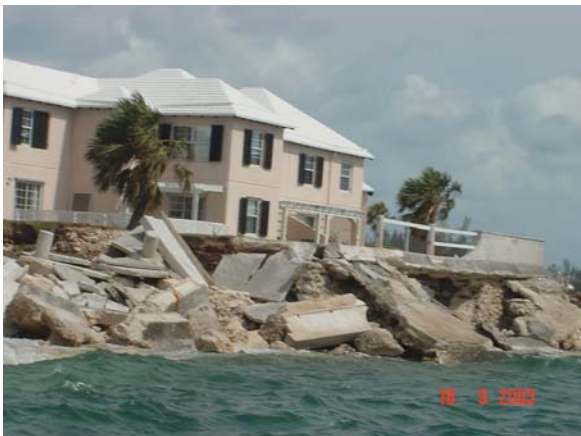
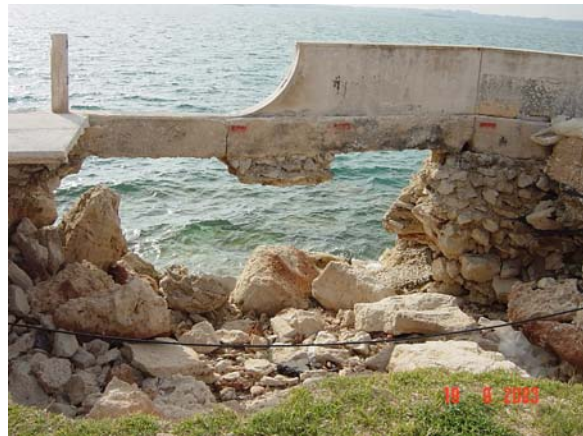
### **2.3.1. Seawall failure**

In general, two different modes of failure were observed for seawalls and shore protection structures. These included: impact forces, which broke apart the structure and scattered debris inland, and drawdown forces, where structures were overtopped, the backfill material eroded and the weight of the receding water resulted in overturning the structure in a seaward direction. Inadequately reinforced or non-existent foundations were also cited as contributory factors for these structural failures, or else where foundations were built on sand. At several sites, debris or parts from a failed seawall were carried inland, acting as projectiles and causing more severe damage to adjacent buildings, which would otherwise have only suffered from flooding damage. Shoreline damage was also observed to be often quite localized, with adjacent properties somehow avoiding damage. These could often be explained by differences in setback or elevation, or by inconsistencies in the type of shoreline protection employed. Progressive erosion was also thought to have resulted in the weakening of structures, eventually leading to their collapse in the storm. Finally, some structurally sound solutions were observed. These were characterized typically by properly reinforced concrete walls, which had been founded on rock.

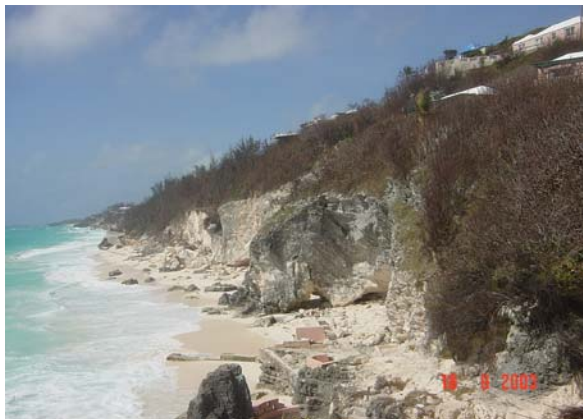
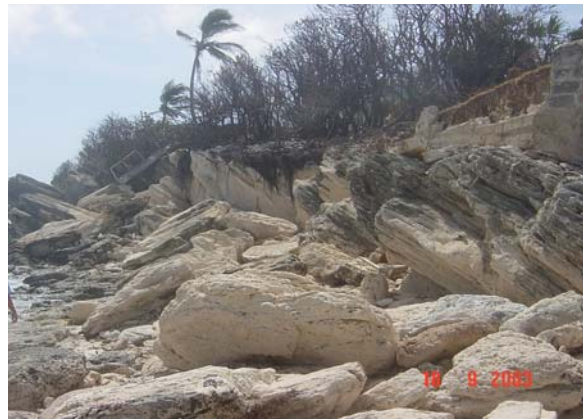
### 2.3.2. Cliff Failure

The rock-falls that were observed along cliff-type shorelines ranged from minor to spectacular, in which single blocks weighing more than 50 tonnes had been eroded. This type of cliff failure puts infrastructure (buildings, roads, etc.) into a zone of increased risk. In general, however, the following agents of cliff failure were observed:

- Wave attack at the toe of the cliff, leading to oversteepening and/or instability in the upper layers;
- Through wave attack, the outer weathered and hardened layers of the Aeolian limestone had been stripped away, leaving a soft, sandy core exposed. Once these soft areas became exposed, erosion of the rock proceeded at a rapid pace during the storm;
- High-pressure jets of water (from breaking waves) were shot up through narrow vents in the cliff face rock. These jets weakened blocks of cliff face that would not normally have been exposed to wave action during the storm, thereby leading to cliff failure in elevated sections of the cliff.

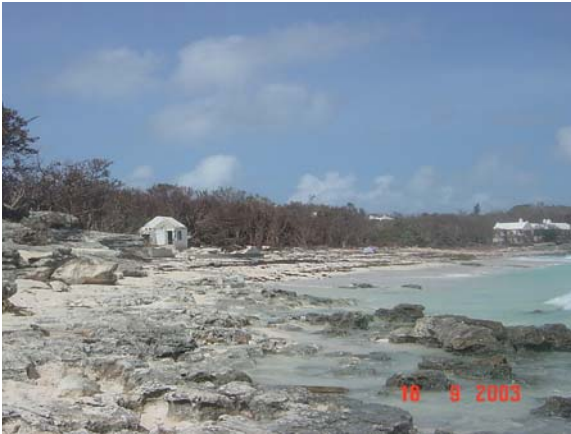
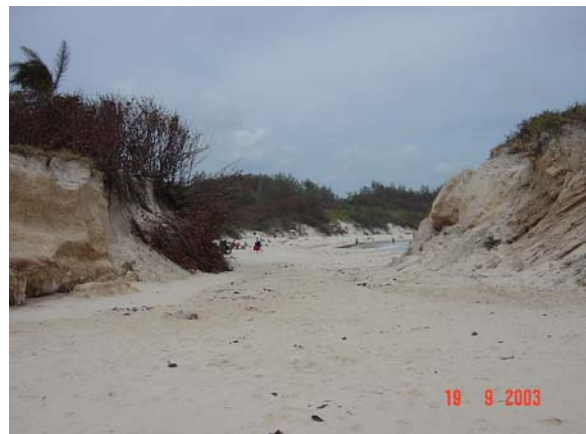
### 2.3.3. Beach and Dune Erosion

Beach erosion was observed to take two forms. In some instances, sand and debris were pushed inland, while in others sand was carried offshore. Where sand was carried offshore, beach recovery is already occurring (i.e. at Horseshoe Bay), and is expected to continue over the next few months. At several locations, sand dunes were severely cut back (by up to 20-30 metres). The recovery process on sand dunes is slower than beaches, since it depends on the movement of above-water beach sand to the back of the beach by aeolian processes, followed by consolidation. This process may be expected to take a number of years, but may be aided by the application of dune fencing.

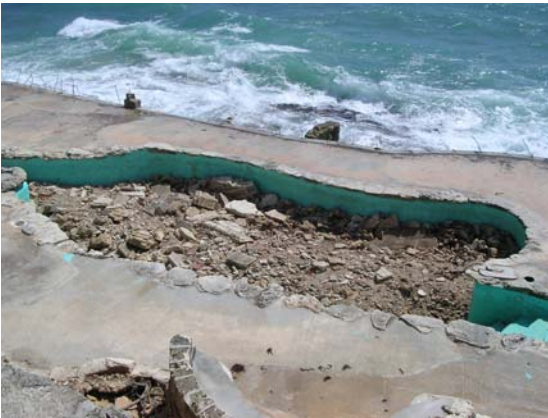
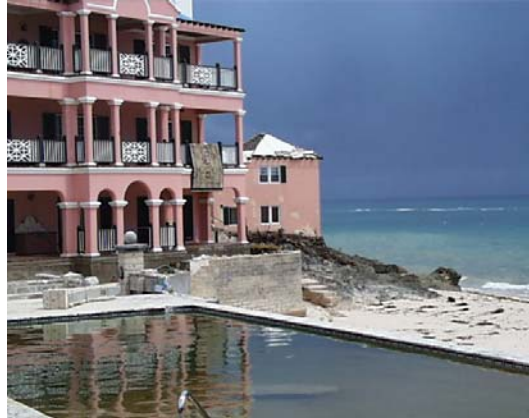
#### 2.3.4. 'Setback' Policies

Hurricane Fabian demonstrated the importance of appropriate set back distances between buildings and the shoreline, and the consequences of inadequate setbacks. In some cases, swimming pools were filled with rock and debris from the seabed. In other cases, buildings that were located too close to the ocean were badly damaged by waves. The amount of setback to be used will depend primarily on the slope of the shoreline, the nearshore bathymetry, the rate of erosion of the shoreline and the geotechnical stability of the rock strata along the shoreline. While existing developments are already too close to the shoreline, this must be considered in the siting of new developments.

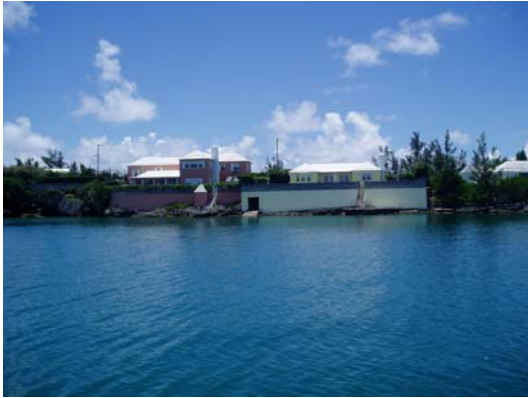
A high seawall, with substantial, flat landfill behind it. Not generally in keeping with the Bermuda Image, and the considered to be at one end of the shoreline protection spectrum.

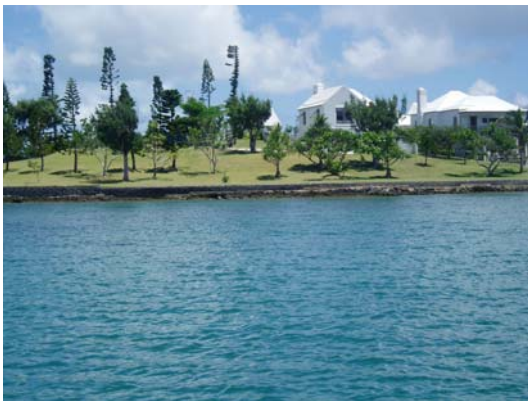
A low seawall with sloping land behind it (no backfill). More in keeping with the Bermuda Image, and mid-way to minimal on the shoreline protection spectrum.

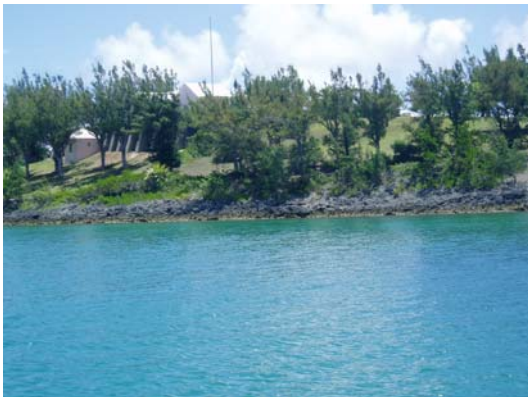
Natural landscape, with sloping coastline, and substantial vegetation. In keeping with the Bermuda Image, and the natural end of the shoreline protection spectrum.

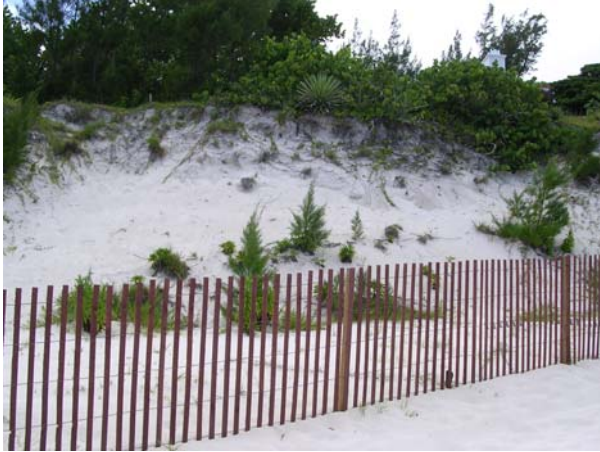
There are two main methods of artificially creating dunes in sandy areas. The first is a mechanical method characterized by implementing fences or windbreaks. These fences are typically made of wooden slats or plastic netting.

The second method is a vegetative method which involves the planting of sand and salt tolerant species and using these to reduce the impacts of wind and for trapping the sand.

There are a number of factors to be considered in the artificial creation of dunes. The porosity of the fencing should be determined, and it is suggested that nothing less than 50% porosity be applied. The recommended ratio of solid to open spacing in the fence should be 80:20. Consideration should also be given to the spacing of the slots and the fences themselves.

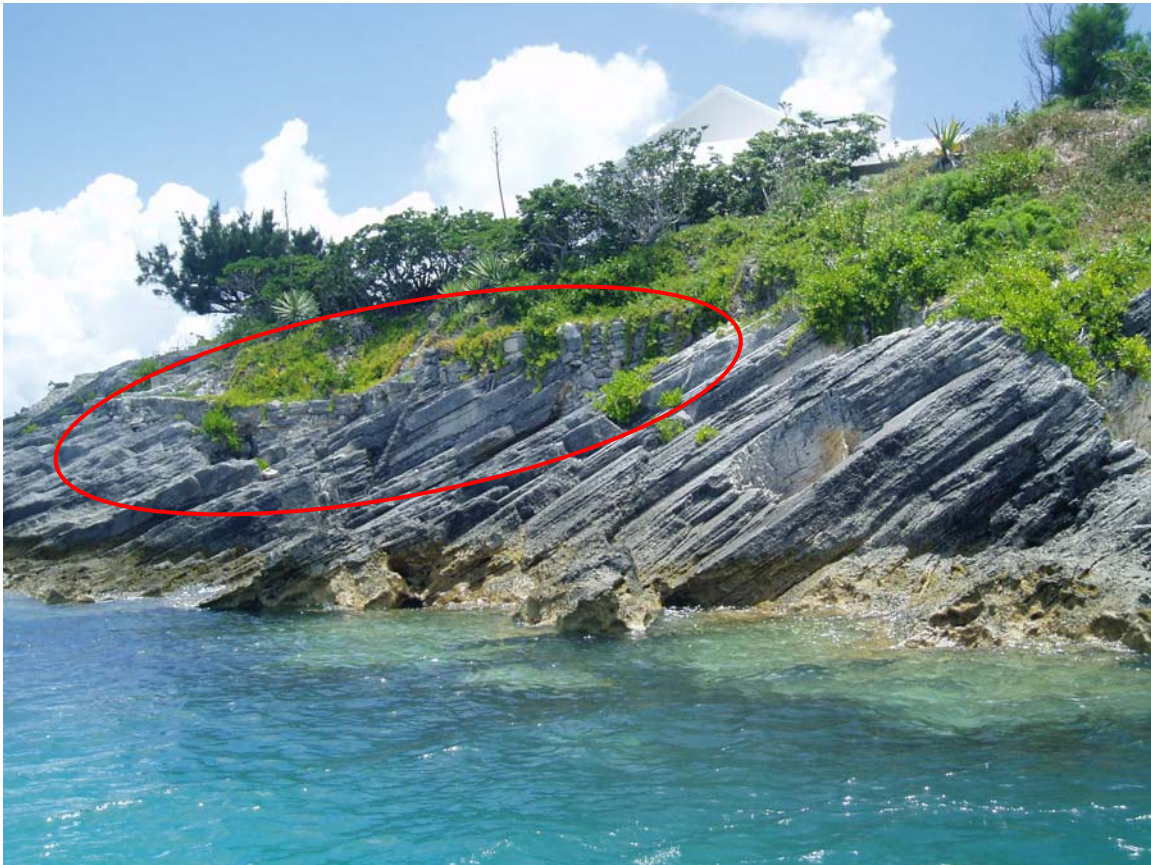
**Figure 3.5** Retaining wall in keeping with the Bermuda Image

Proper attention must be paid to aesthetics particularly in keeping with the Bermuda Image. For seawalls, this may include facing with Bermuda stone or

stepped structures. For repairs of failed cliffs, a surface texturing using moulds, or gunite and colouring of the concrete should be used to match the appearance of the adjacent natural stone. Several examples of Bermuda stone facing were observed to have withstood the wave impacts of Hurricane Fabian. Consideration should also be given to landscaping of the structures (for example, vegetation on top of revetments).

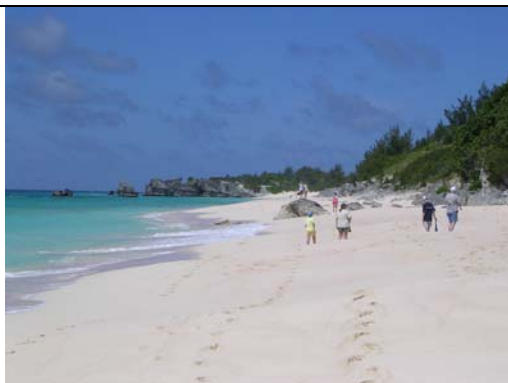
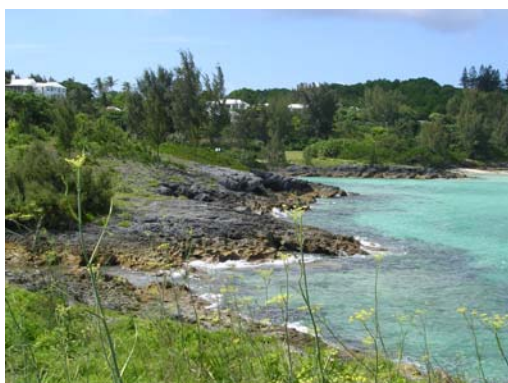
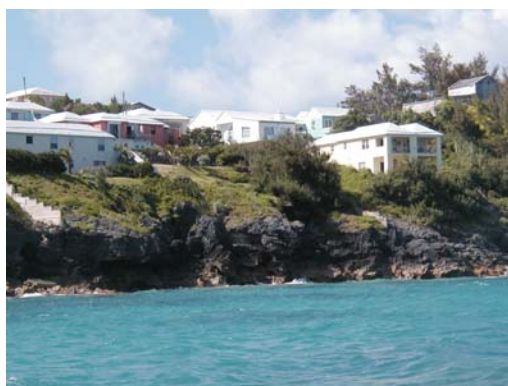
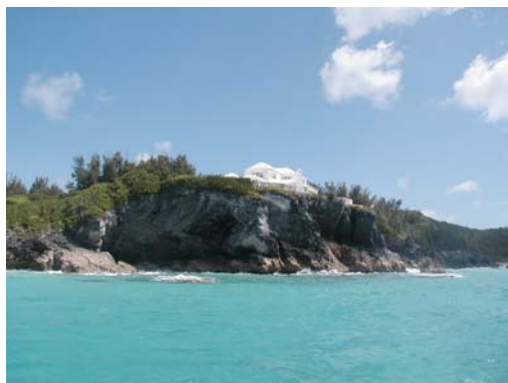
**Figure 4.3** Shoreline Types around Bermuda

**Sandy shorelines (beaches)** are found mostly along the south of Bermuda, although there are some pocket beaches along the north and east coasts and the interior shorelines.

**Flat rocky** coastline refers to low-lying, relatively flat, rocky coastline with typical elevations occurring between sea level and 1 meter above MSL. These are found mostly along the north-central coast.

**Low cliffs** are represented by steep rock faces between 1 and 7 meters high and are found at various locations around the island, including the north-east coast and the south coast.

**High cliffs** are represented by vertical rock faces greater than 7 meters and are found mainly along the eastern and south-eastern areas of the island.

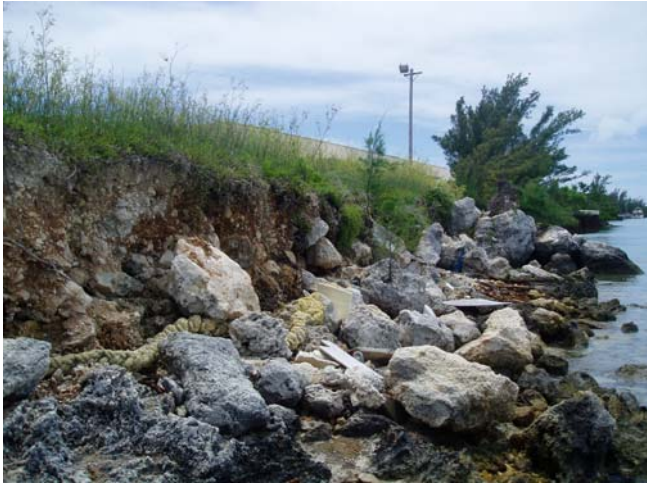
The shoreline is presently comprised of mainly rubble and debris. Most of the shoreline is about 3m above mean sea level. The existing shoreline is graded almost vertically. Without proper armouring, the shoreline is prone to significant erosion from hurricanes.

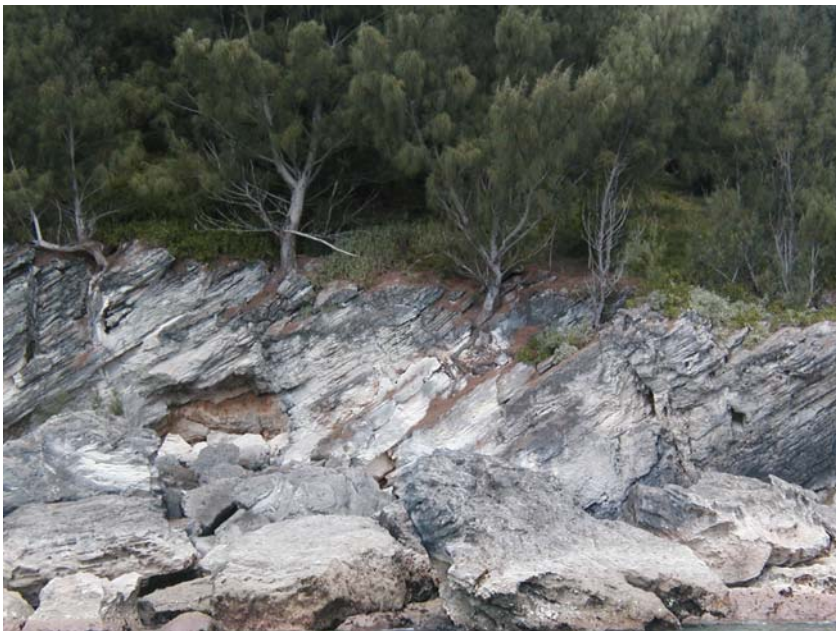
The problems with the trees are related to the root structure of the plants, coupled with the reproduction mechanisms of the species. The roots of the trees are thick and shallow, and are able to anchor the plants in areas with very little soil. As such, the trees grow well in the soft rock of the Bermuda shoreline, using crevices to access nutrients and support. The result is that the soft rock chips and breaks from the penetration of the *Casuarina* root, thereby eroding the rock. Additionally, because of the height of the trees (up to 70 - 90 feet) and the shallowness of the roots, the species is very susceptible to being uprooted and blown around during strong winds and hurricanes, further breaking up the soft rocky shoreline.

In order to address the problem of the *Casuarina*, and to mitigate the erosion caused by these trees, an appropriate Eradication Programme and Public Awareness Campaign need to be developed. These initiatives should seek to remove the *Casuarina* in the coastal areas and replace them with an endemic species such as the Bermuda Cedar.

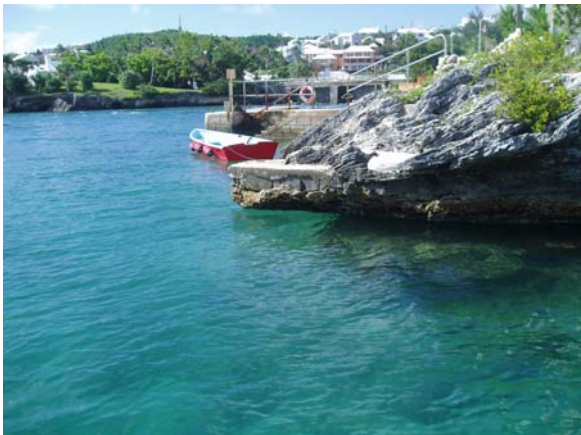
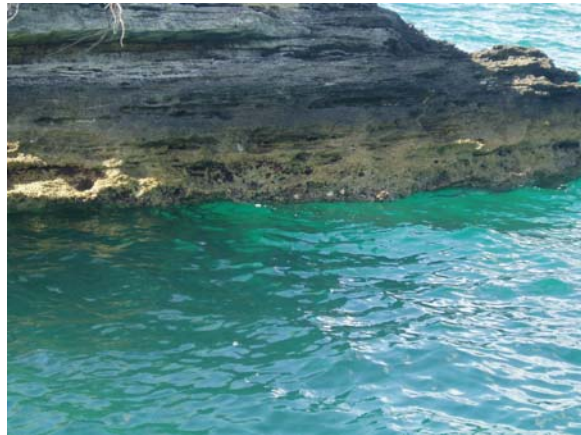
The action of boring and grazing organisms such as gastropods, bivalves and worms living in rocks within the intertidal zone removes significant rock material over time to form a distinct notch along the coastline of Harrington Sound. These notches extend up to 5 meters inland and undermine the rock which will eventually collapse.

Research needs to be conducted into the specific eroding organisms in Harrington Sound to determine their biology and ecology in order to develop appropriate management strategies. Until such research and plans are developed, shoreline protection will need to be considered on a case by case basis.
