# **Proceedings**

**13th Annual  
National Conference on  
Beach Preservation Technology**

## **Habitat Enhancement and Protection Shamrock Island, Corpus Christi Bay, Texas**

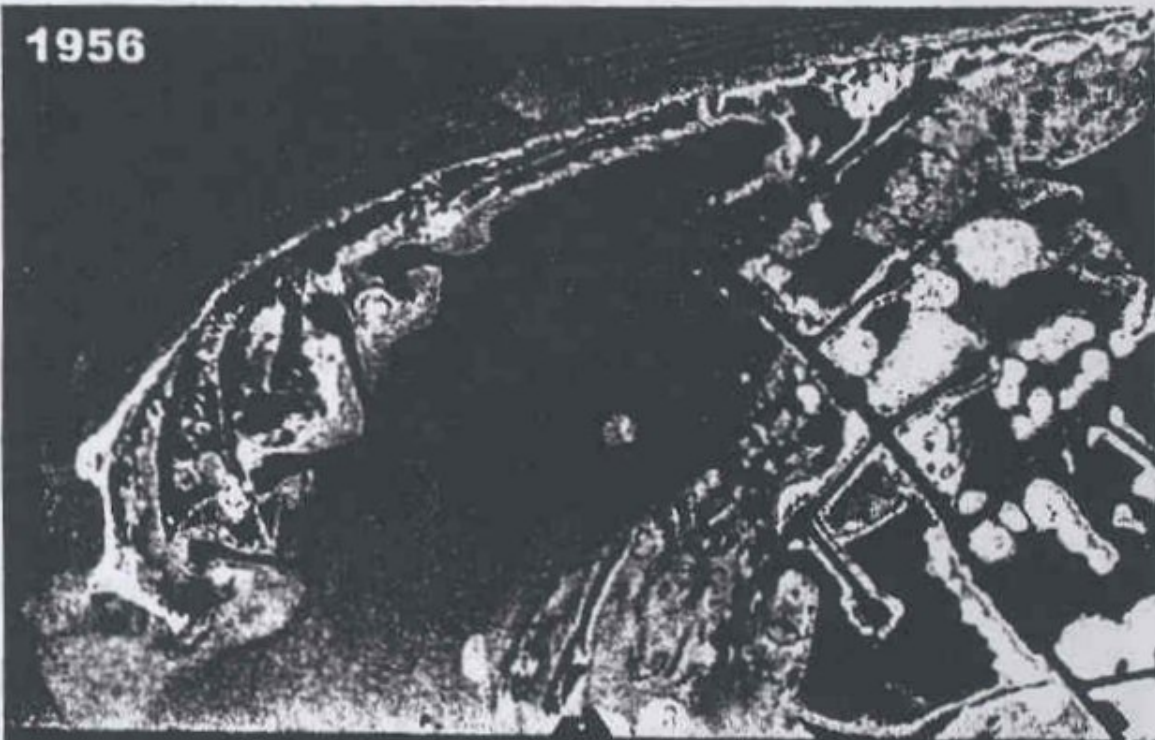
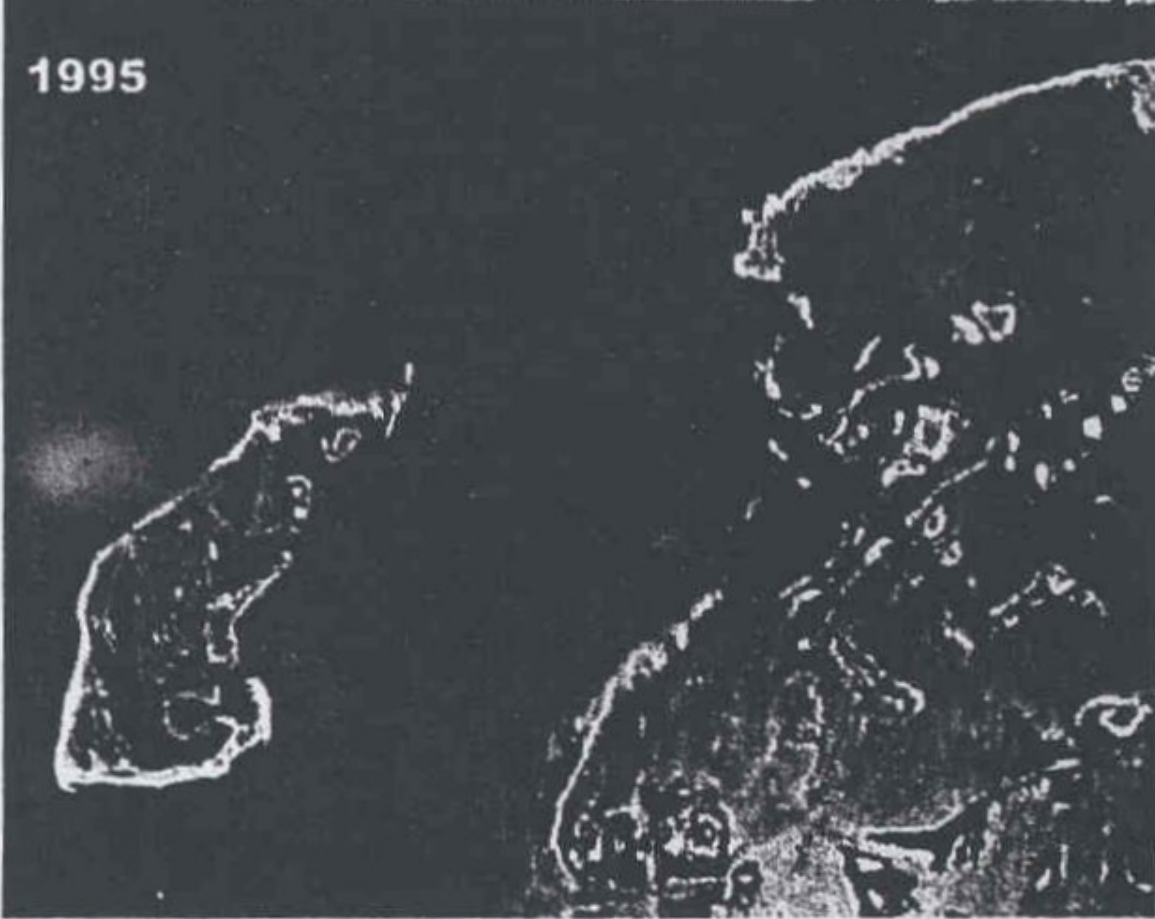
**Figure 2 – 1956 and 1995 Aerials**  
*Shamrock Island, Texas*

Shamrock Island is undeveloped and widely regarded as some of the best aquatic and colonial waterbird habitat in south Texas. The Island was formed as a spit and was once connected to Mustang Island by a "land bridge" at its north end. It became detached following construction of navigation channels through the Island around 1951 and erosion by Hurricane Celia in 1970. Since its detachment from Mustang Island, the north and northwest areas of Shamrock Island have experienced considerable beach erosion and loss of wetlands, losing approximately 17 acres between 1950 and 1997. Figure 2 shows the shoreline changes that have occurred between 1956 and 1995. The beach area at the southern end of the Island is the only nesting area for the royal tern in south Texas.

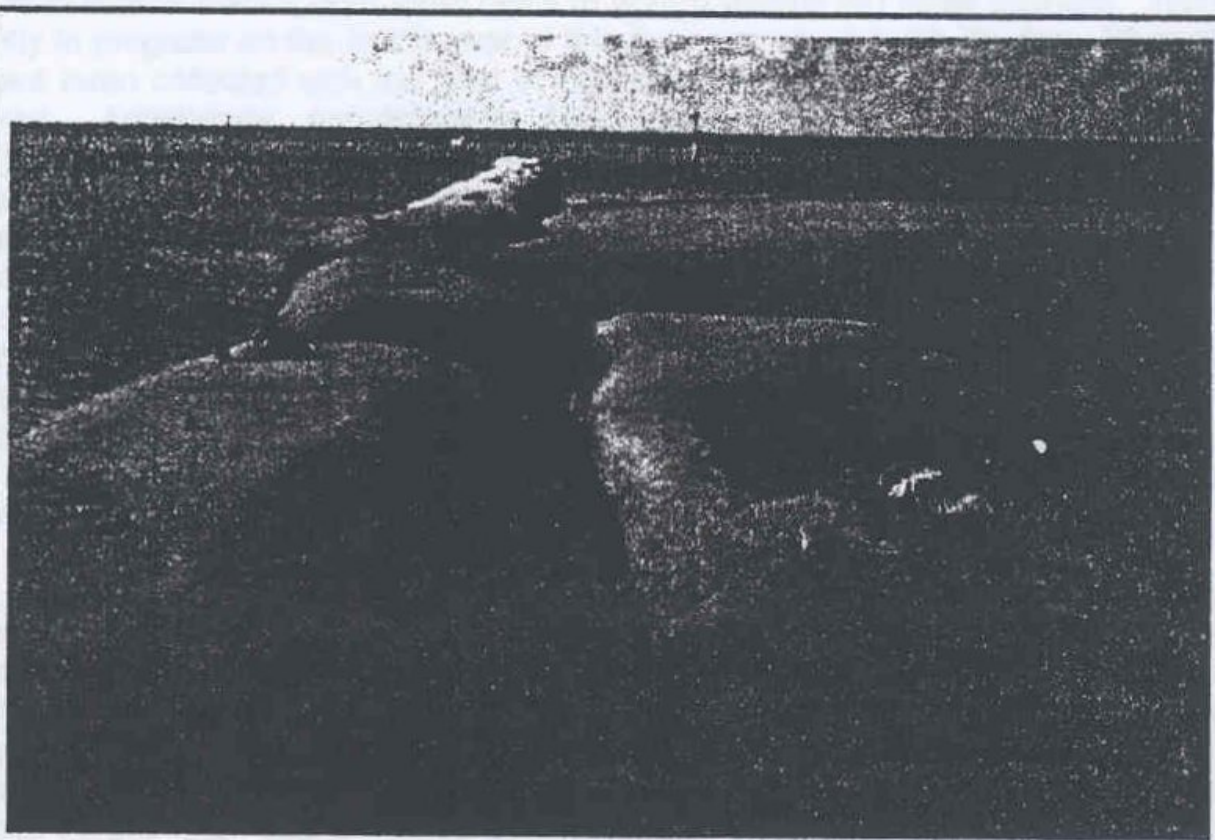
**Figure 10 – Geotube Protecting Small Boat Channel**  
*Mustang Island, Texas*

- Geotubes can also be used as groins. One such project designed by SMA incorporated geotubes filled with grout and has been in place for over a decade serving as a terminal groin on a bay recreational beach.
- Geotubes can serve as jetties on navigation channels. One such application was designed by an SMA professional in order to protect the entrance of a small boat channel into a major ship channel (Figure 10).
