BEACH EROSION INVENTORY OF CHARLESTON COUNTY, SOUTH CAROLINA:

A PRELIMINARY REPORT

South Carolina Sea Grant
Technical Report Number 4

March, 1975
SC-SG-75-4

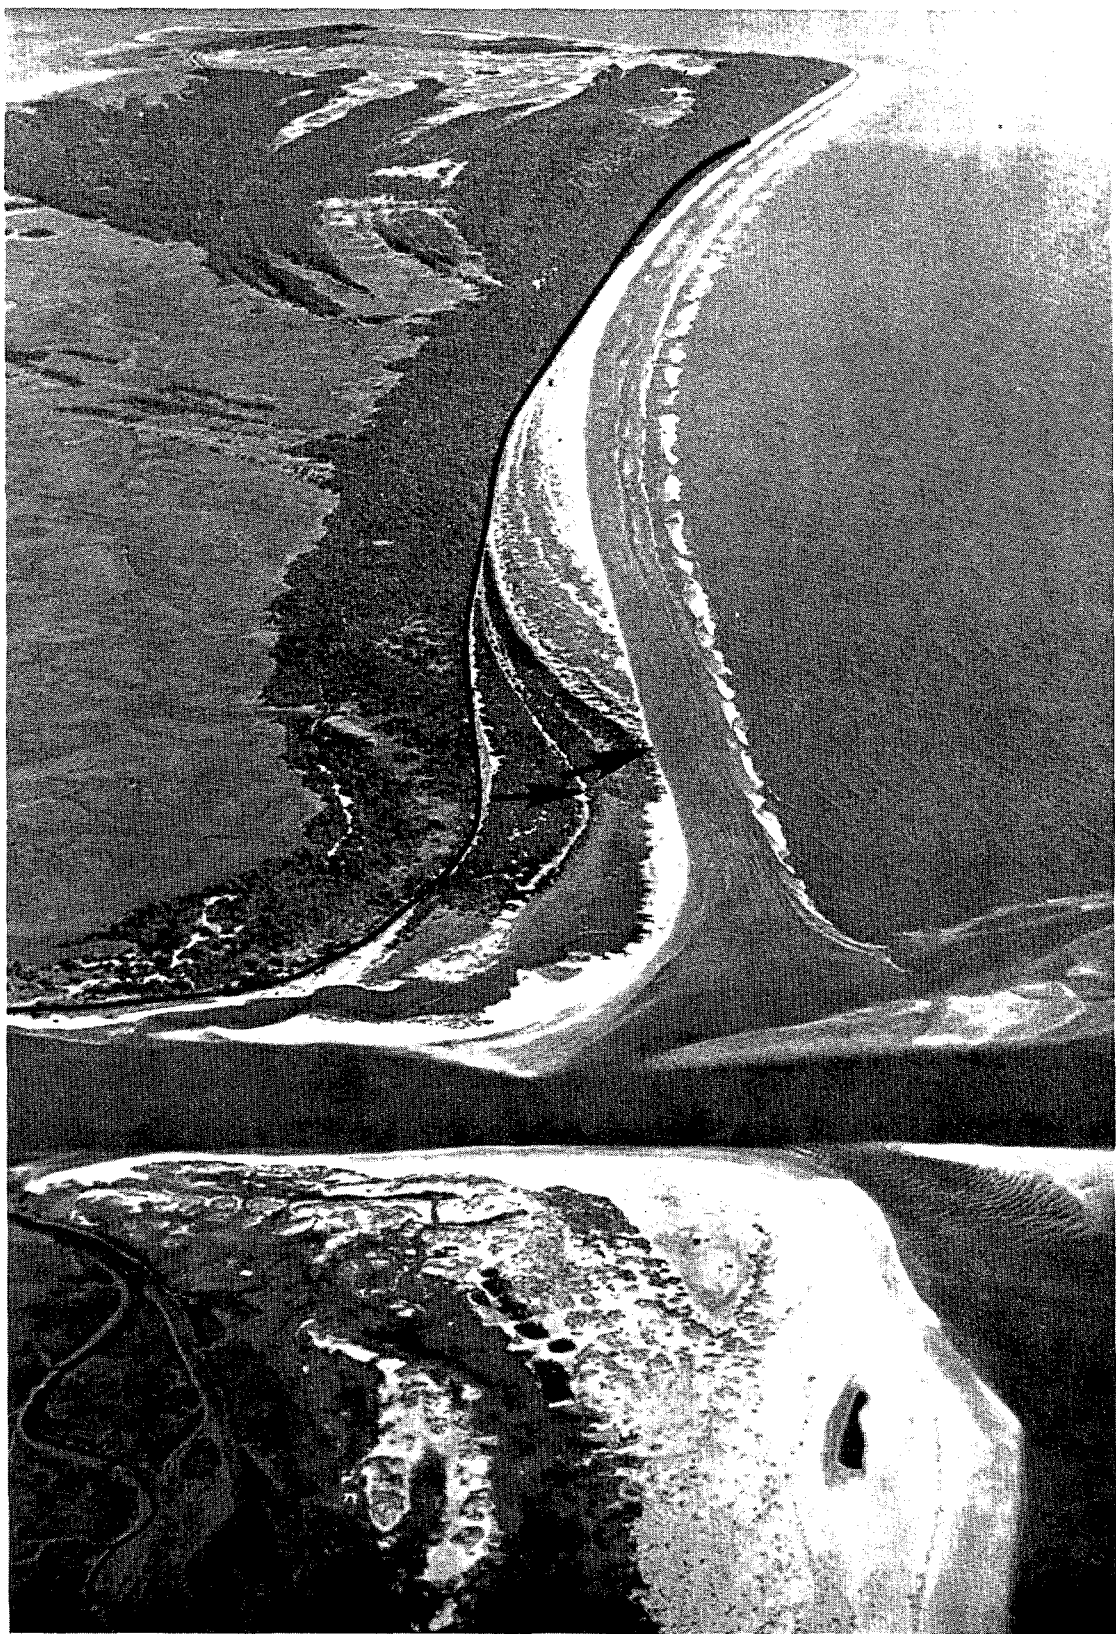
Figure 31. The location of 1896 shoreline is shown by the black line on this recent photograph of Bull Island, South Carolina, taken in January, 1975. As the inlet morphology changed, the north side of the inlet prograded seaward as a series of curving beach ridges. These ridges are now truncated by erosion as the inlet morphology continues to change. View looks north.

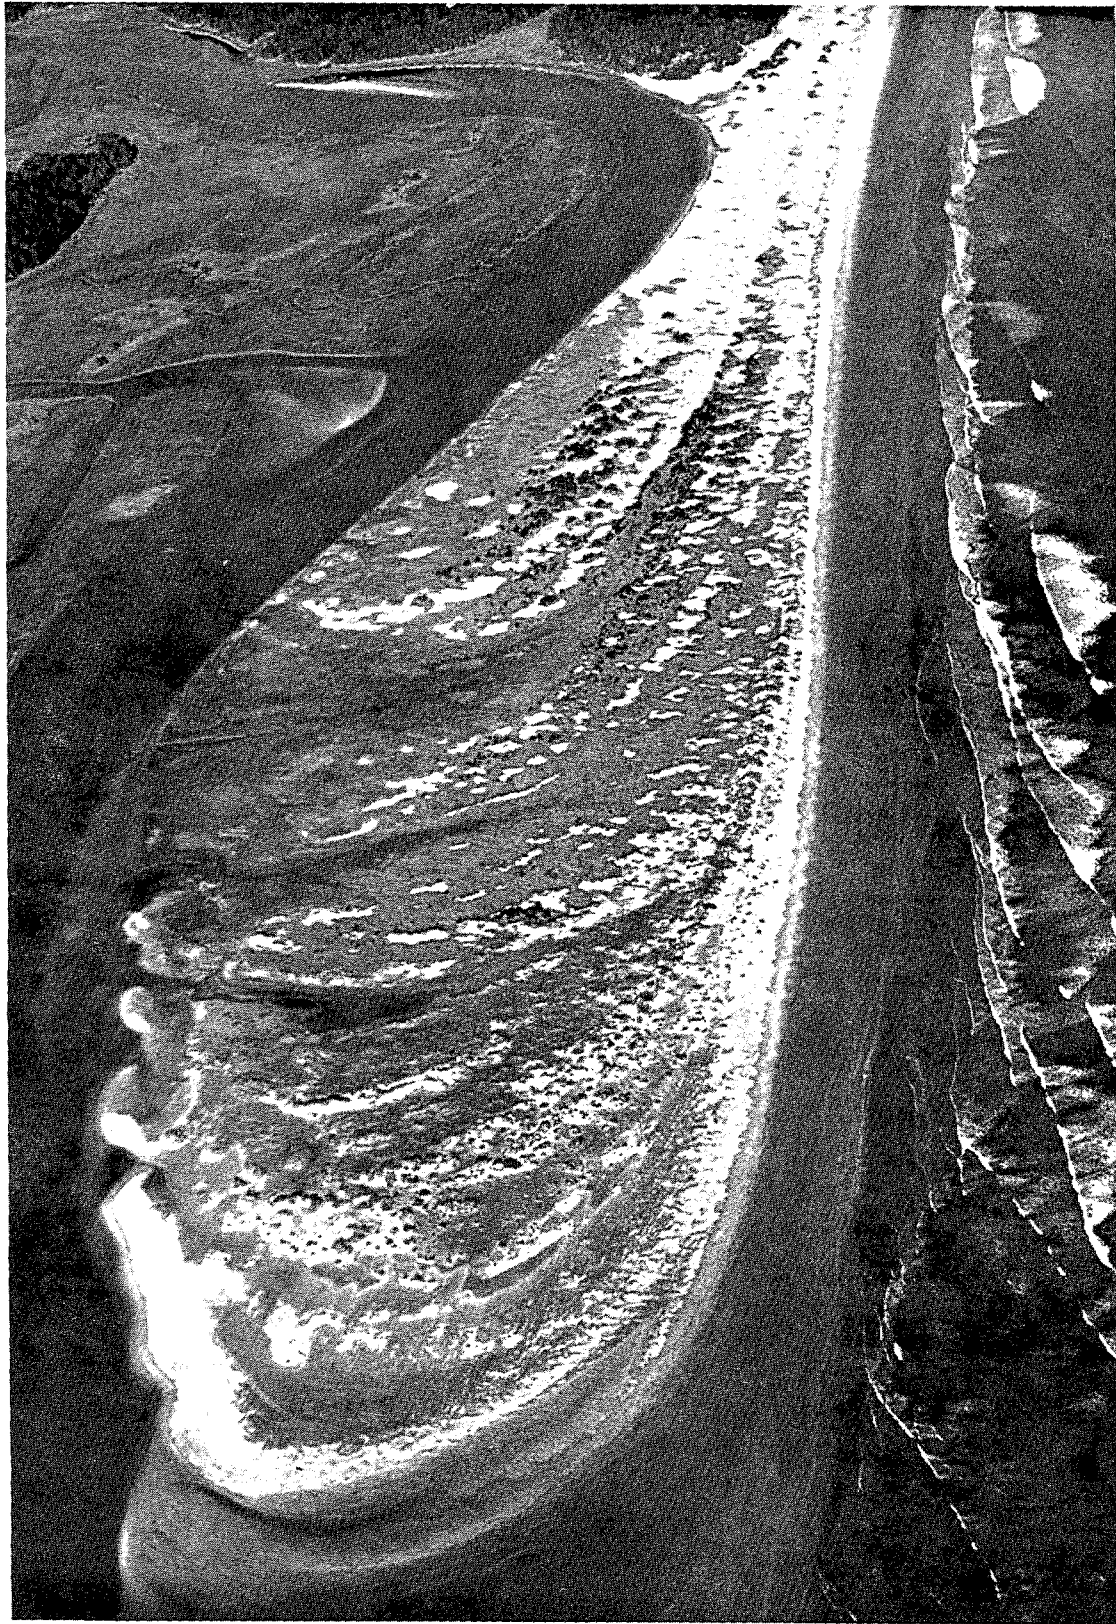
Figure 35. South end of Kiawah Island. The lateral migration of Kiawah River Inlet has resulted in deposition of this classic recurved spit. View looks northeast towards Kiawah Island. This section of coastline has been highly variable through time. Photograph taken January 7, 1975.

One severe shoreline change, which the erosion-deposition graphs do not clearly show but which is indicated in the tables in Appendix 1, is the lateral migration of Kiawah River Inlet. Between 1939 and 1973 the inlet has migrated up and down the beach in the vicinity of locations 15, 16, and 17. During periods of constructional wave activity, the inlet migrates southwestward in the direction of dominant longshore transport (Fig. 35). When storm waves are

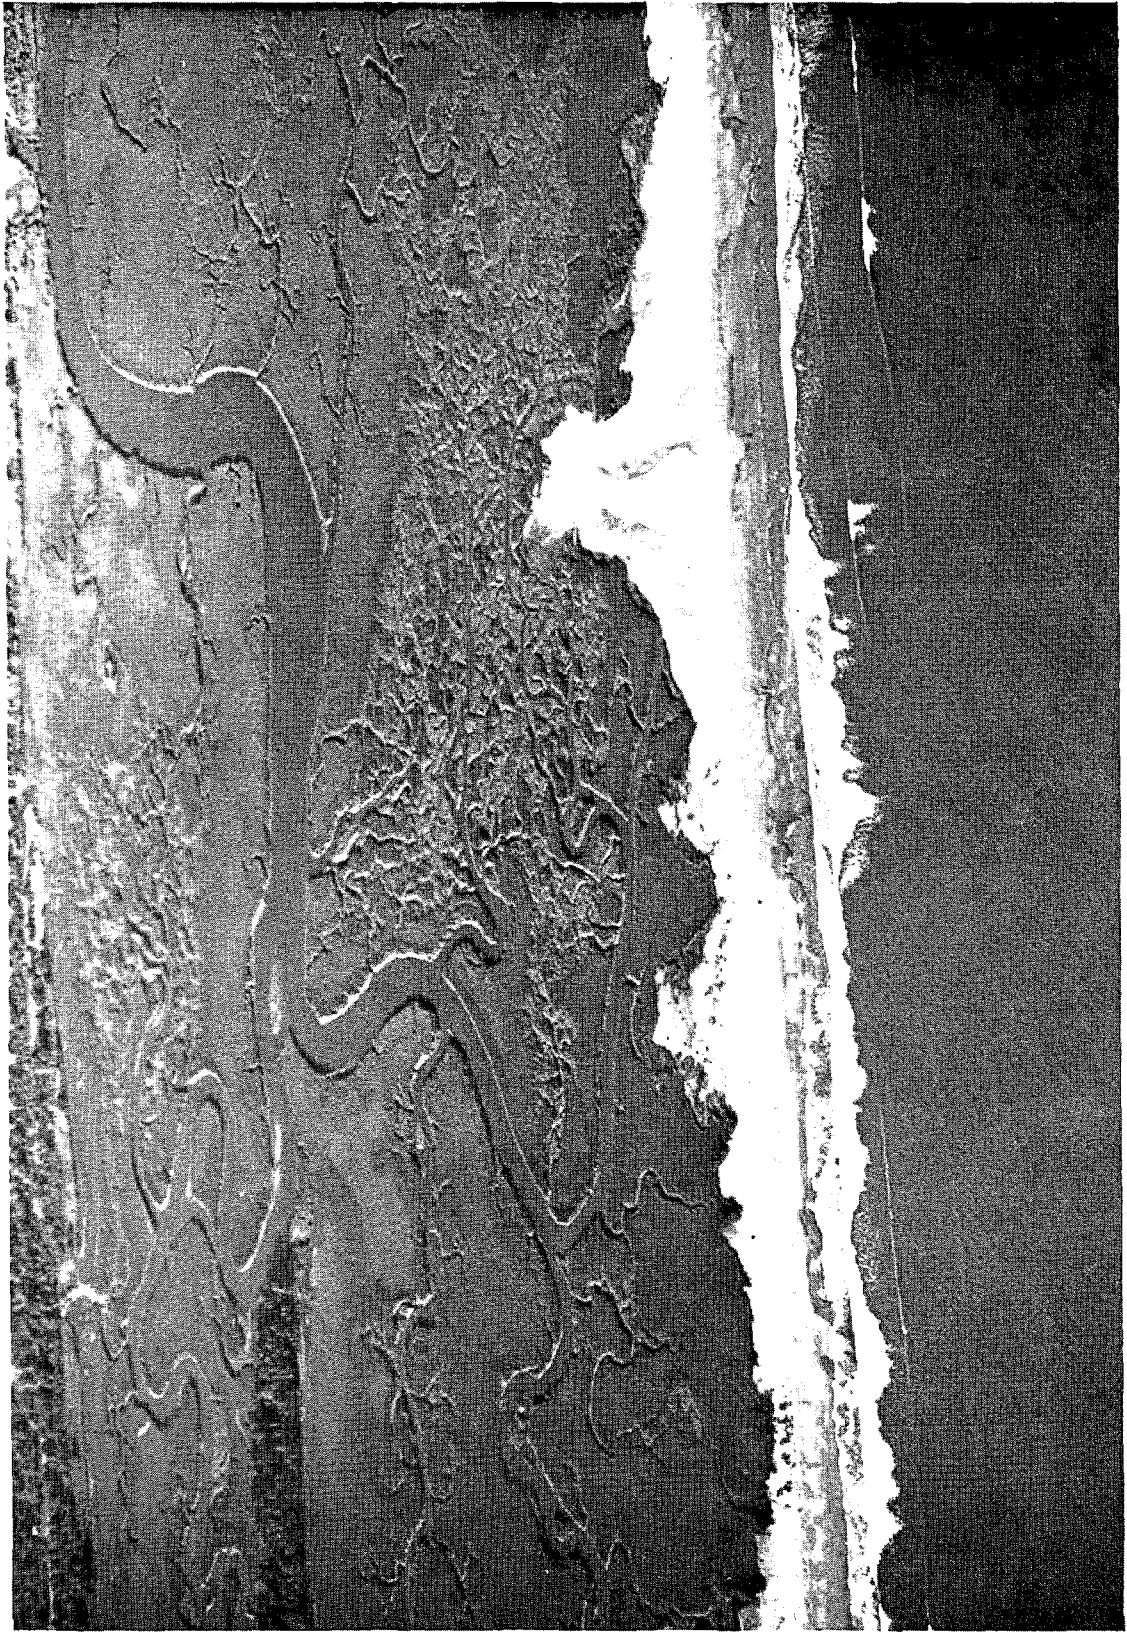
Figure 36. Edingsville Beach. This seriously eroding shoreline is eating away at the marsh. As erosion occurs, sediment washes over the beach and into the marsh forming a washover terrace. Note marsh sediments (peat) exposed on the beach face. Photograph taken January 7, 1975.
