Joe E. Moraley II
DUNE STABILIZATION
AND
BEACH EROSION

CAPE HATTERAS NATIONAL
SEASHORE
NORTH CAROLINA

DUNE STABILIZATION
STUDY 1972

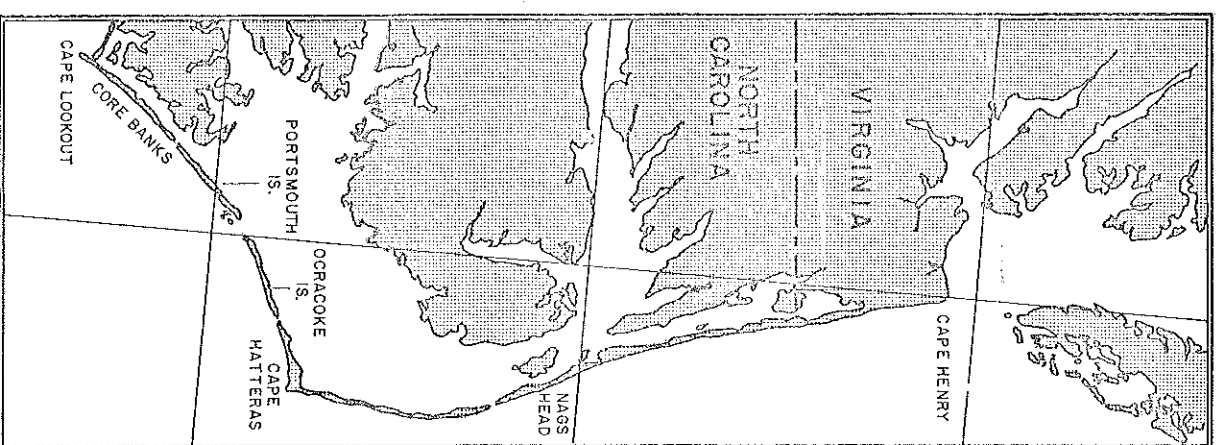
PLATE I. THE NATURAL BARRIER ISLAND

The unaltered barrier system can meet the challenge of periodic extreme storms since there is no permanent obstruction in the path of the waves and surge. Most of the initial stress of an extreme event is sustained by the broad beaches. Because no resistance is created by impenetrable landforms, water flows harmlessly between the dunes and across the islands with the result that wave energy is rapidly exhausted. The combination of high tides and high waves occasionally succeeds in eroding the beach-face and low lying fore dunes and carrying sand and shell inland or completely across the island and into the marshes.

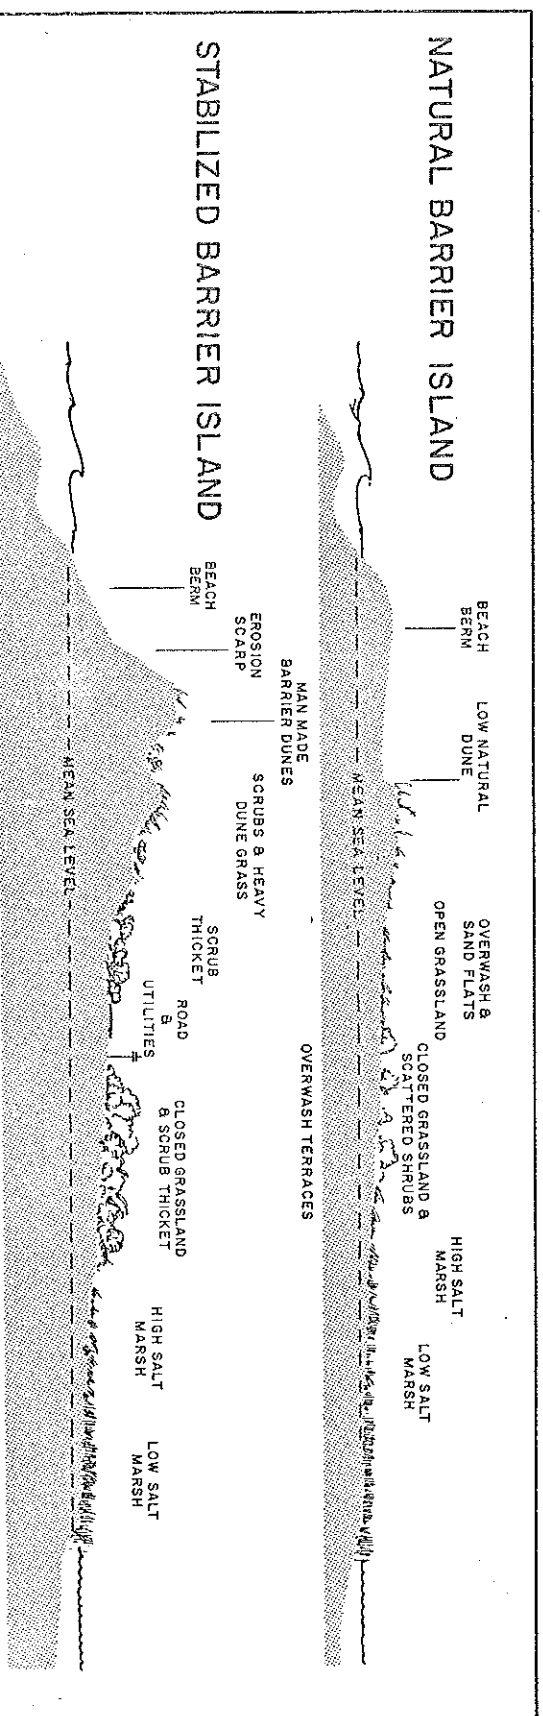
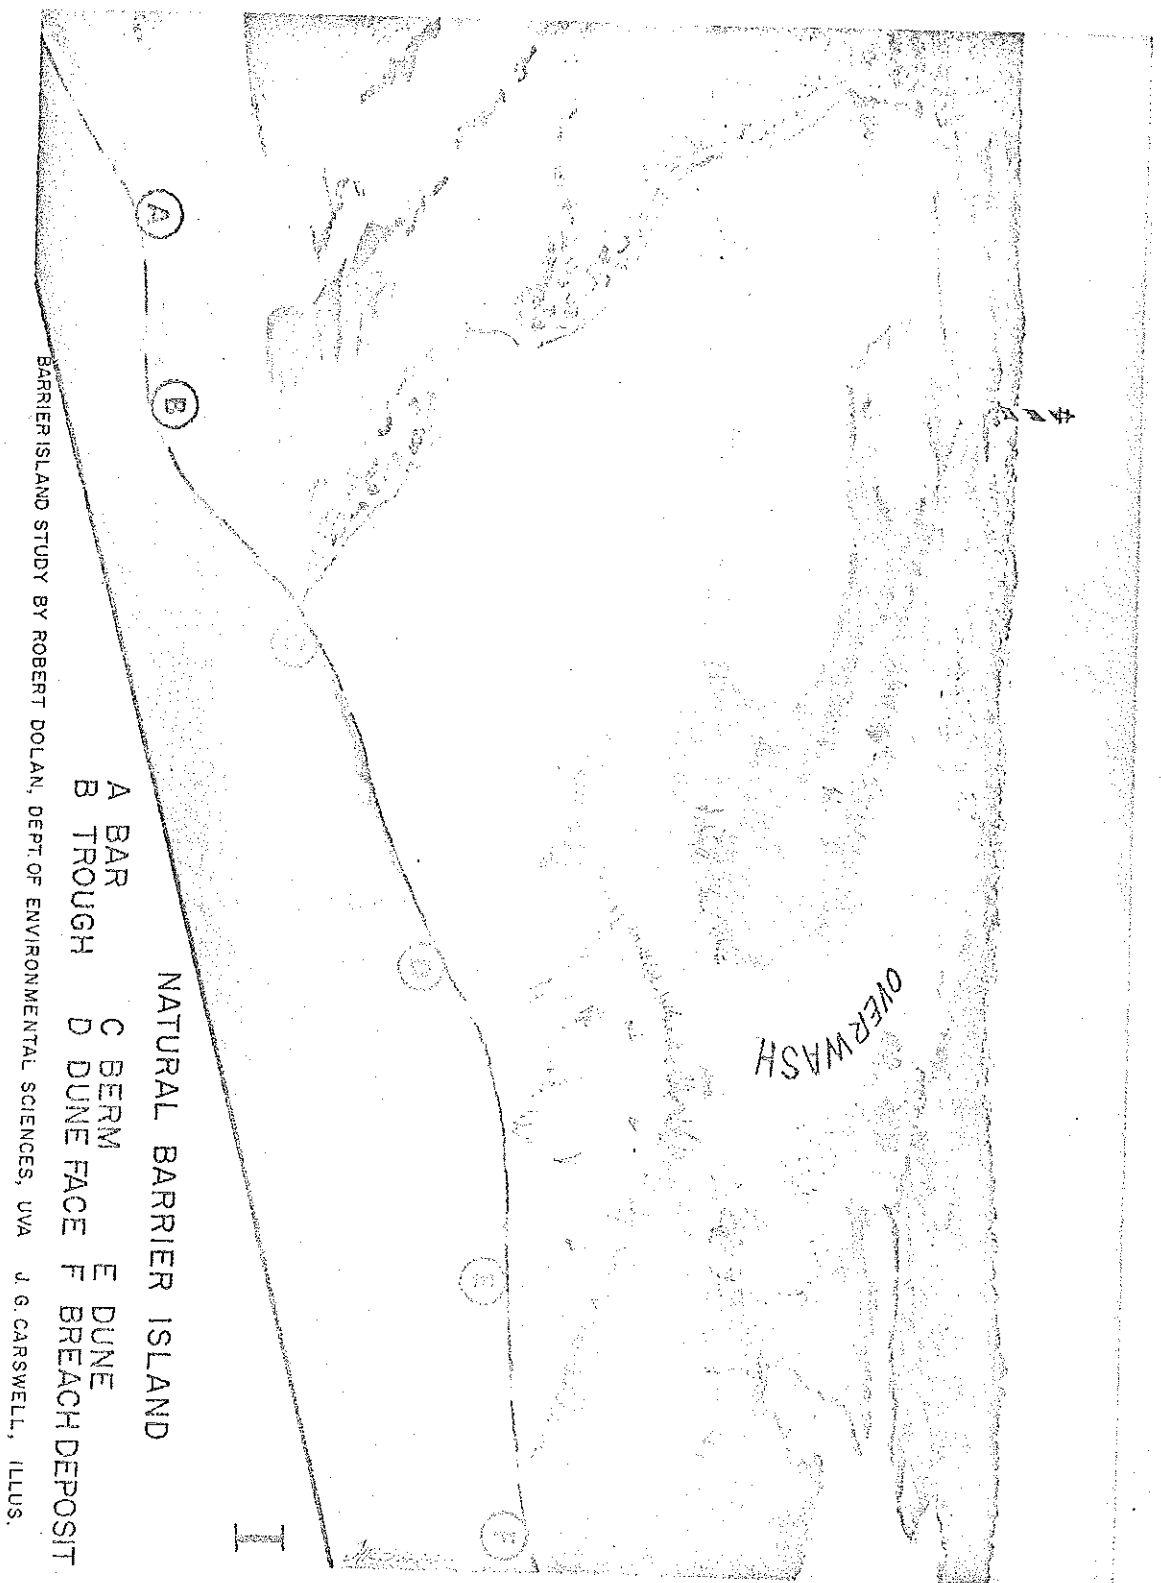
PLATE II

THE STABILIZATION PROCESS

The frequency of destructive storms along coastal North Carolina, with accompanying oceanic overwash, precluded the establishment of a permanent road network until the 1930's. It was determined at that time to construct a protective dune system between the proposed road and the beach. In the period between 1936 and 1940, the CCC and WPA, under the direction of the National Park Service, erected almost 3,000,000 feet of sand fencing to create a continuous barrier dune along the Outer Banks. This was augmented in the late 1950's by the National Park Service so that at present almost a continuous mass of vegetation blankets the barrier island from south Nags Head to the southern tip of Ocracoke Island.

As the system is stabilized, man builds roads and utilities that establish a "line-of-development" which soon becomes a "line-of-defense." Widespread private and public property development contributes directly to increased pressure to protect this line. It is important to stress that the dune lines, road lines, utility lines, or property lines have no natural significance.

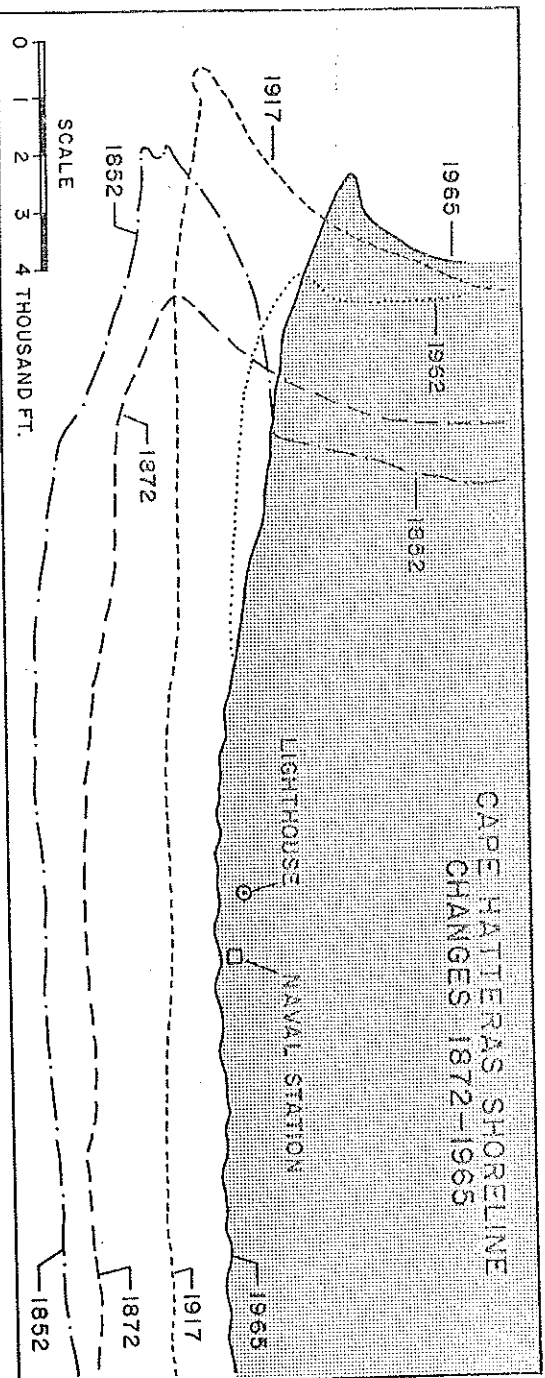
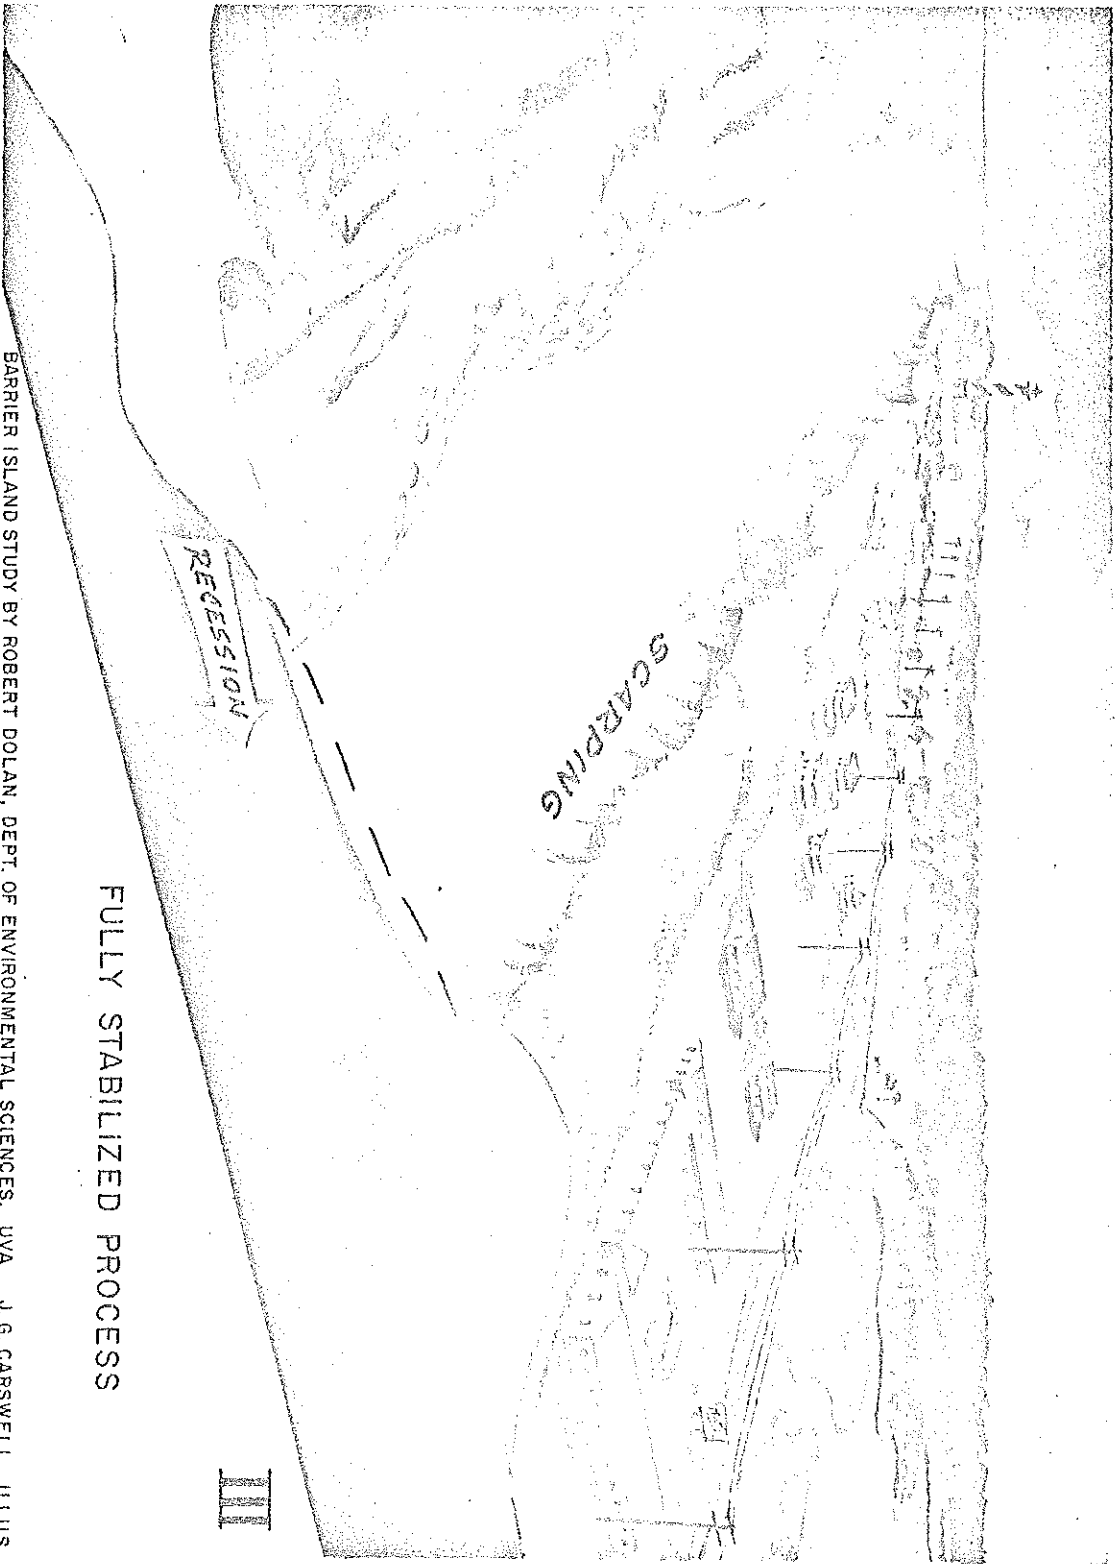
PLATE III

FULLY STABILIZED SYSTEM

Thirty years of artificial dune stabilization has greatly altered both the ecological and geological structure of the Cape Hatteras sector of the Outer Banks. A comparison of cross-sections of Hatteras Island show the extent to which stabilization has brought changes in beach morphology. The most striking difference between the natural and altered barrier islands, other than the presence of the artificial barrier dune system, is a marked difference in beach widths and the deeper inshore water depths that lead to increased wave energy dissipated on the beach-face. Along many of the Hatteras Island stretches, altered 30 years ago, the beach has receded to 150 feet, or almost disappeared.

FULLY STABILIZED PROCESS

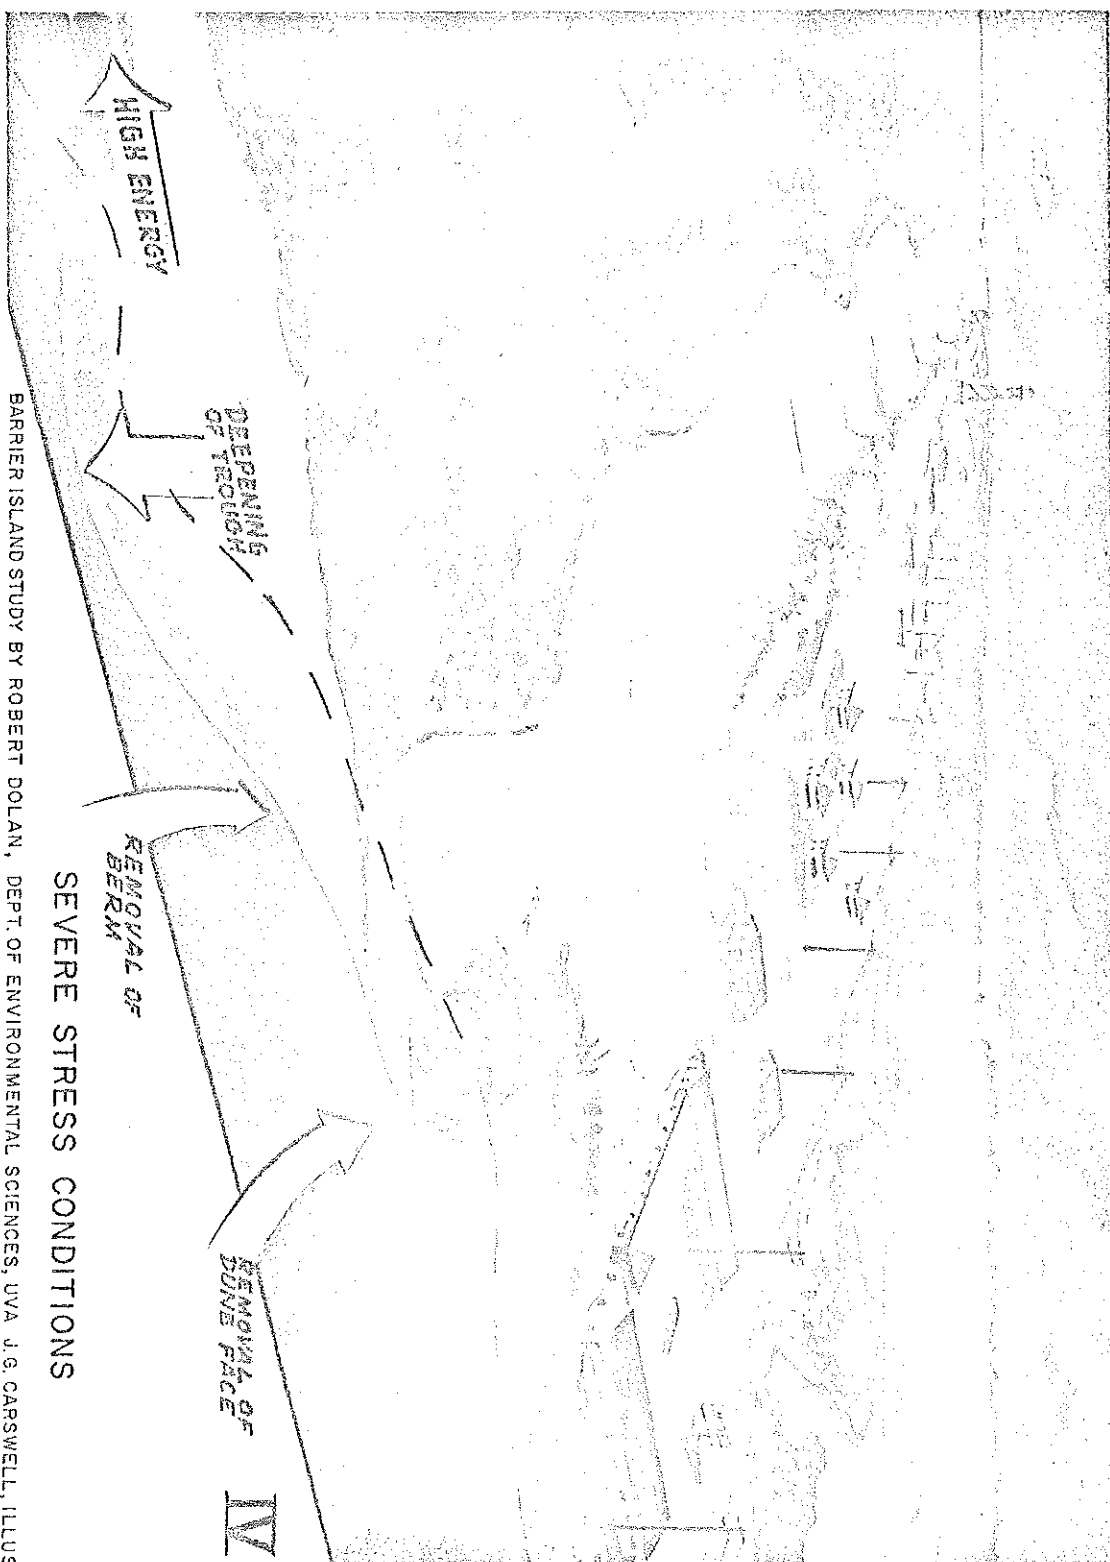
PLATE IV

SEVERE STRESS CONDITIONS

The beach narrowing process, combined with the presence of permanent dune structures, has created a situation in which high wave energy is concentrated in an increasingly restricted run-up area, resulting in a steeper beach profile, increased turbulence, and a tendency for the beach sand to be broken up into finer pieces and washed away. The net effect is increased erosion and further narrowing of the beach. Ultimately the beach may all but disappear above the high water mark, and wave uprush is then applied directly to the stabilized dune. This has occurred in several places within the Cape Hatteras National Seashore and has resulted in a gradual undercutting of the dune front, with eventual destruction of the dune system and endangering of man-made structures behind the dunes.

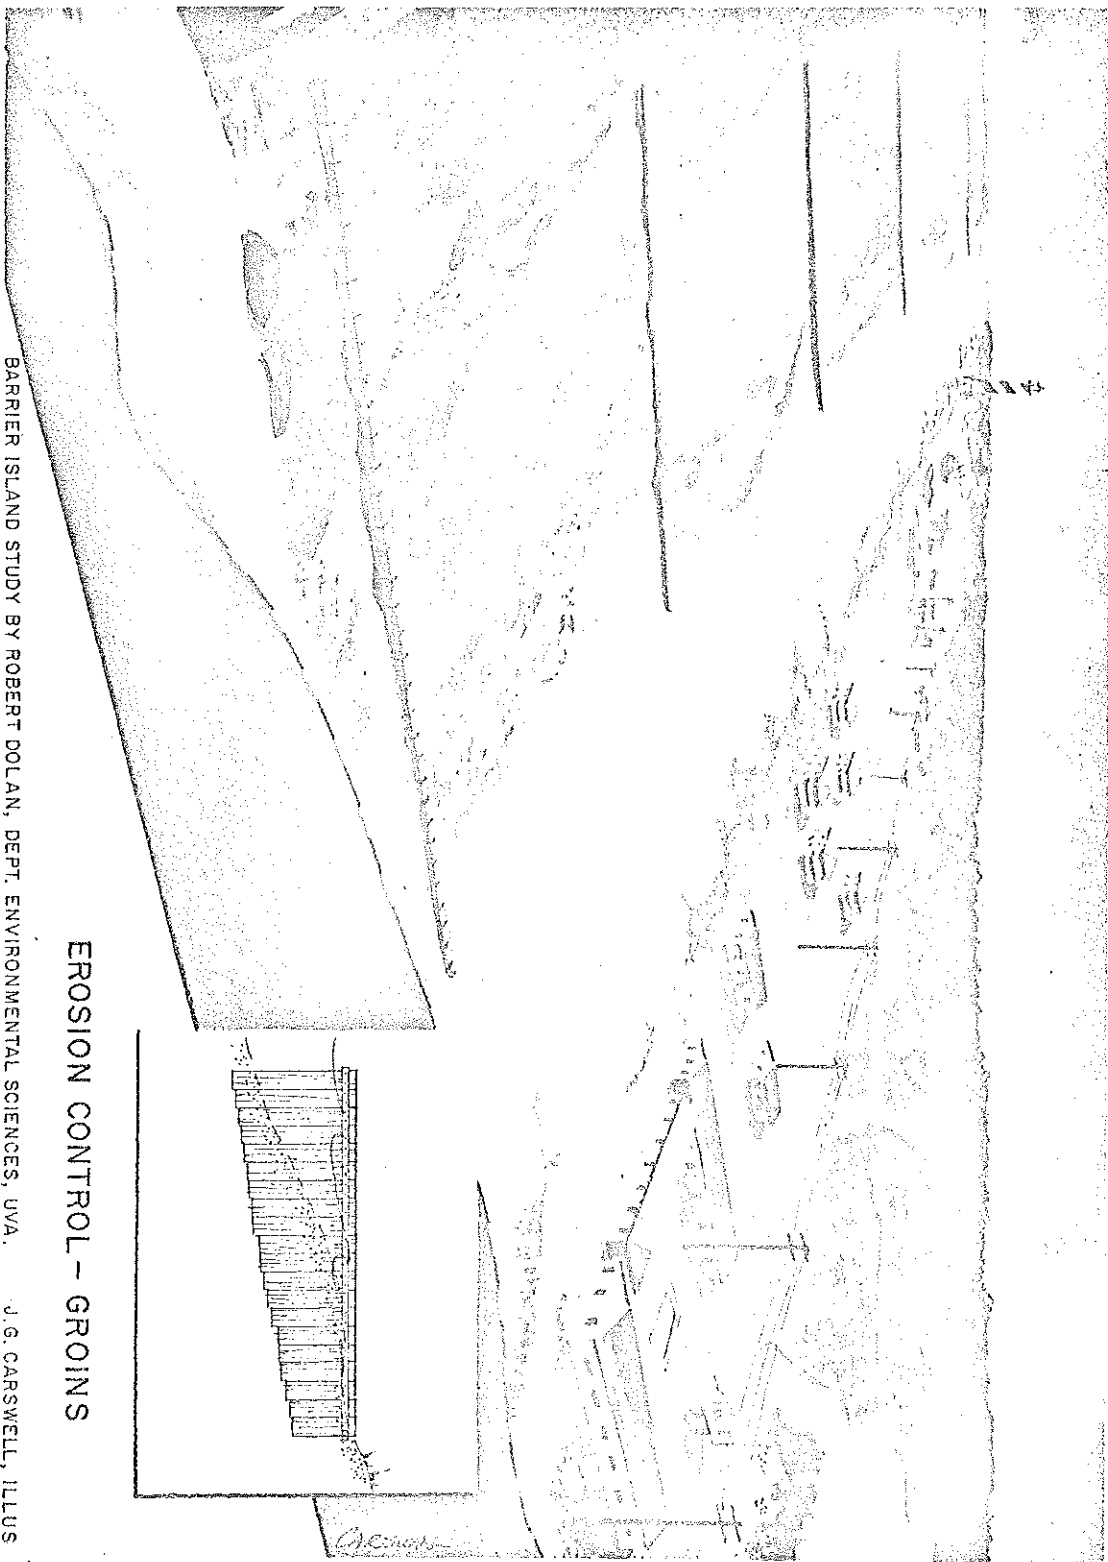
EROSION CONTROL - GROINS

Groins are obstructions placed in the path of the longshore currents for the purpose of trapping littoral drift. These structures work only when (1) littoral drift sediment is of significant volume, (2) the material is at least sand size, and (3) only when the land down the beach from the groin is considered expendable. The reason for this is that groins trap sand, and the sand gained at one place must be lost at another. Nourishment is commonly needed to fill or re-fill the groin compartments as the sands are lost.

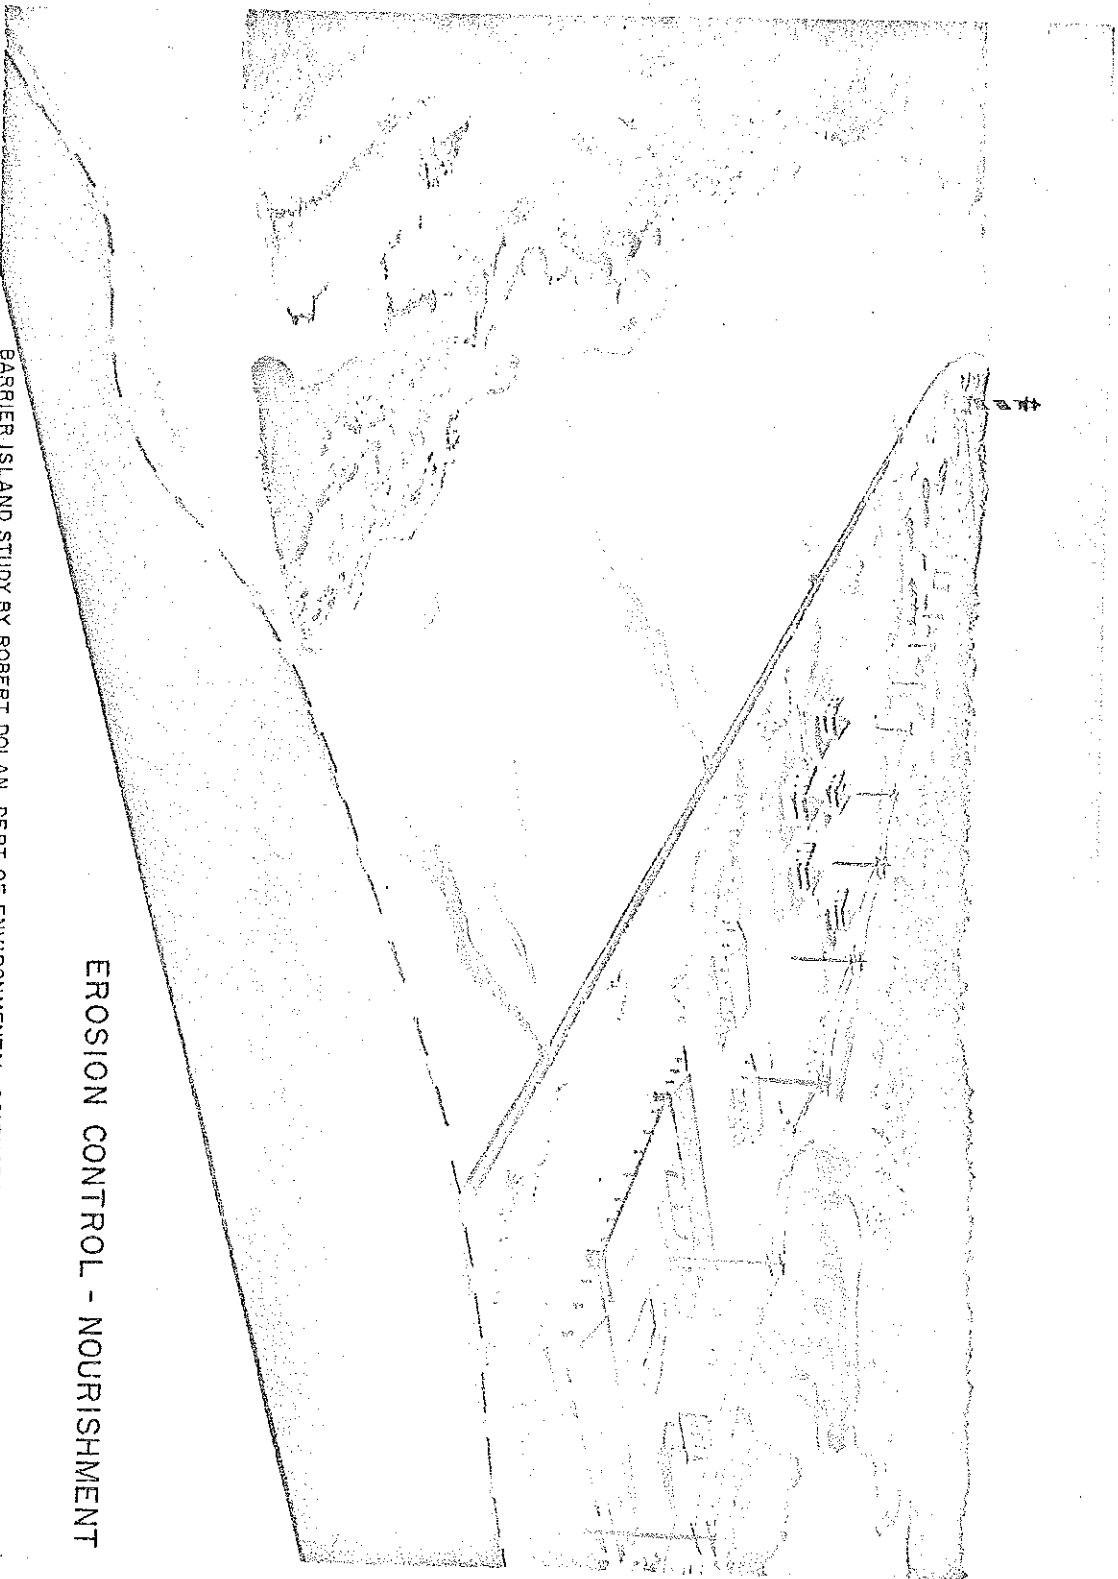
For more than a century, coastal structures, including jetties, groins, and sea walls, have been built in the inshore zone in an effort to trap sand and protect beaches. In general, these structures have collectively aggravated problems rather than resulted in solutions. The disadvantages span a wide range of physical problems. Artificial beach nourishment, on the other hand, has long been considered the most desirable method of protection because:

- (1) Placement of sand on a beach does not alter the suitability of the systems for recreation.
- (2) Nourishment cannot affect adversely areas beyond the problem area.
- (3) If design failure occurs, the results of the "structure" are soon dissipated.

Perhaps the greatest disadvantage to artificial nourishment is that great quantities of sand of suitable quality (type and size) are commonly not readily available. In the past, sands were dredged from sounds and bays immediately inland from the beach, or transported from inland sources. With the recent concern about estuarine ecology, and the fact that sound materials are generally too fine to be effective as beach nourishment, estuarine and bay sources are less desirable and no longer as available. The only future prospect for large quantities of sand for nourishment purposes appears to be offshore sources and materials dredged from the coastal inlets.
