GOOSE ISLAND SHORELINE PROTECTION AND RESTORATION OF ADJACENT HABITATS Feasibility Study/Alternatives Analysis

Protect and restore wetland habitats on GI at Goose Island State Park in Lamar, Aransas County

- Protecting the 1 mile long eroding shoreline of Goose Island and
- Creating smooth cordgrass marsh

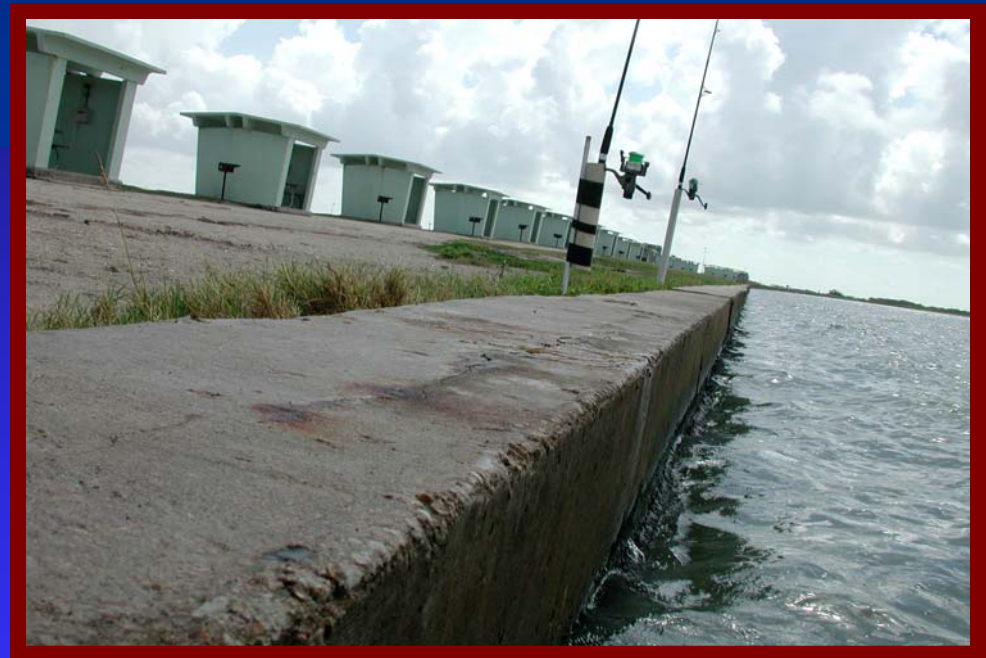
EROSION ON GI SHORELINE

- Significant erosion on the unprotected western section
- TPWD analysis of aerial photography:
 - Land eroded between 1969 and 1995: 17.1 acres
 - Average erosion rate: 0.66 acre/year

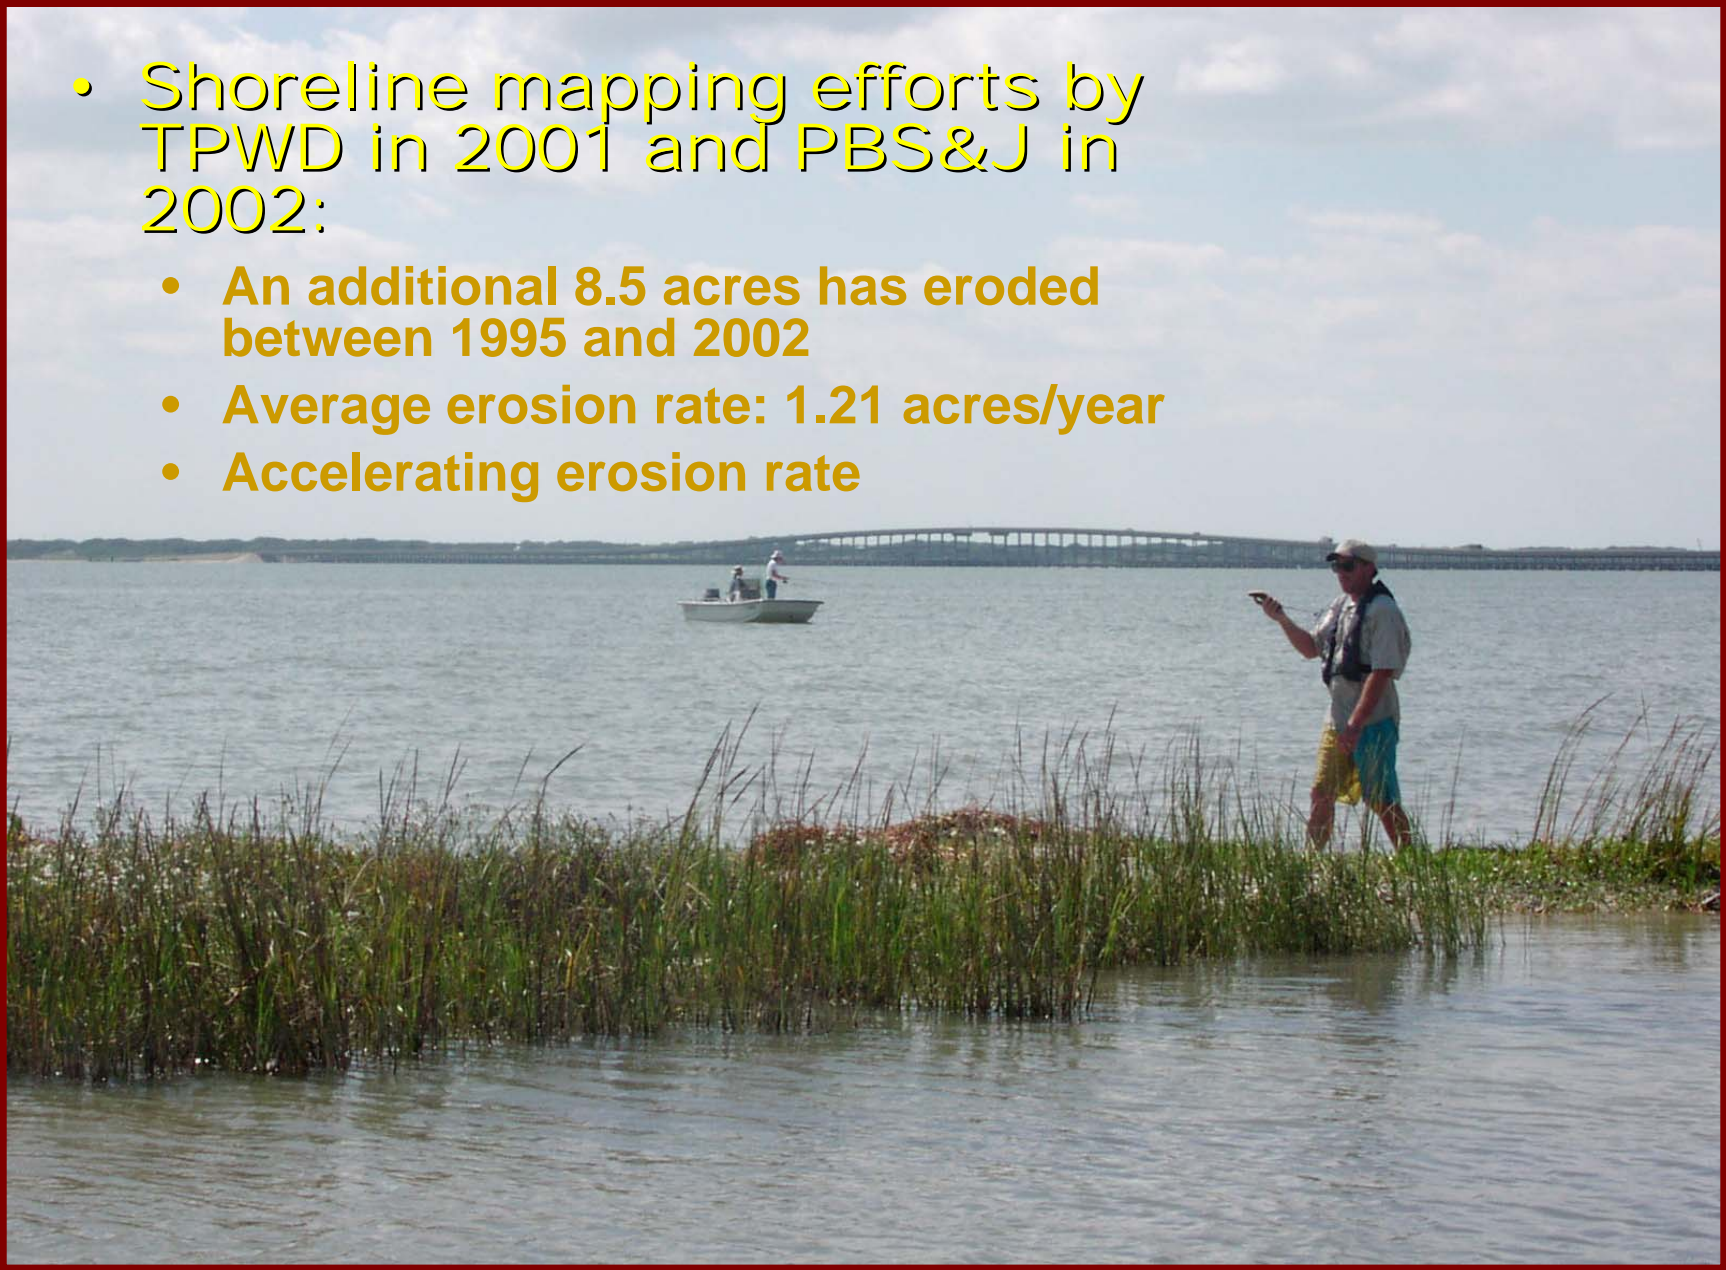
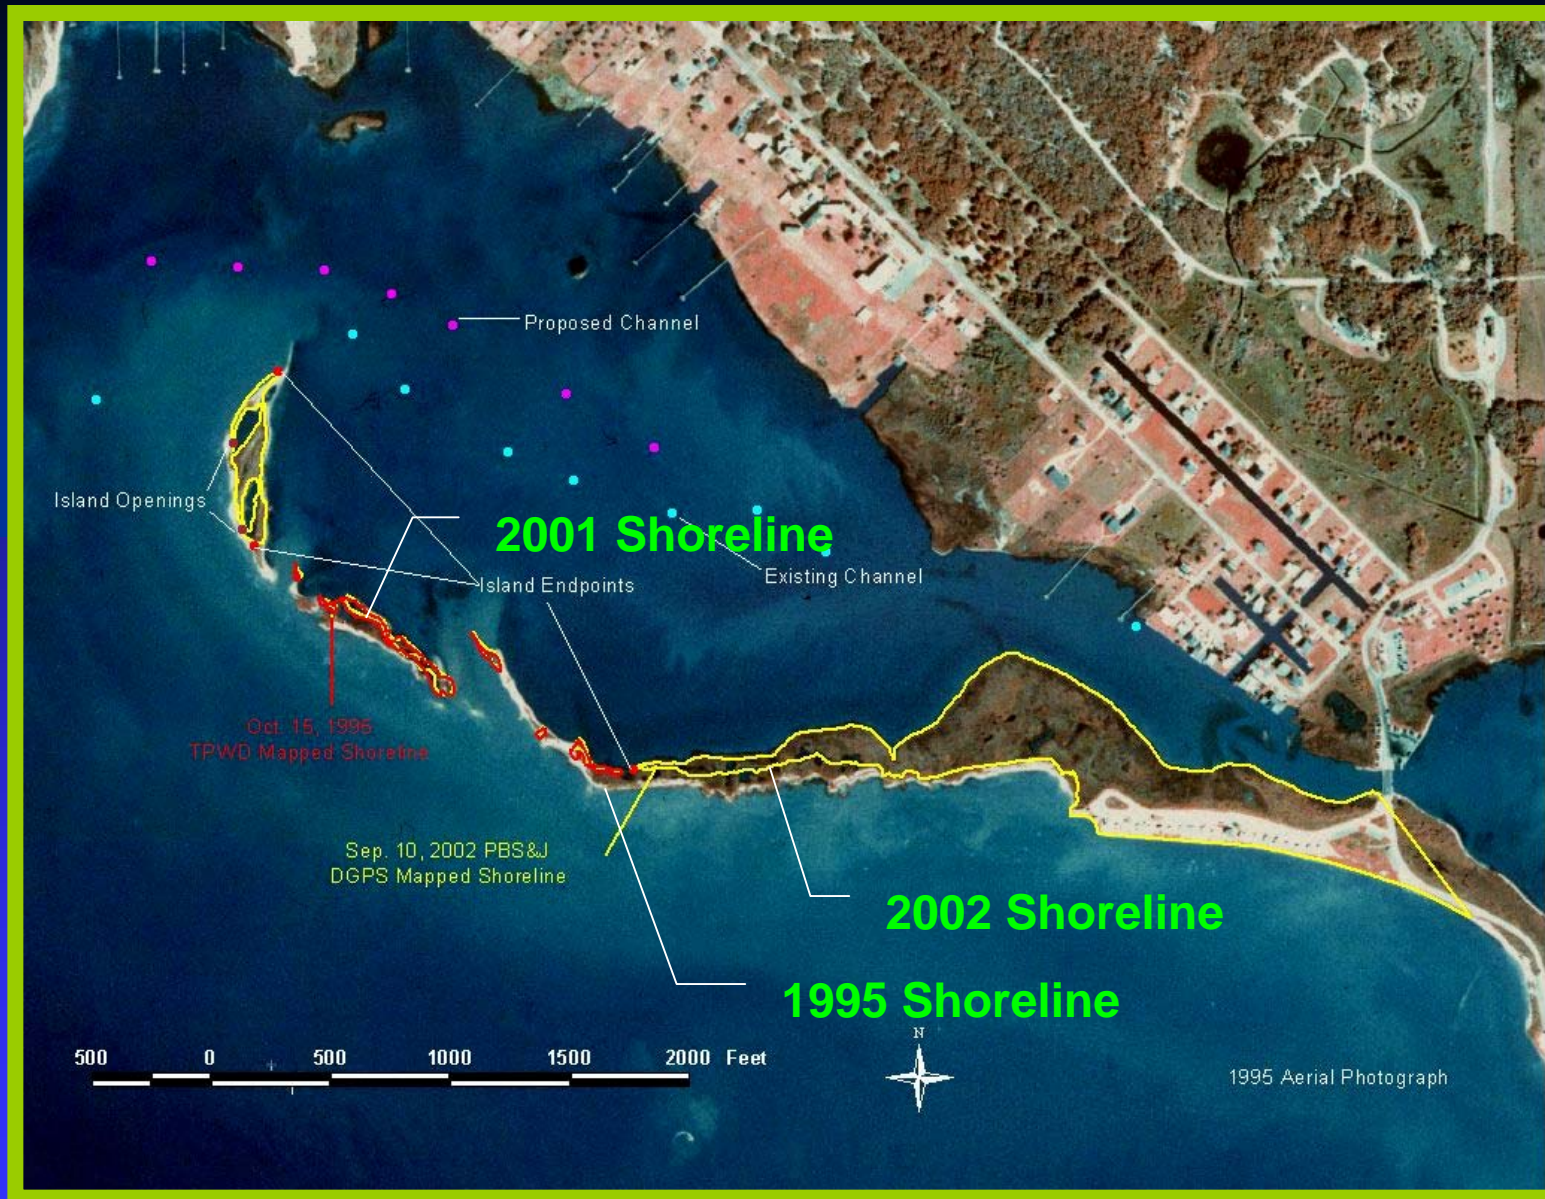
GI Shoreline Changes Between 1995 and 2002

- Shoreline mapping efforts by TPWD in 2001 and PBS&J in 2002:
 - An additional 8.5 acres has eroded between 1995 and 2002
 - Average erosion rate: 1.21 acres/year
 - Accelerating erosion rate

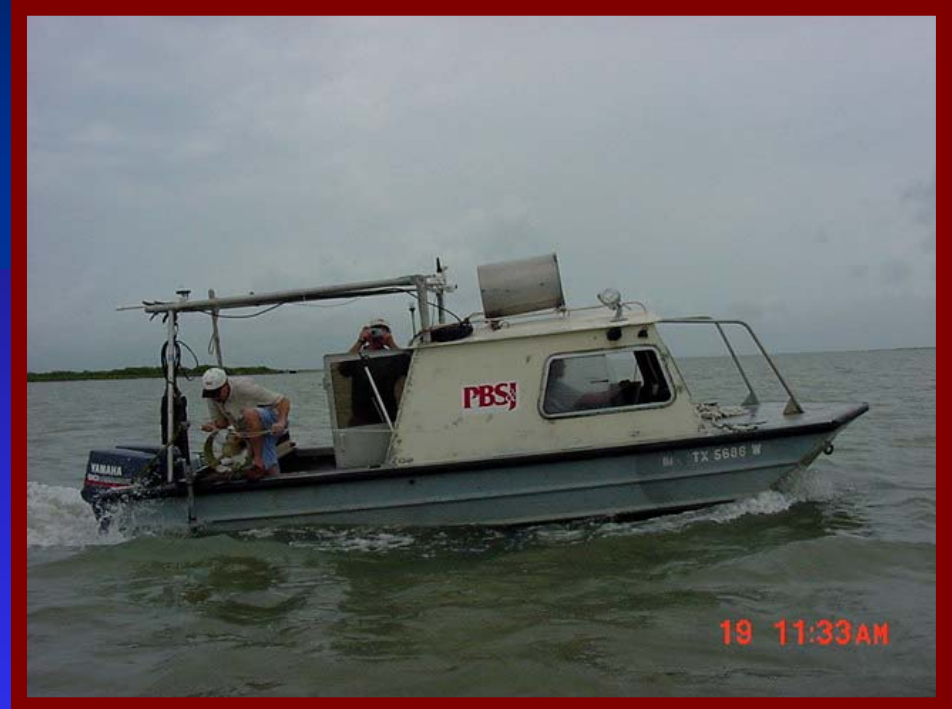
PBS&J SURVEY BOAT

- A 20-foot (ft) aluminum workboat
- Hydropro 2.0 navigation software
- A Satloc SLX GPS with Omnistar differential correction receiver
- An EG&G Geometrics G 881 cesium magnetometer
- A CODA Technologies DA50 side-scan sonar data acquisition system
- An Edgetech TD272 sonar towfish
- An Odom Hydrotrac echo sounder with a narrow beam (4-degree), 200-kHz transducer

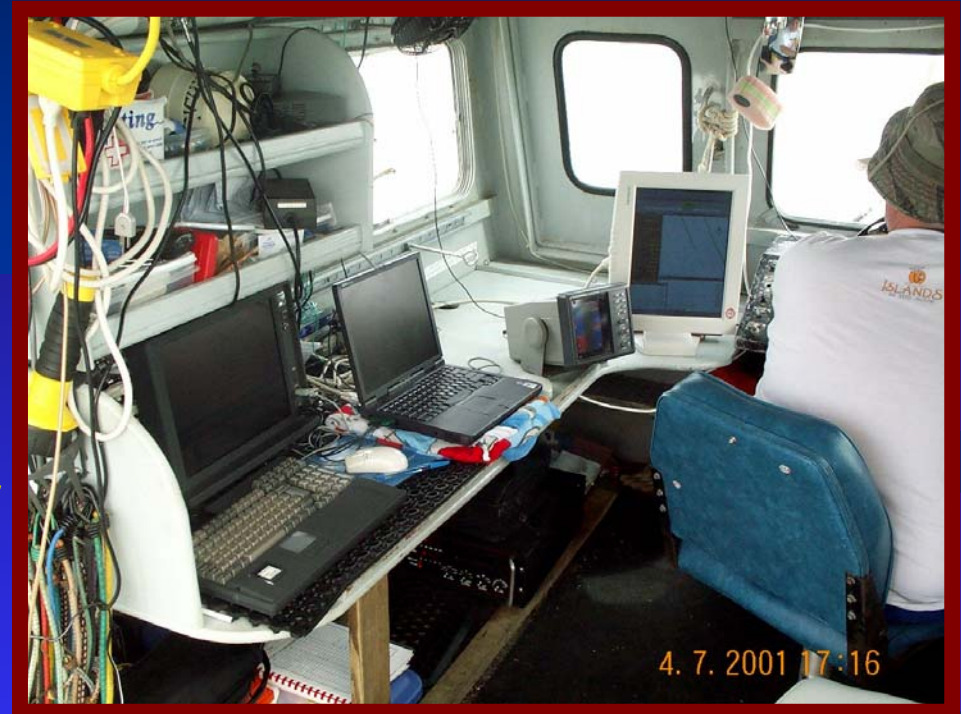
PBS&J SURVEY BOAT

- A TSS DMS 05 heave compensator
- A Valeport VTM740 automatic tide recorder
- Sonar transducers at a depth of about 2 ft
- Echo sounder transducer at 1.1 ft beneath the surface
- Boat speeds at 2.5 to 4.5 knots (2.9 to 5.2 mph)
- Side-scan sonar range - 98 ft on each side of the towfish
- Magnetometer readings - once per second
- Water depths - four times per second

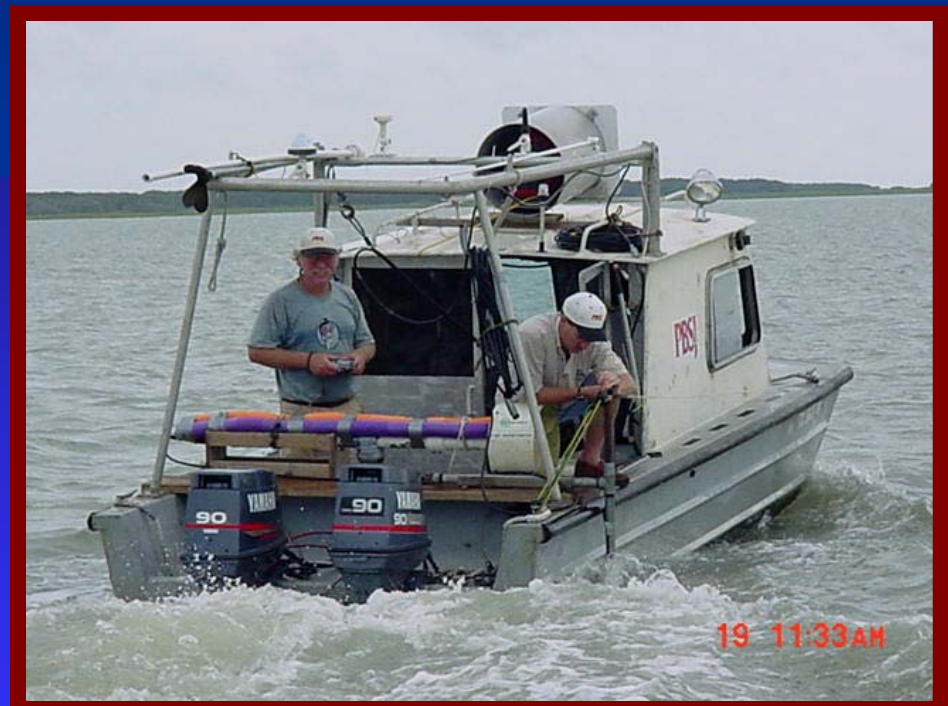
BATHYMETRY SURVEY

- Boat survey to as near shore as possible (~ 3 ft deep at high tide)
- Near shore survey along transects perpendicular to shoreline at 500-ft interval
- Tidal correction using TCOON gage data
- Data converted to NAVD88 via two bench marks
 - 036.001 4513 B 1989 located at Copano Bay State Fishing Pier Building
 - 036.002 4513 C 1989 located at Copano Bay State Fishing Pier

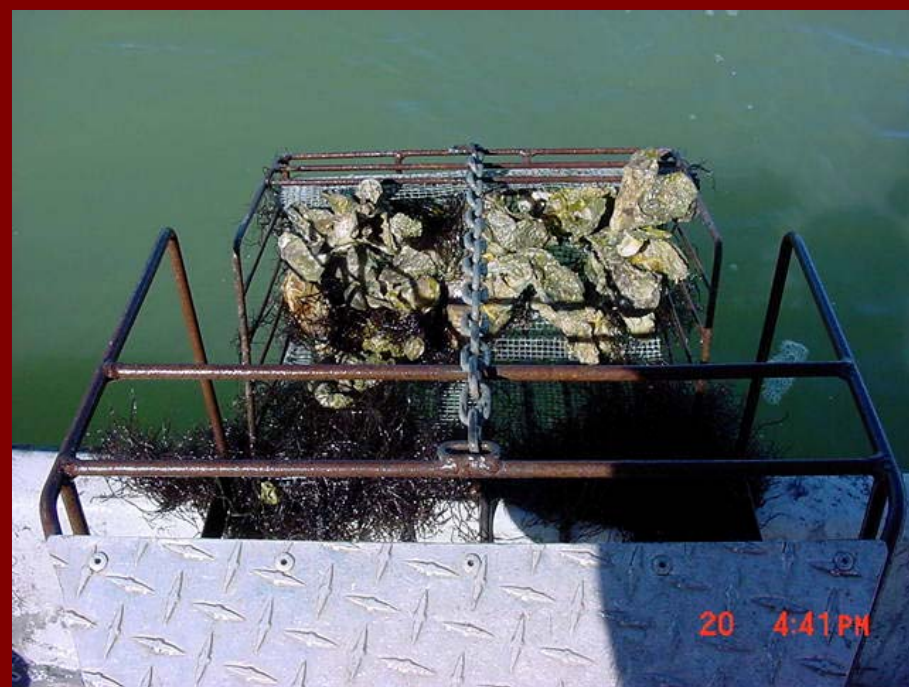
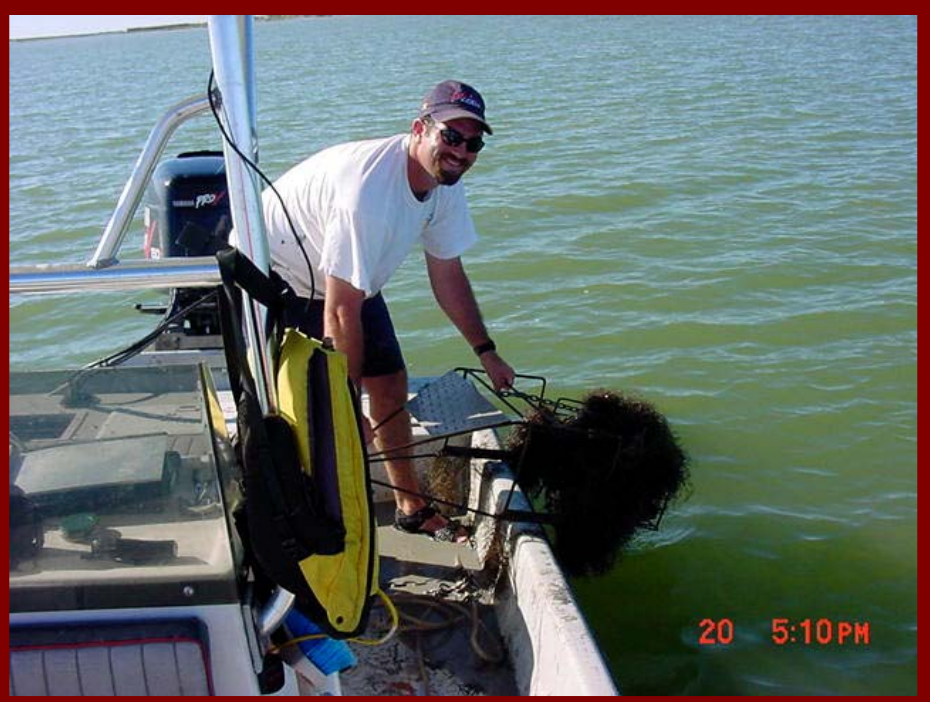
SEAGRASS AND OYSTER SURVEY

- Side-scan sonar to map substrate anomalies that might represent oyster reefs or seagrass beds

- Physical survey
 - Verify all substrate anomalies identified
 - Areas not accessible by side-scan sonar

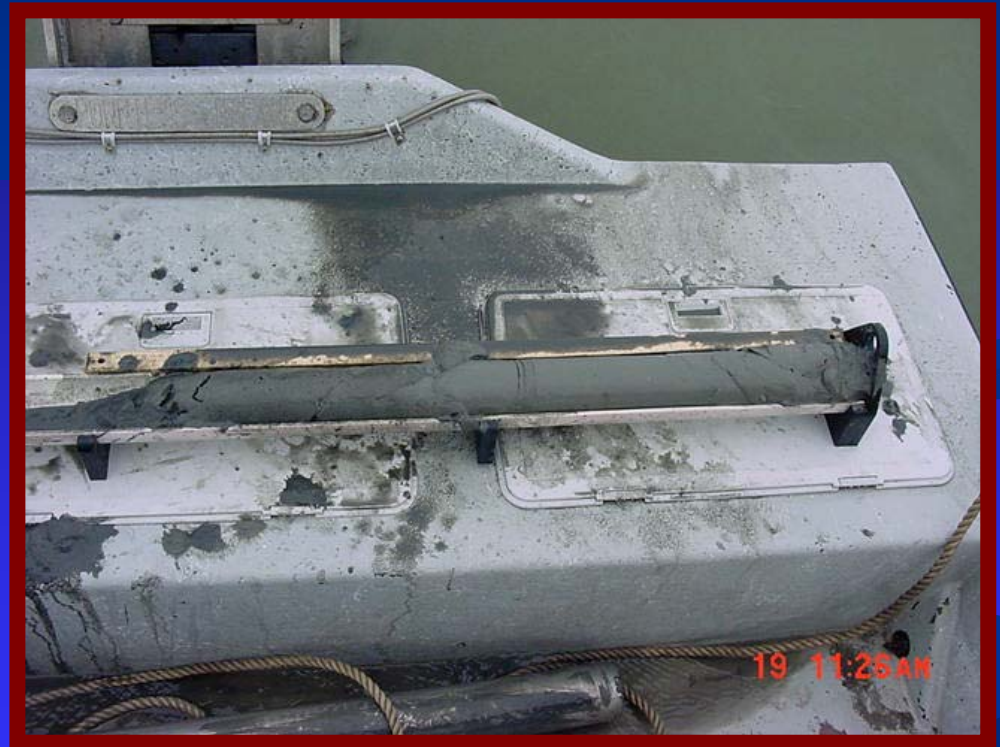
GEOTECHNICAL SURVEY

- **1974 NRCS Soil Survey:**
 - Tatton Complex" (Tn)
 - 60% Tatton loamy sand
 - 40% other soils
- **2002 Survey by PBS&J**
 - 25 Coring Locations
 - 3-in diameter, 3-ft long
- **Laboratory Testing:**
 - Top 16 inches: clayey-sand (54.8% sand, 5.5% silt, 39.7% clay)
 - 16-36 inches: silty-sand (81.2% sand, 18.8% silt, 0.0% clay)

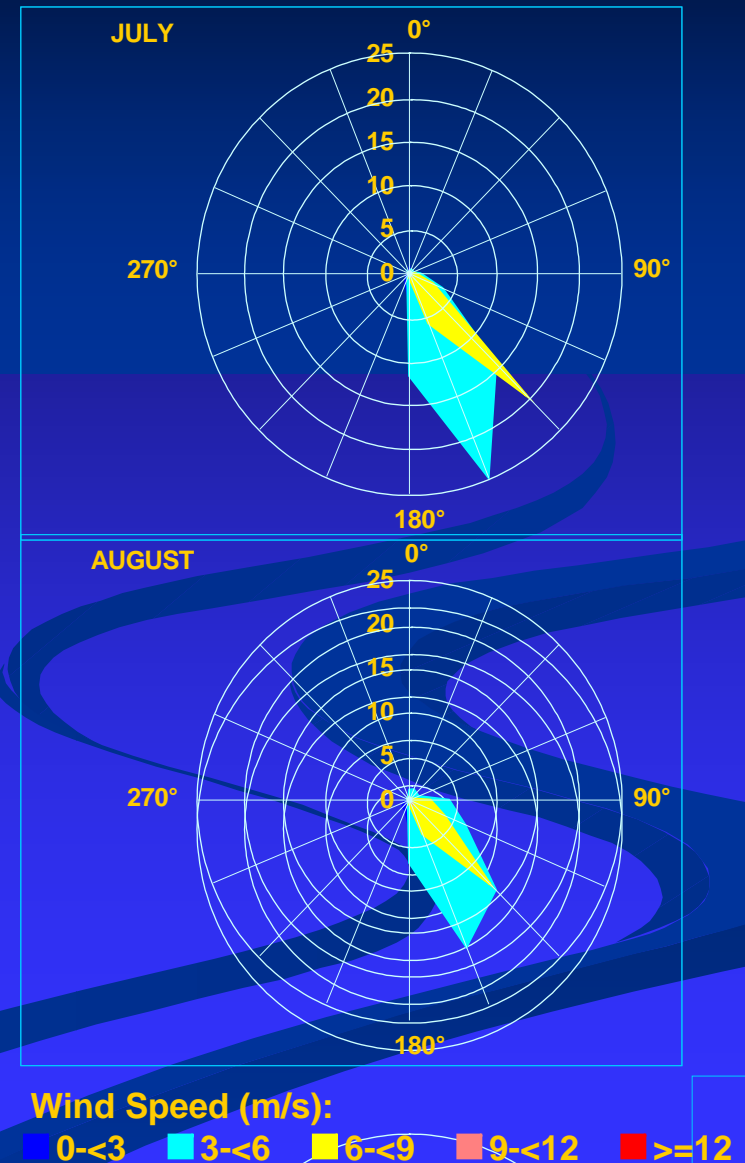
WIND ANALYSIS

■ Wind Roses

- Five wind speed categories
- 16 wind directions

- SE wind at 22.5 knots
- SSE wind at 22.5 knots
- S wind at 15 knots

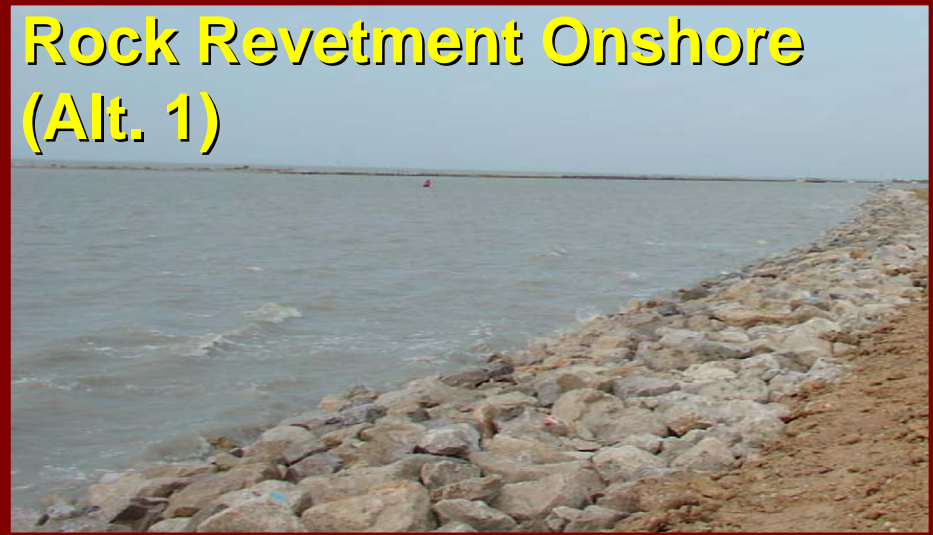
**Rock Revetment Onshore
(Alt. 1)**

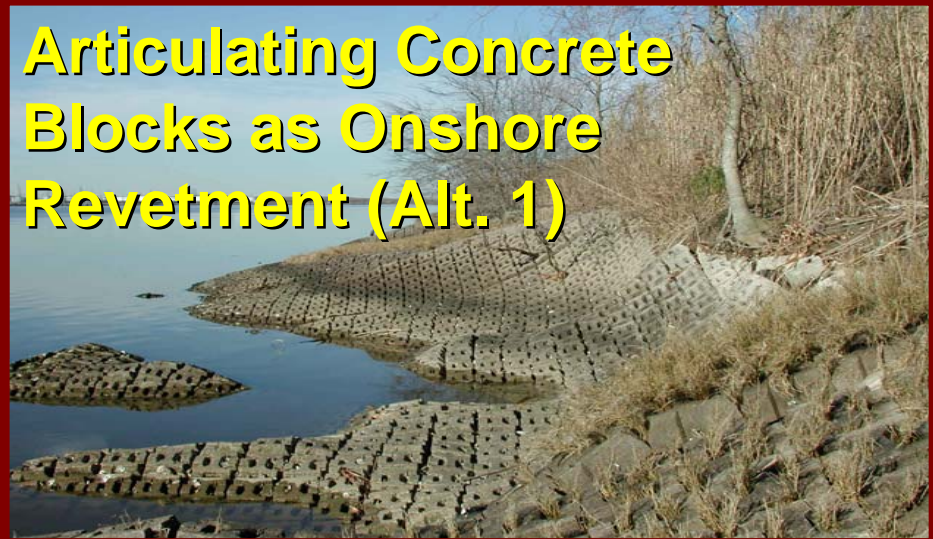
**Articulating Concrete
Blocks as Onshore
Revetment (Alt. 1)**

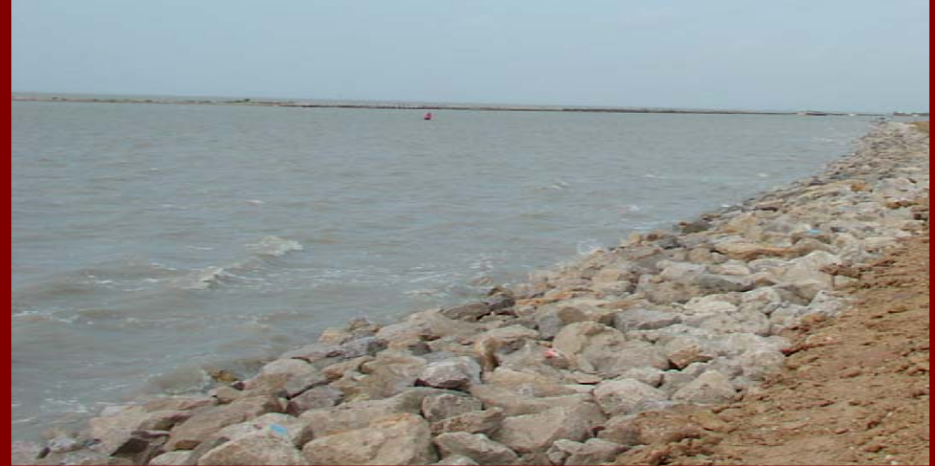
Rock Revetment Onshore

Alternative 1 - Onshore Revetment

- Only addresses shoreline erosion
- Does not restore wetland habitats
- Possible impacts to seagrass beds and smooth cordgrass marsh

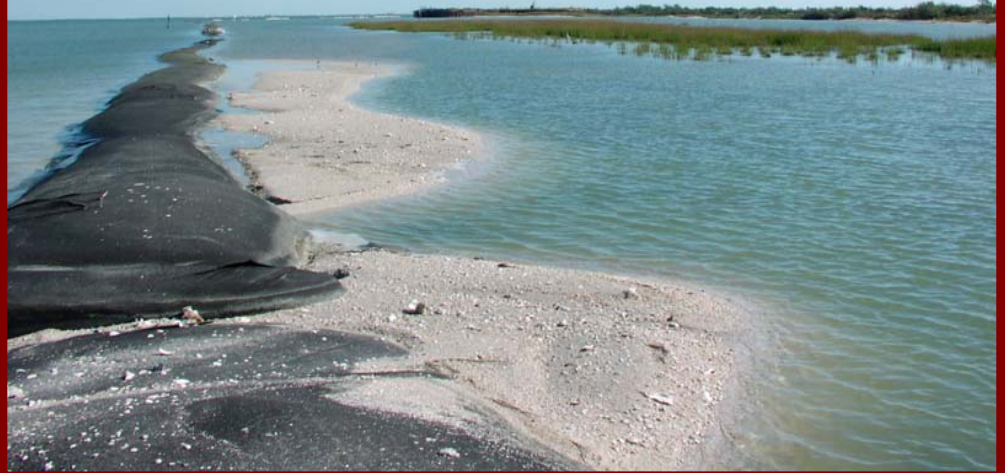
- Creates lagoon effect between breakwater and shoreline which may enhance seagrass habitat reestablishment of marsh
- Less environmental impacts

Offshore breakwater on Shamrock Island and the resulting lagoon effect

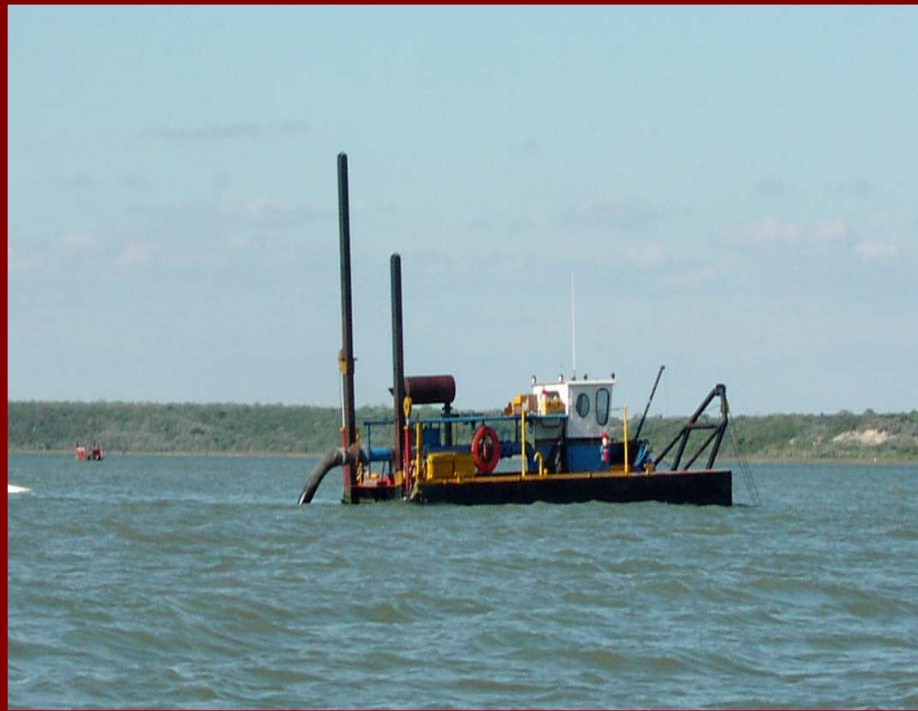
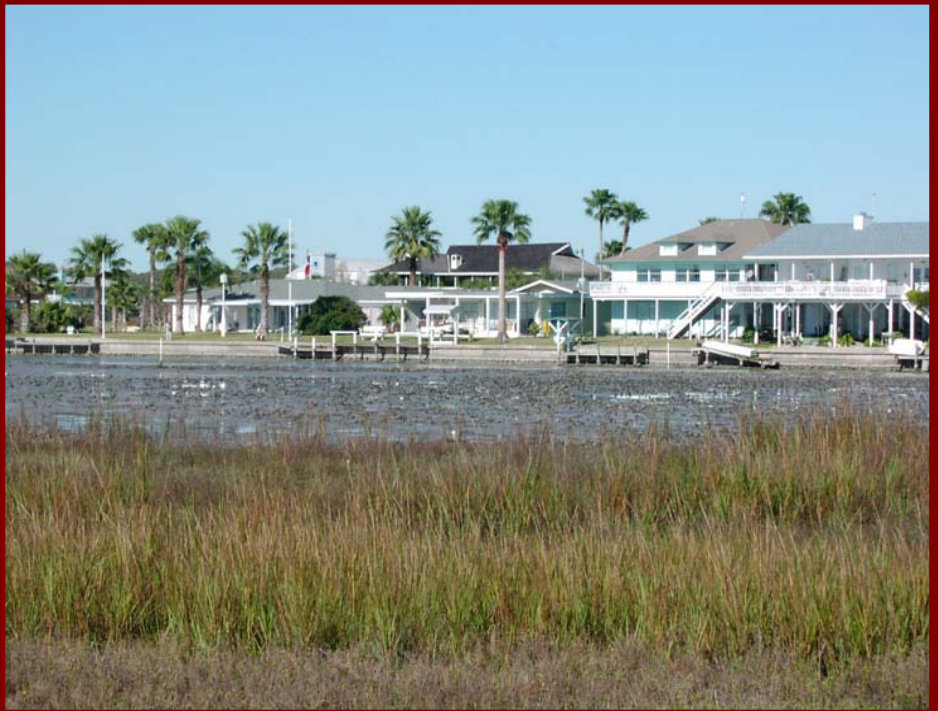
Placing dredge material from boating channels that access Neptune Harbor and Goose Island State Park boat ramp into confined marsh cells.

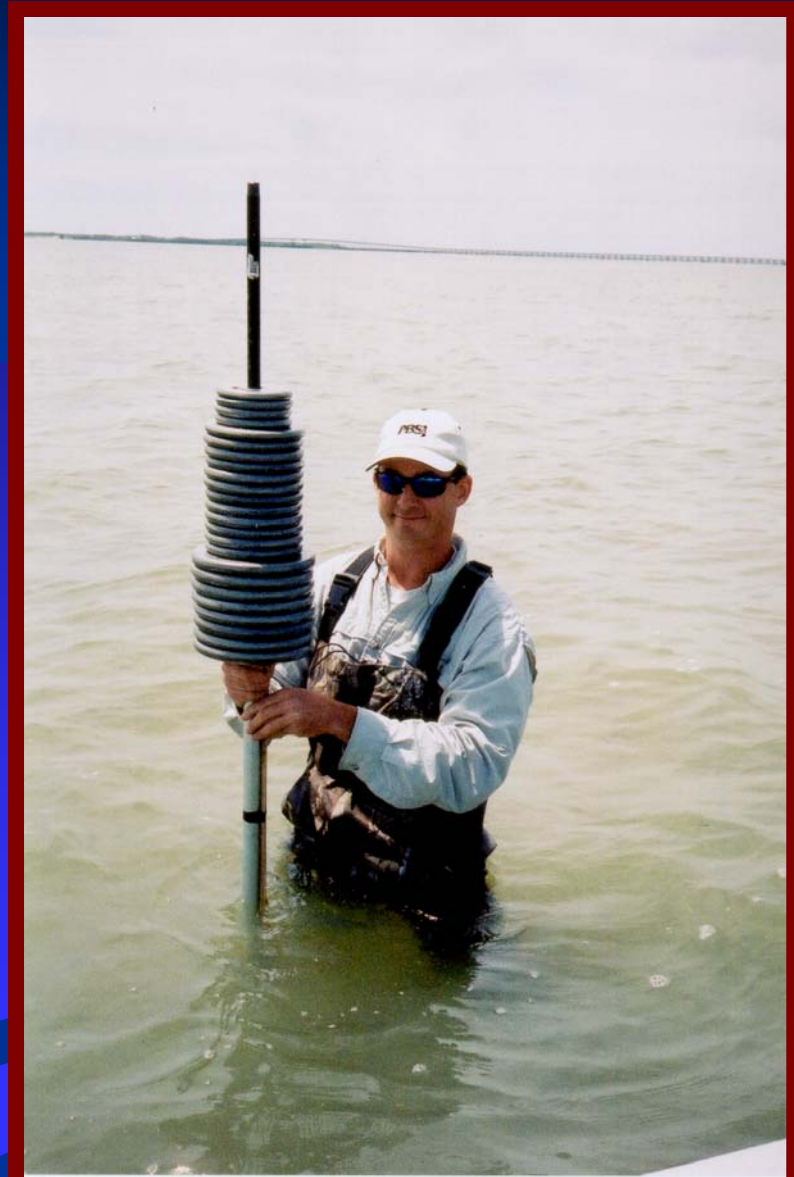
GEOTECHNICAL INVESTIGATION

- Along preferred offshore breakwater alignment
- Soil-bearing capacity
- Vane-Shear Test
- Plate-Load Test
 - 6-inch round steel plate
 - Max 165 pounds of weight
 - 15 min loading time
 - Max 4 in settlement (mostly less than 1 in)
- Significant sand and shell composition found
