***Severe Beach Erosion Caused  
by Permanent Beach Sand Loss  
Through Rollover Fish Pass  
Bolivar Peninsula, Texas***

**September, 1999**

**Richard L. Watson, Ph.D.  
Consulting Geologist  
P.O. Box 1040  
Port Aransas, Tx 78373  
(361) 749-4152 (253) 981-0412 fax**

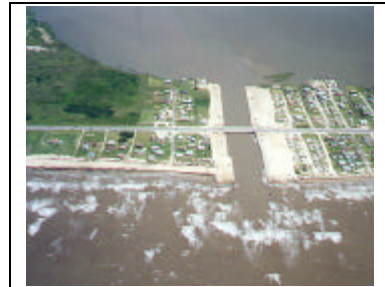
Figure 2 Rollover Pass

Most artificially created small passes (inlets through the barrier islands and peninsulas) on the Texas coast have tended to close naturally because the movement of beach sand along the coast in the littoral drift system exceeded the capability of the tidal flows through the passes to keep them flushed free of sand. Rollover Pass is an exception to this trend. Figure 2 shows Rollover Pass in July, 1999. The original steel sheet pile bulkheads lining the pass have been replaced with new concrete bulkheads. Wide concrete armored ends now extend beyond the beach, into the Gulf.

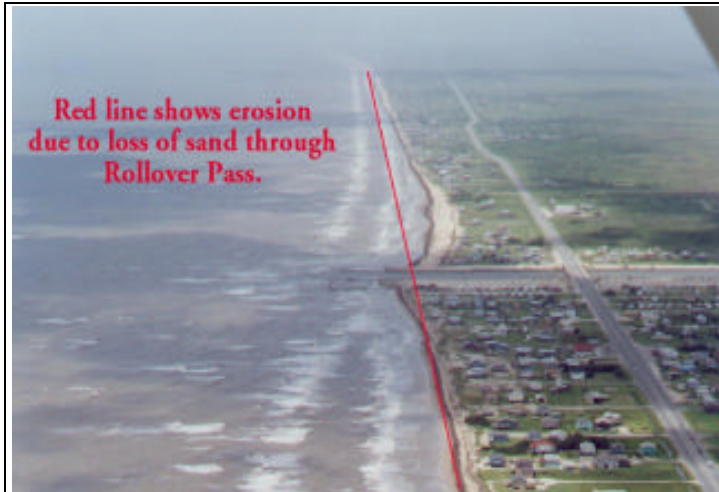
Figure 4. Beach Erosion Southwest of Rollover

This July 1999 photograph shows the severe beach erosion southwest of Rollover Pass described by Lockwood Andrews and Newnam in 1974. Since 1974, the erosion has progressed dramatically. The present shoreline would be at the location of the red line or further to the east (left in the photograph) in the absence of beach erosion caused by sand loss from the beaches through Rollover Pass (Fig. 4).

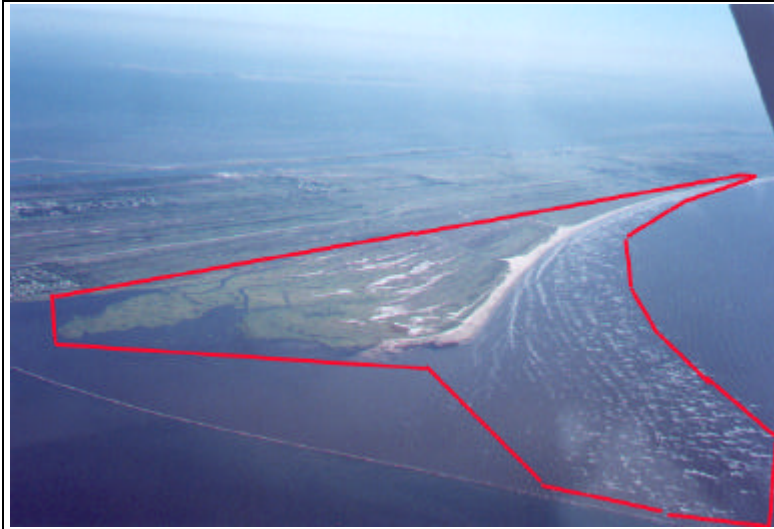
Figure 6. Accumulation of sand north of Galveston jetty

This huge accumulation of beach materials was carried west along the shore of Bolivar Peninsula and accumulated north of the jetty at the Galveston Entrance Channel is shown in Figure 6. All of the material enclosed in red was deposited since the jetty was built 123 years ago in 1876. This amounts to about 260,000 cu yd/yr. This is fairly close to the 200,000 cubic yards estimated to be lost to the

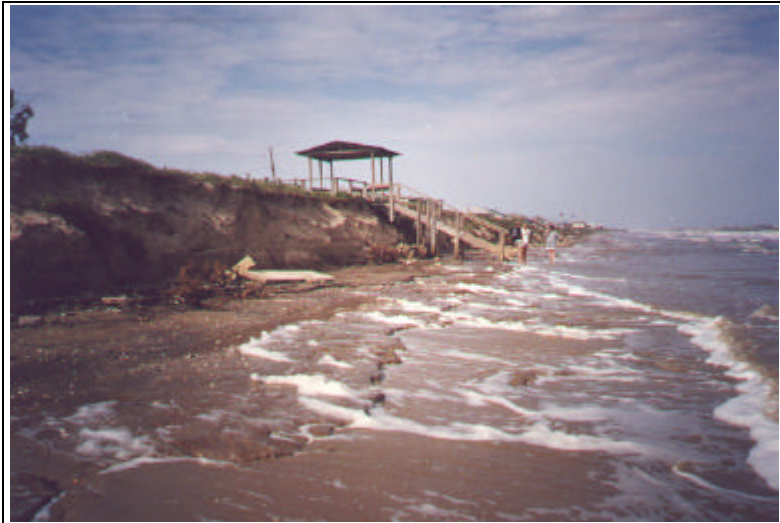
Figure 19 (Beach at Gordon House late summer 1995)

tropical storm Dean. Note the ledges of clay forming the beach instead of sand. This is very significant because it shows the shoreline eroded back so far inland, that there is no longer a thick sand body in the location of the beach.

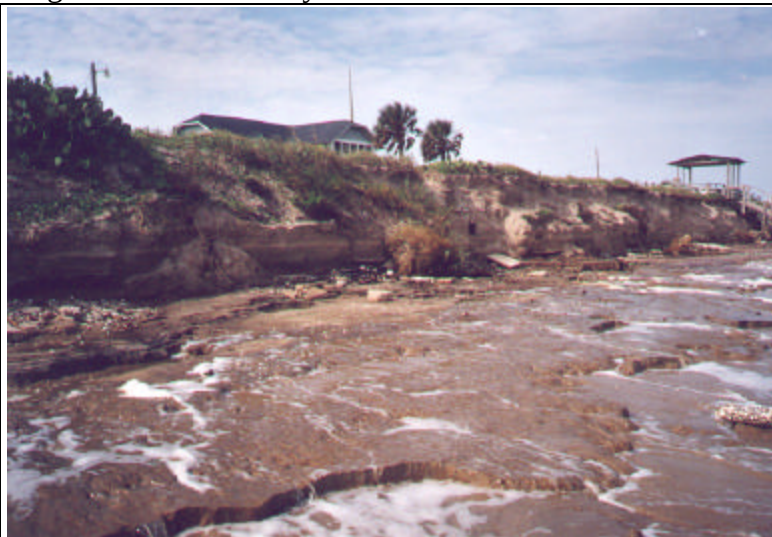
Figure 20 Late Summer 1995 at Gordon house

- 45 the beach between major storms (Fig. 20).

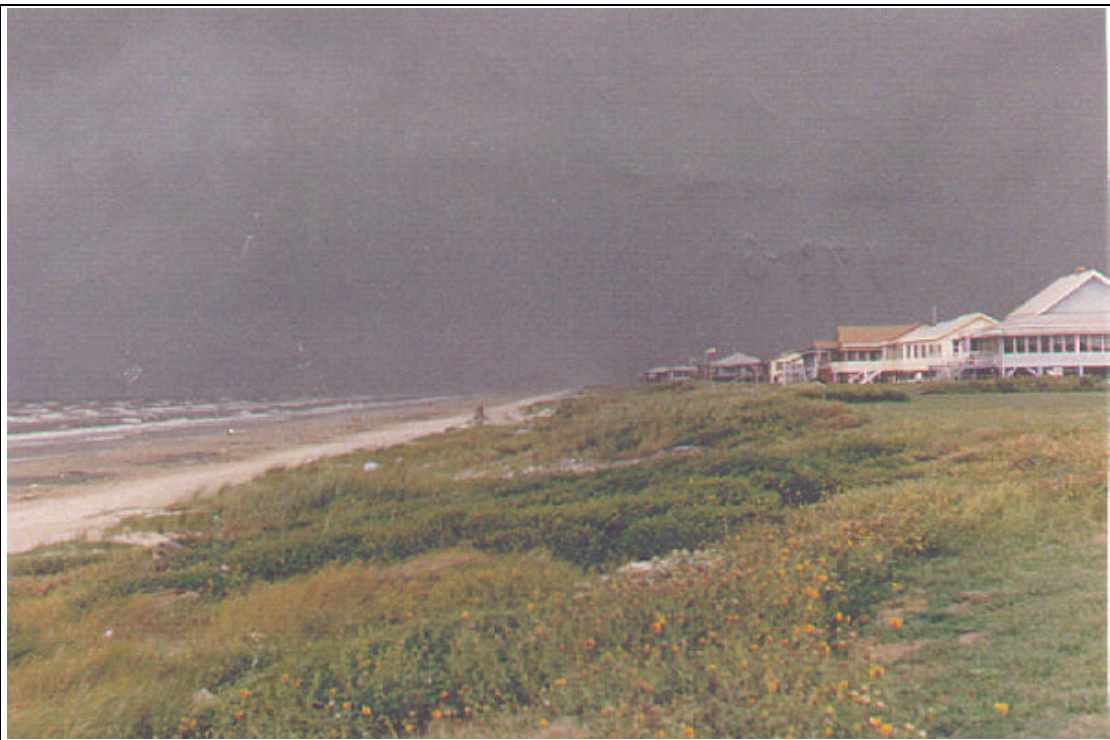
Figure 27 West from the Green and Gordon Houses in 1983.

Dean caused bluff retreat up to several miles west of Rollover Pass. Before 40 years of sand loss through Rollover Pass, the beaches in the vicinity of Rollover Pass were relatively wide and backed by a low dune ridge and wide, vegetated yards seaward of the houses.

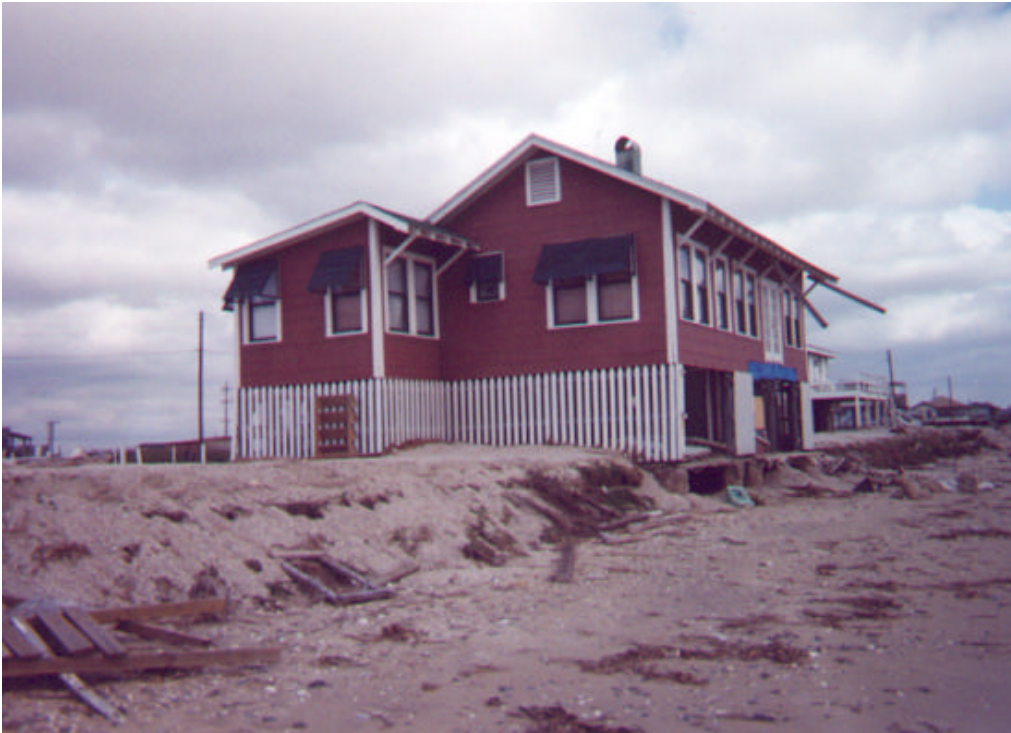
## Seewald House Post Frances

This house will not be moved because the owner does not own any land to the north.  
He will lose the house unless the beach is restored.

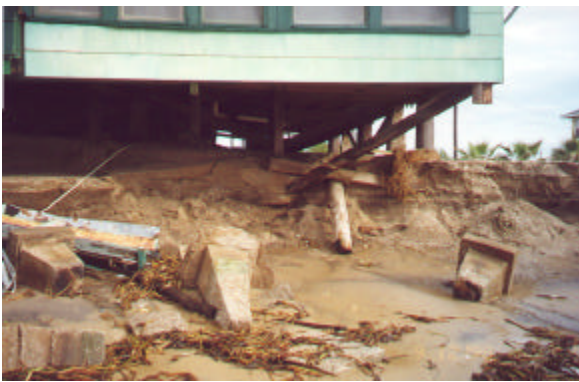
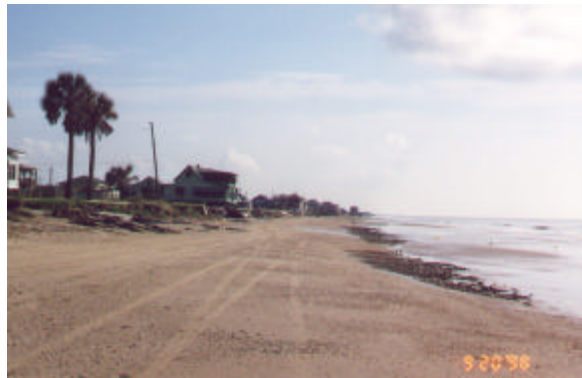
Erosion under Sauer house and beach in front of Gordon and Sauer houses showing exposed clay beds.

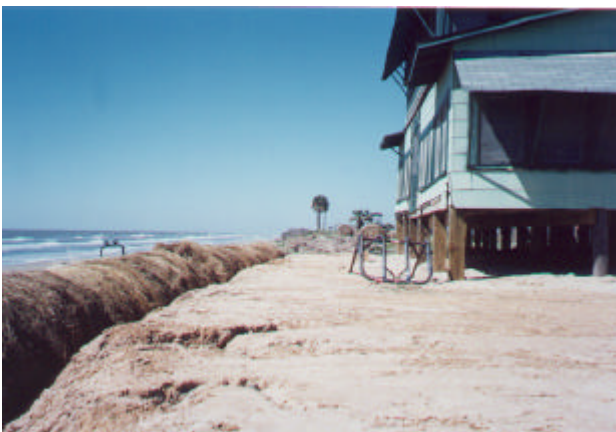
The Sauer house in September, 1999 after new support has been added and fill placed under and in front of house.

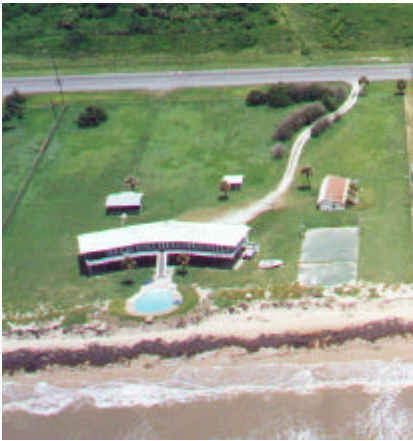
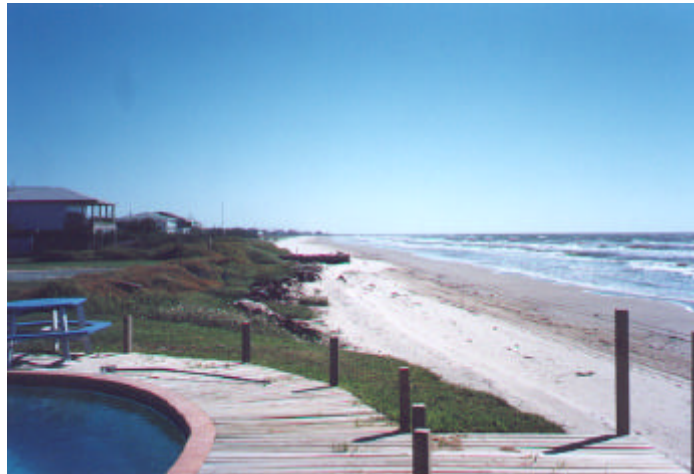
The photo on the left shows the vegetation line and scarp eroded right up to the pool in July 1999. The photo on the right shows how the pool actually extends beyond the scarp along most of the beach in September 1999.
