Corpus Christi Beach (North Beach) Geology, Challenges and Beach Nourishment

Deidre D. Williams

Conrad Blucher Institute for Surveying and Science

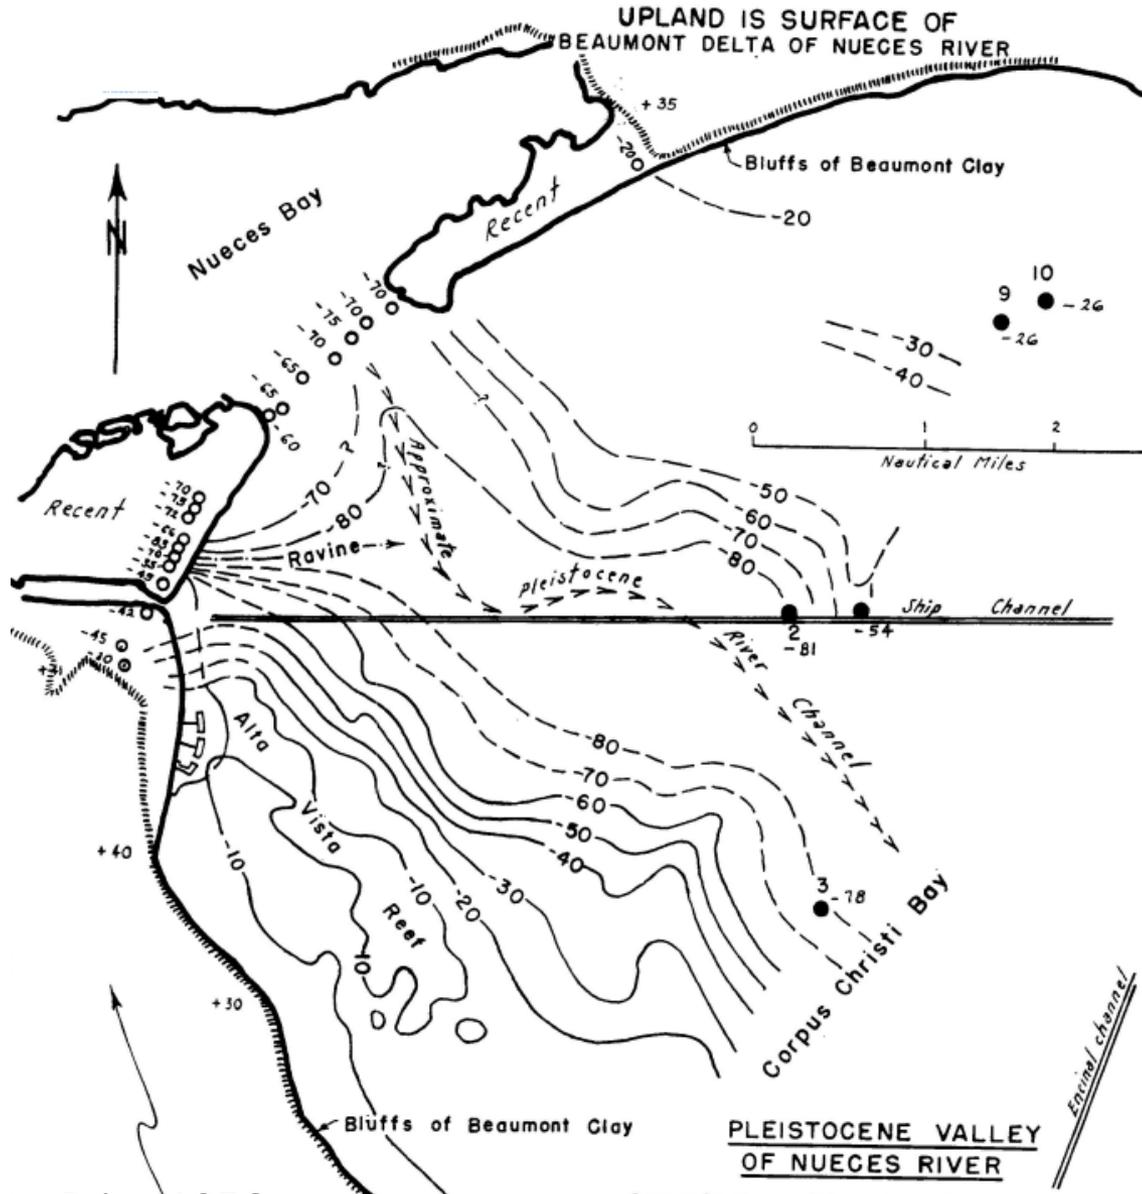
Nueces River Historic Pathway

Pleistocene Epoch:

1.8 Million to 10,000 yrs before present

Recent (Holocene) Epoch:

Known as the time of humans
Basically the last 10,000 yrs.

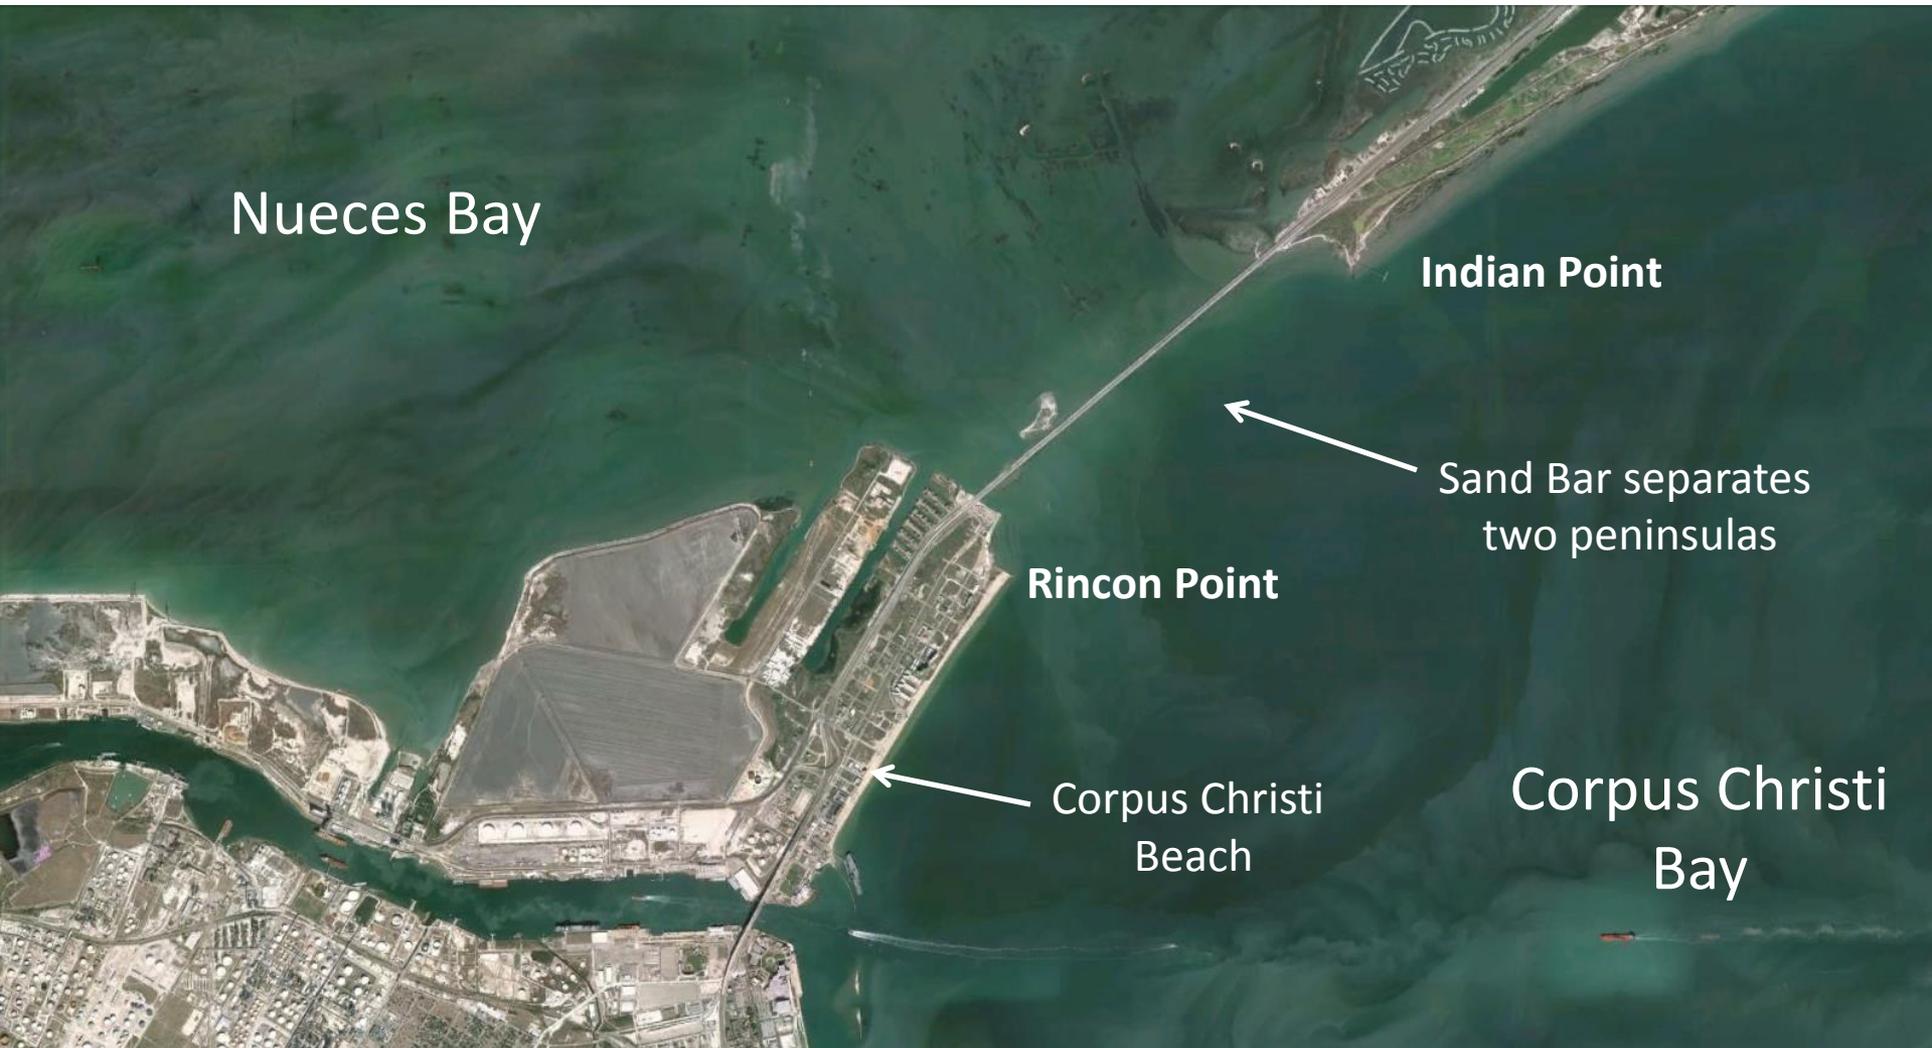
A Tale of Two Sand Spits

Nueces Bay

Indian Point

Sand Bar separates
two peninsulas

Rincon Point

Corpus Christi
Beach

Corpus Christi
Bay

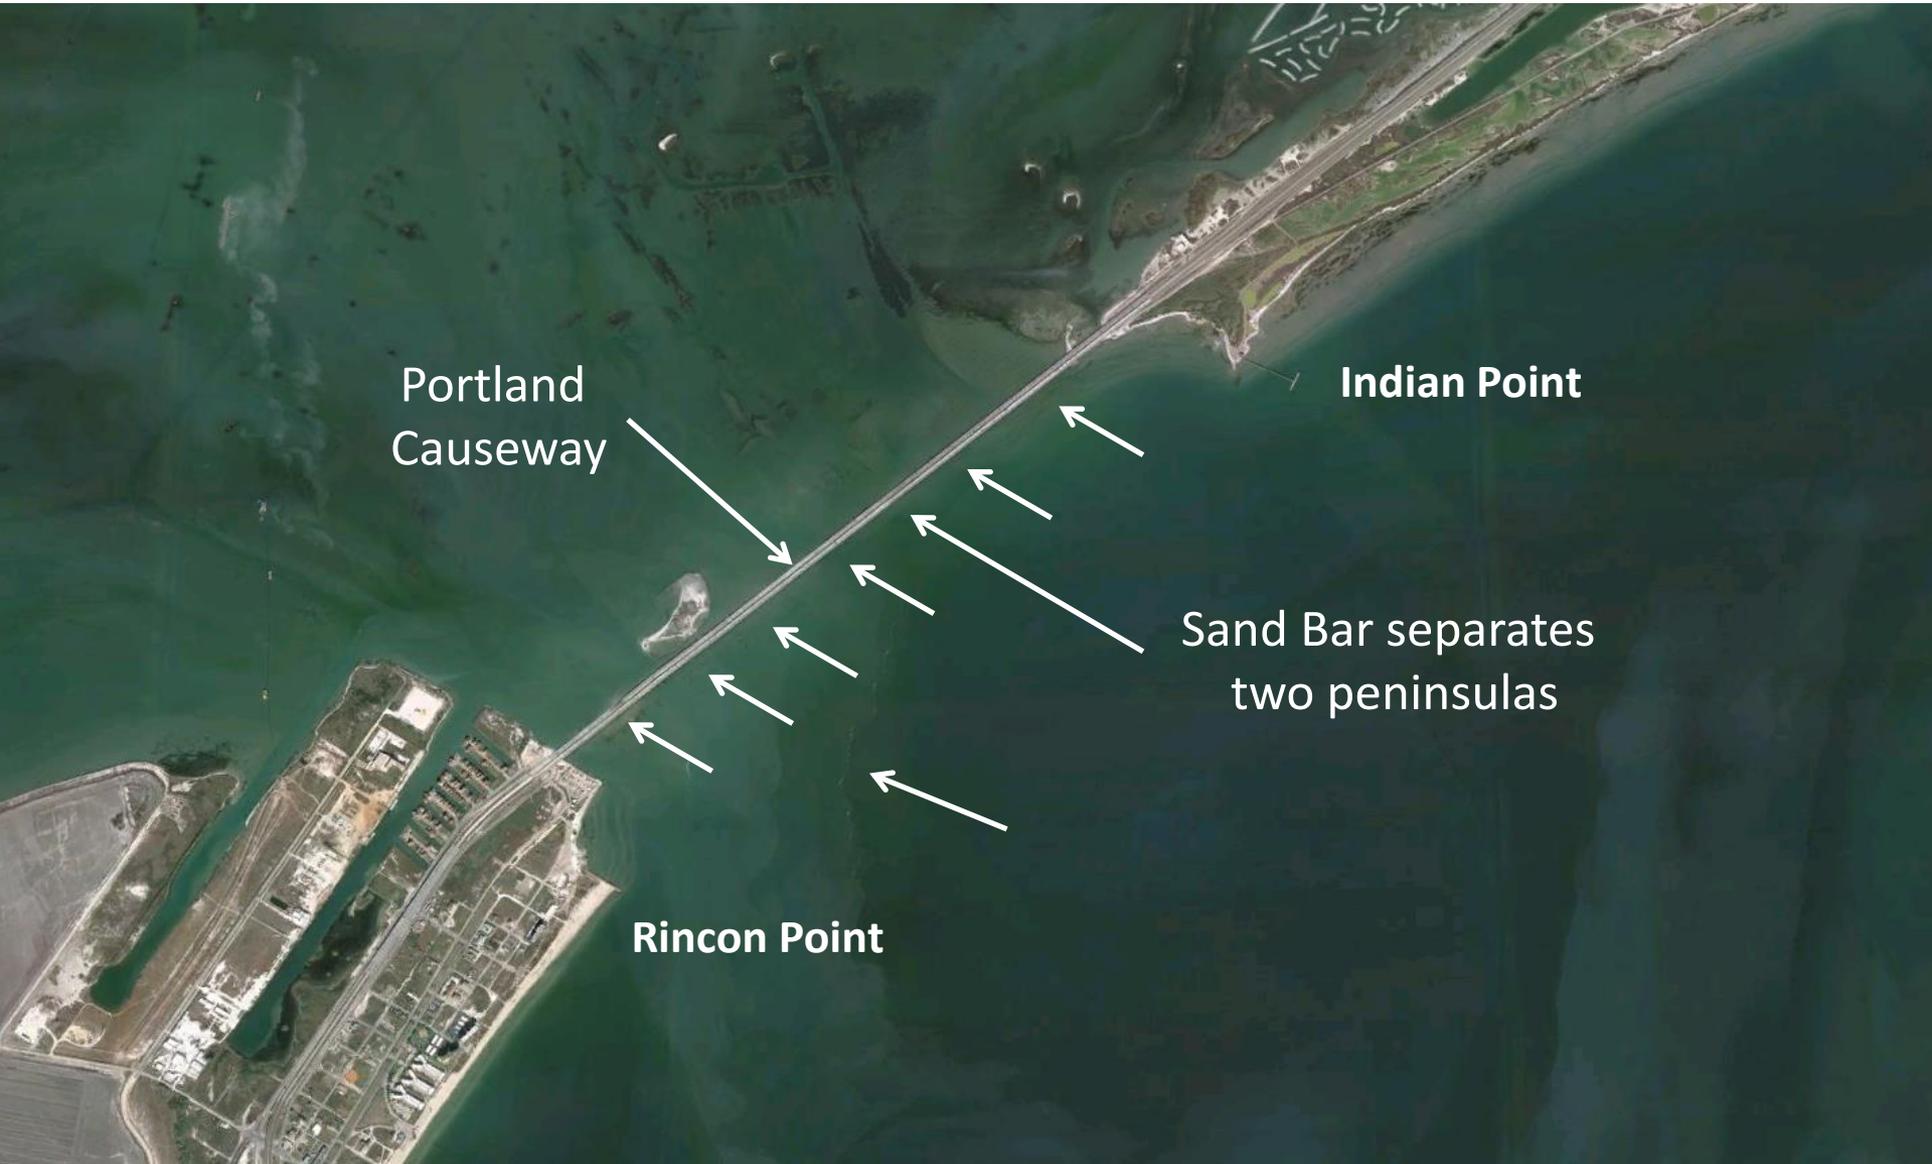
Portland
Causeway

Indian Point

Sand Bar separates
two peninsulas

Rincon Point

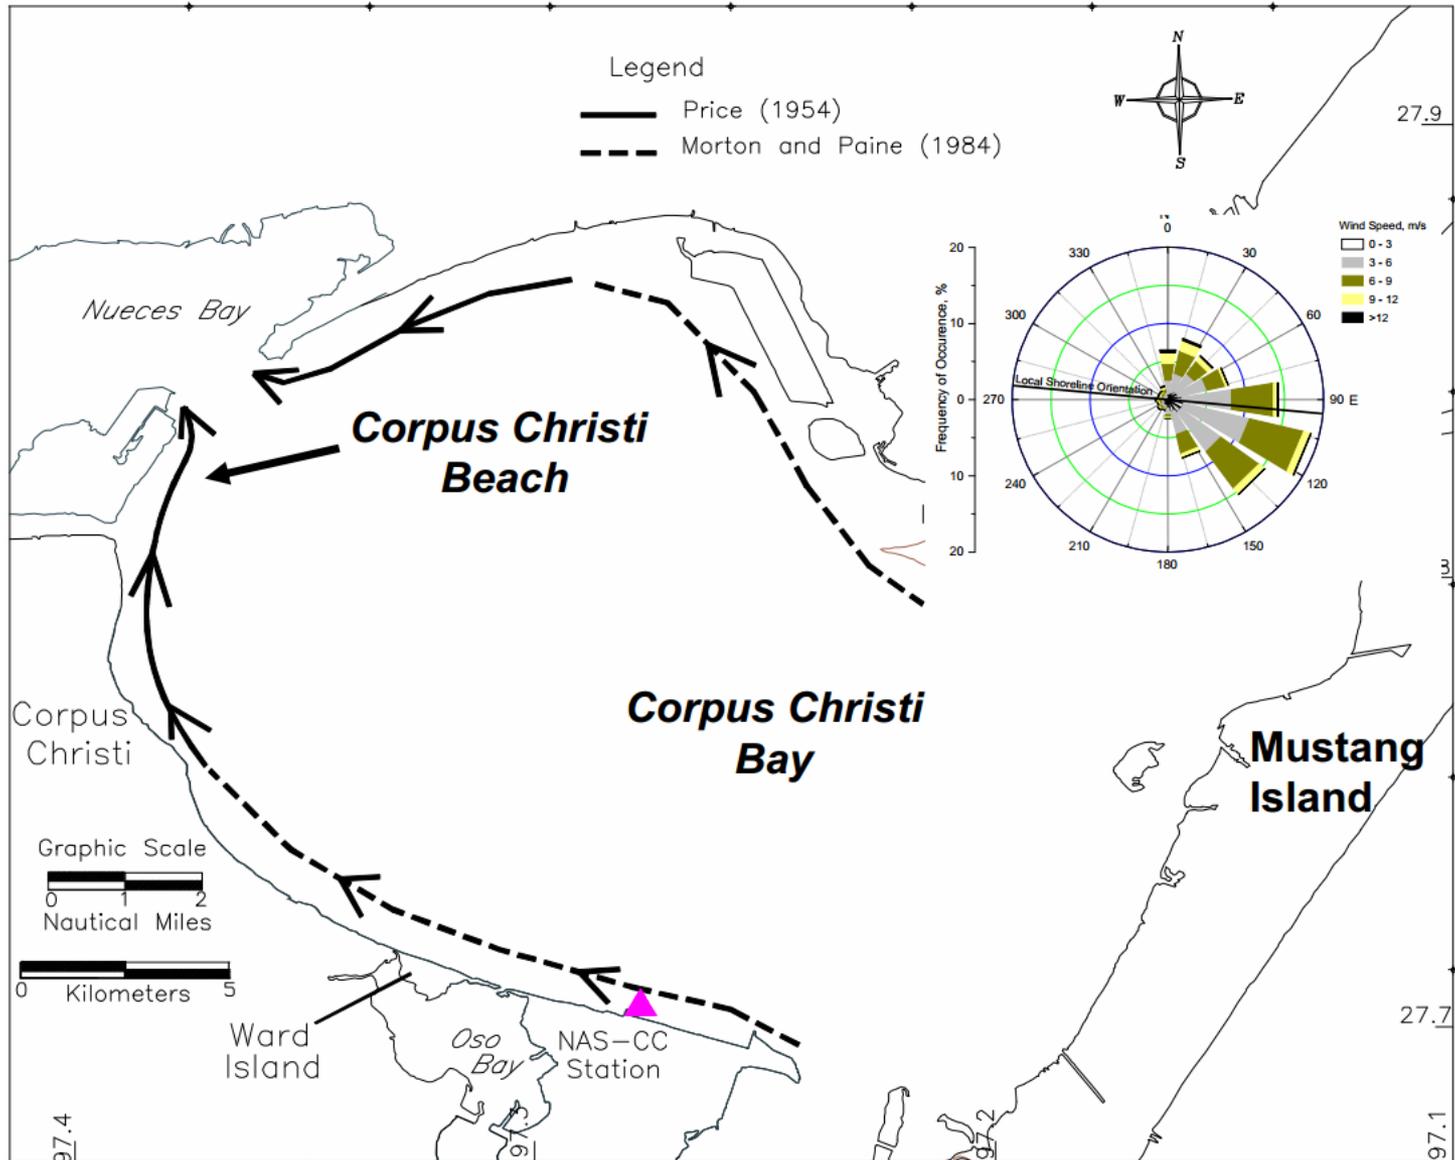
Corpus Christi Bay System Sediment Transport

- Dams eliminate new materials from entering the bays
- Hardening of Shorelines eliminates erosion of downdrift shoreline
 - Revetments, breakwaters groins, rip rap etc.
- Deepening of the CC Ship Channel provides a “sink” for sediment headed to the north from southwest bay nearshore and shoreline
- Sand Trapping by the nearby USS Lexington (functions like groin)
- Storms drag sand offshore to CCBay deep water (minor- Heilman and Shiner 2002)
