OCCOHANNOCK CREEK
Shoreline Erosion Assessment and Living
Shoreline Options Report

October 2008

Shoreline Erosion Assessment and Living Shoreline Options Report

Prepared for
Eastern Shore of Virginia
Resource Conservation & Development Council

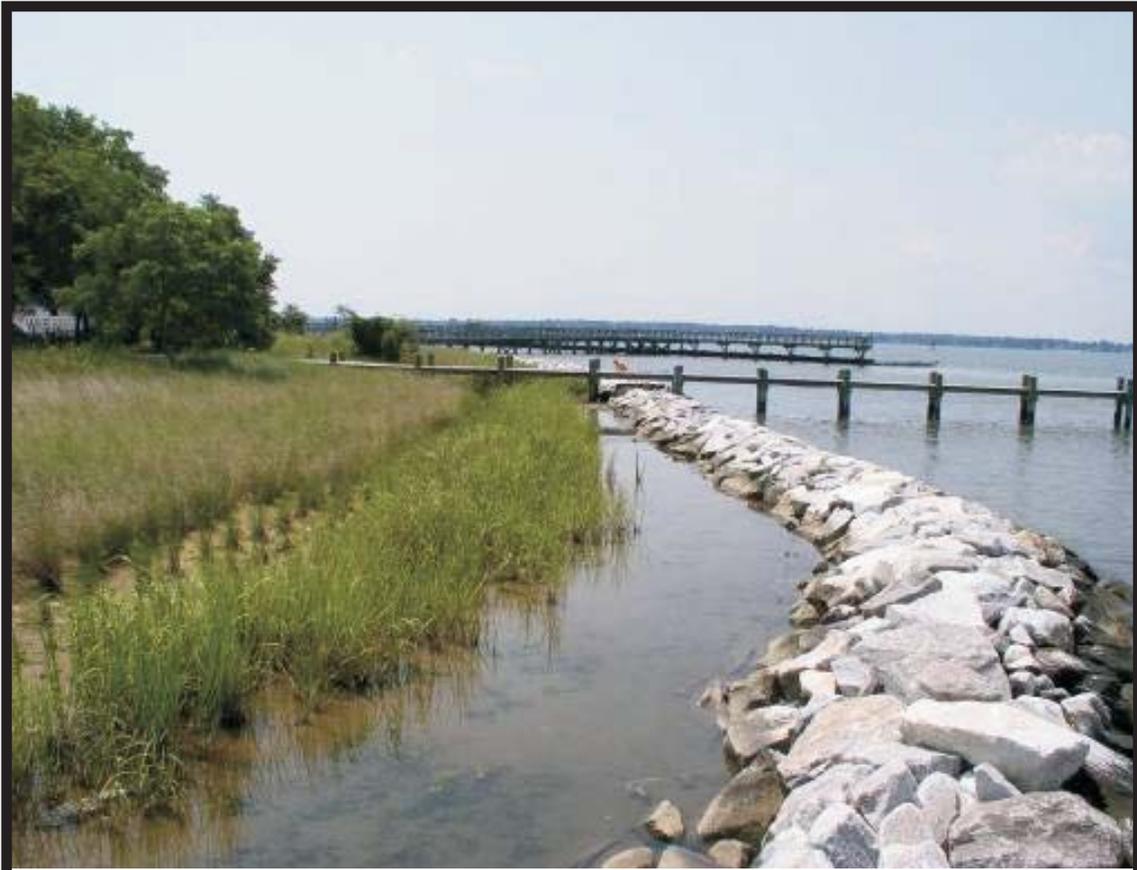
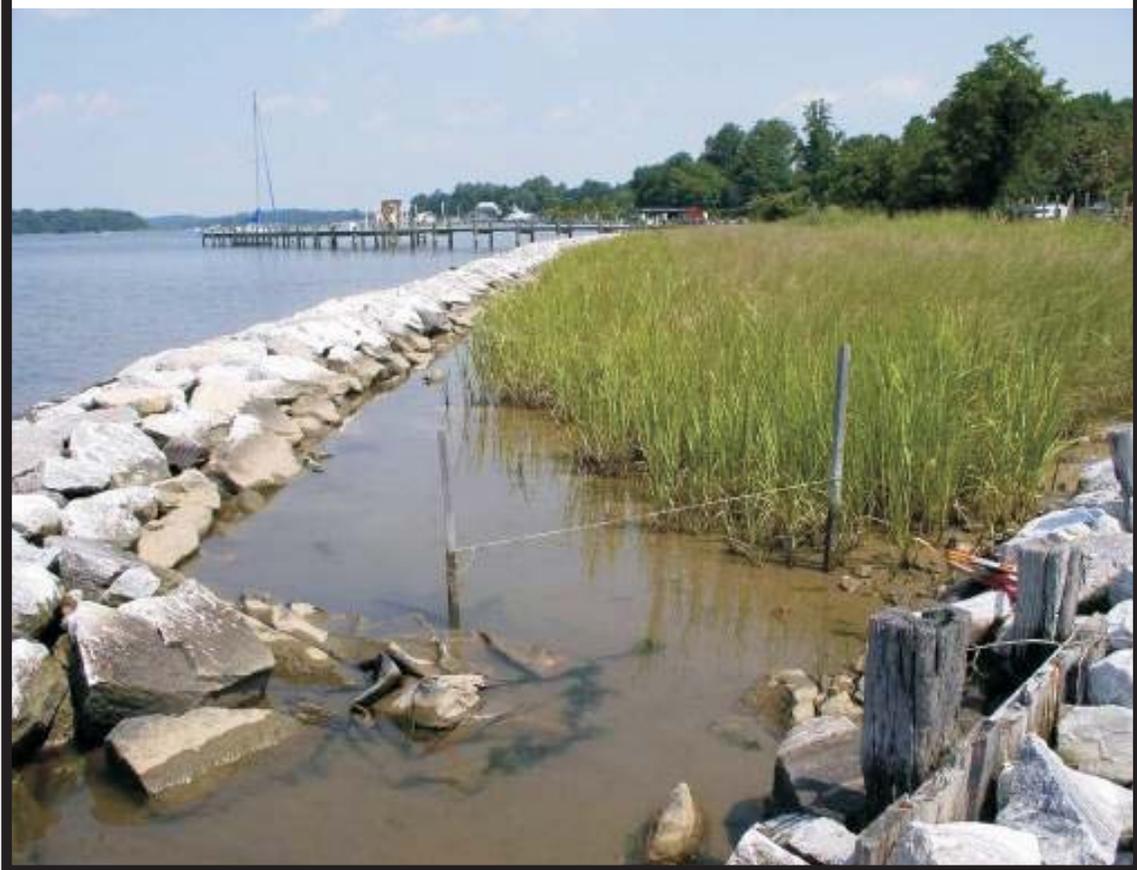
Figure 2. The Poster Child for Successful Marsh Projects. Photos taken at a community marsh in Anne Arundel County. This site received the highest overall marsh ranking and embodies many of the factors deemed essential to a successful project (from Bosch *et al.*, 2006).

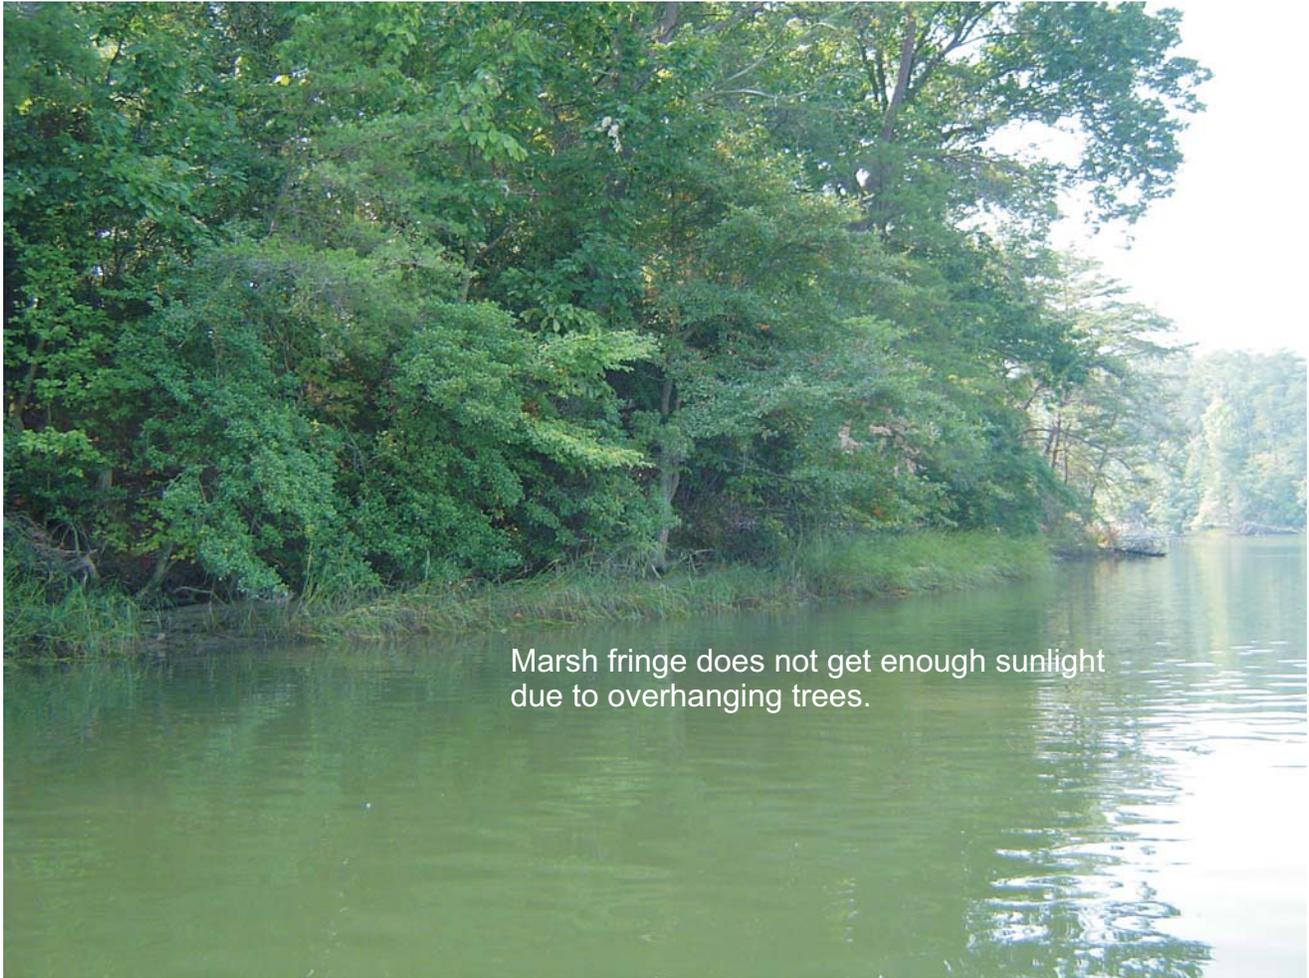
Marsh fringe does not get enough sunlight due to overhanging trees.

Figure 7. Photo taken along Lower Machodoc Creek, Westmoreland County, Virginia showing shading of the marsh by overhanging trees.

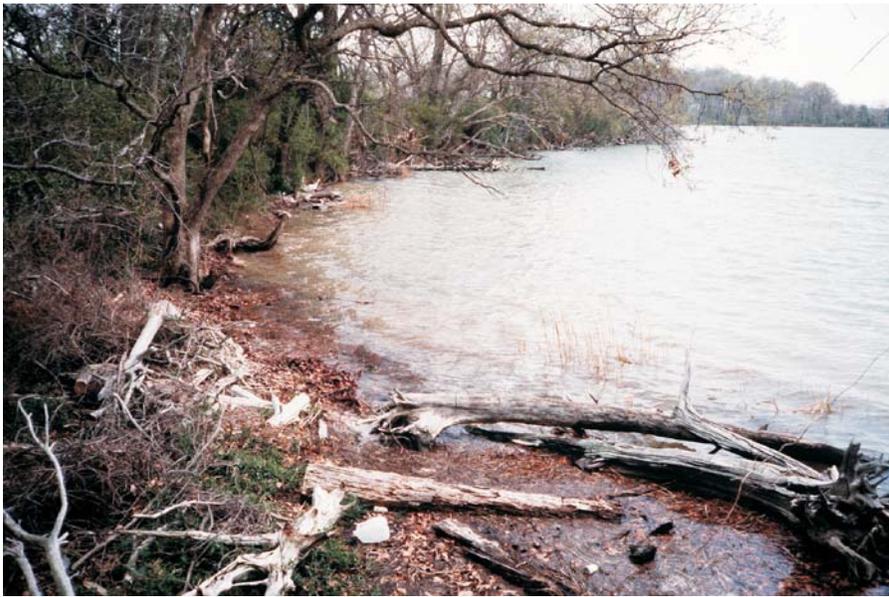
Pre-project shoreline on Wye Island, Kent County, Maryland (1988).

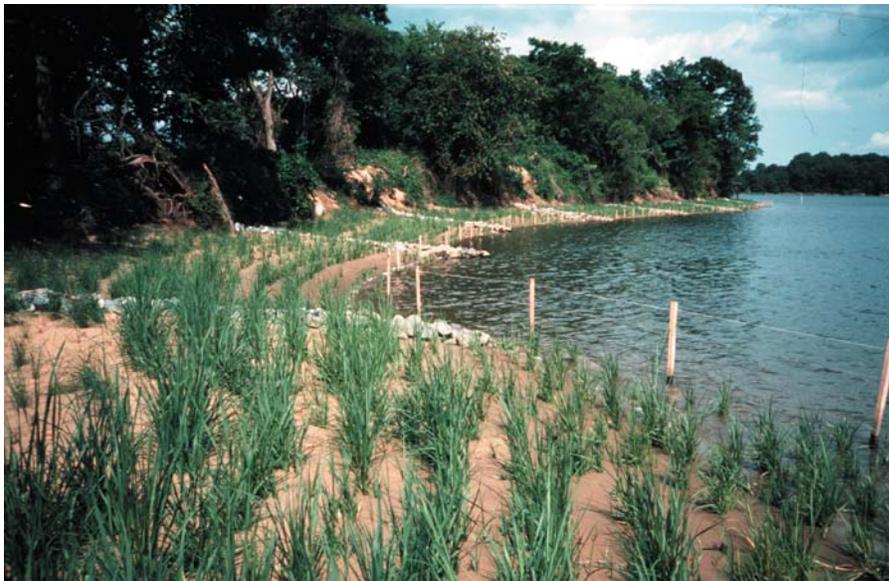
Marsh grass plantings with sand fill and short, stone groins 3 months after installation on Wye Island, Kent County.

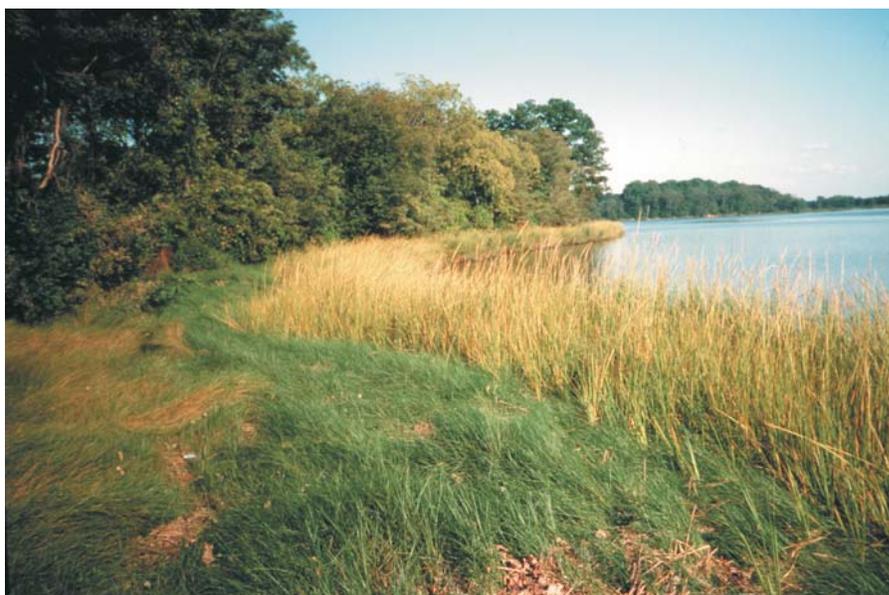
Wye Island project four years after construction.

Figure 8. Photos showing a marsh construction project at Wye Island, Maryland before and after installation and after four years (Hardaway and Byrne, 1999).

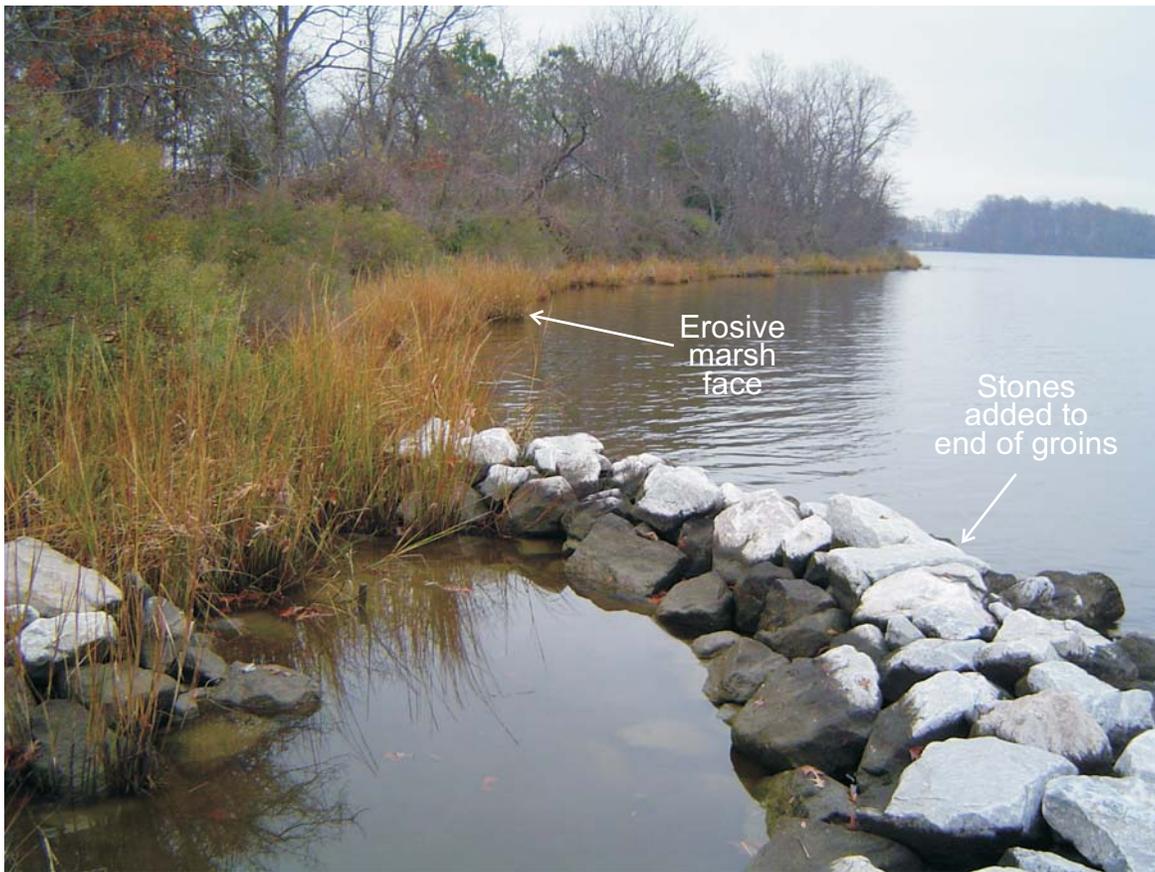
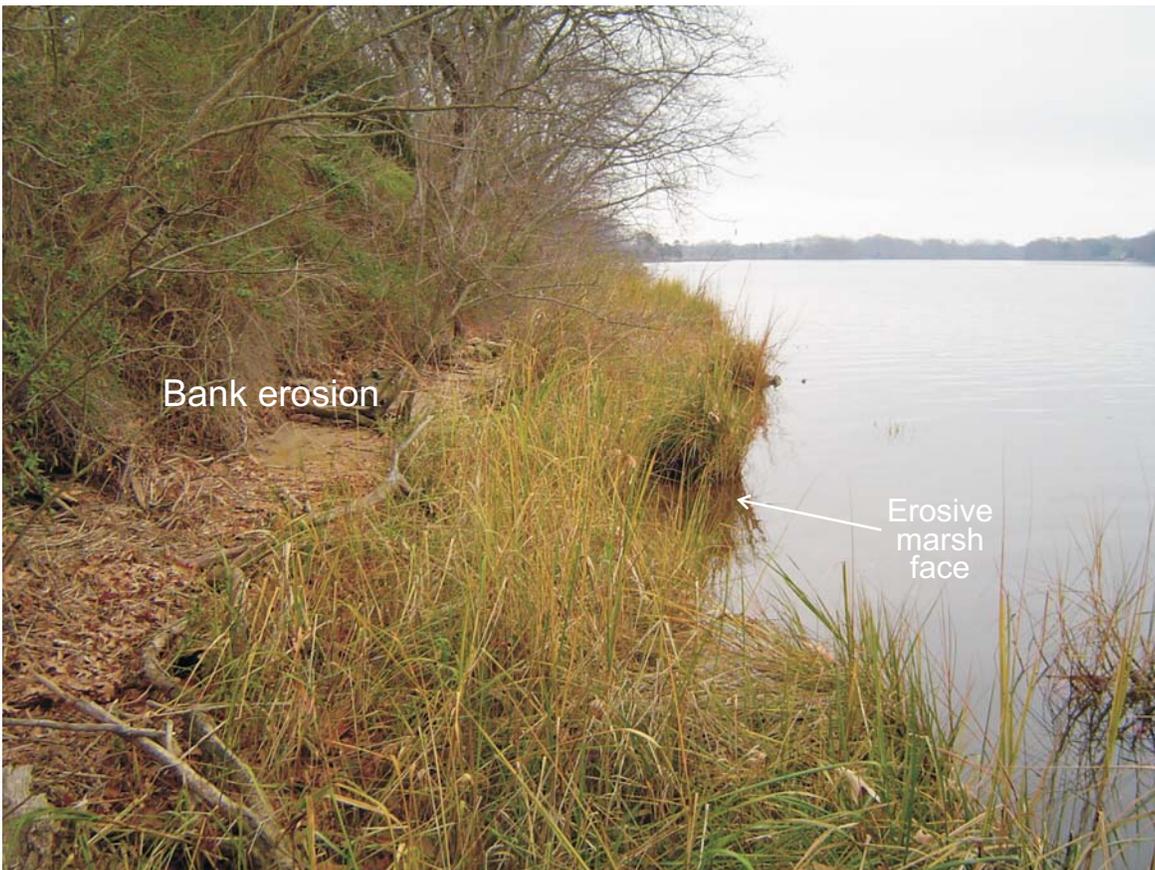
Figure 9. Wye Island, Maryland on 29 November 2006 (18 years after installation) showing the erosion of the planted marsh and the upland bank.

These types of shore management solutions must have maintenance before and after the project. The project at Wye Island is degrading because trees had grown over the marsh through time and shaded out the plants (Figure 9). This allowed wave action to directly impact the bank. Sand that was protecting the bank is deflated and now the bank is eroding again. Trees must be trimmed if they shade the marsh over time. Marsh grasses and potentially even sand may need to be replaced after storm events. Property owners need to understand their shoreline and recognize when it may be in distress.

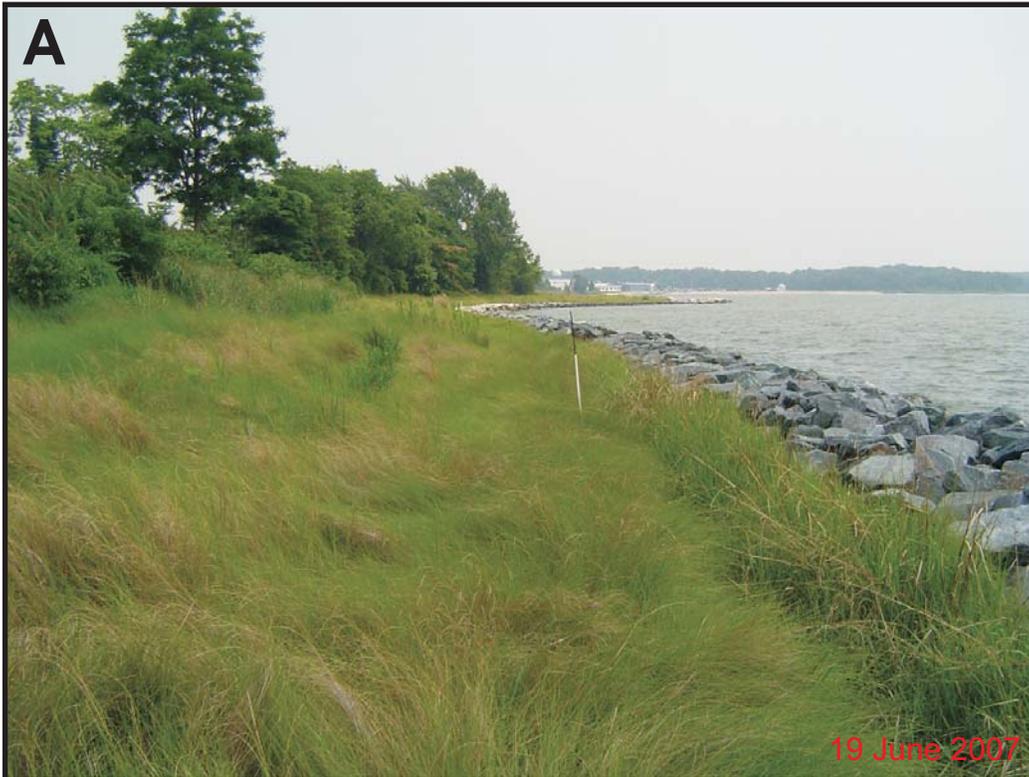
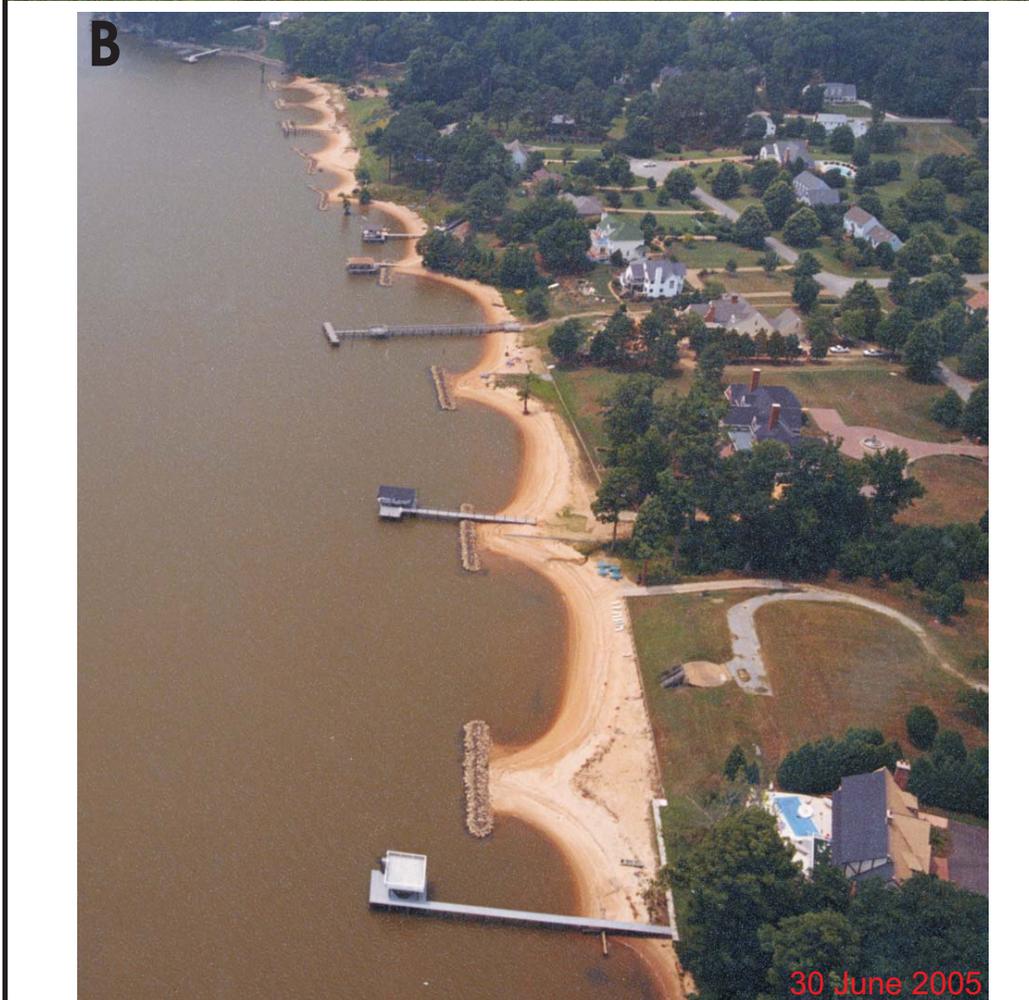
Figure 10. Photo of A) a sill project at Webster Field in St. Mary's County, Maryland and B) a breakwater system on the James River, Virginia.

- 3) Stone sills: The stone sill has been used extensively in Chesapeake Bay over the years especially in Maryland (Figure 10A). The general cross-section (Figure 5) shows the sand for the wetlands substrate is on about a 10:1 slope from the base of the bank to the back of the sill. The elevation of the intersection of the fill at the bank and the sill will determine, in part, the dimensions of the sill system.
4. Breakwater System: Although single breakwaters can be used, two or more are recommended to address several hundred feet of coast (Figure 10B). Breakwaters can also have varying levels of protection where increased dimensions generally correspond to increased increased fetch exposure and where a beach/dune shoreline is desired.

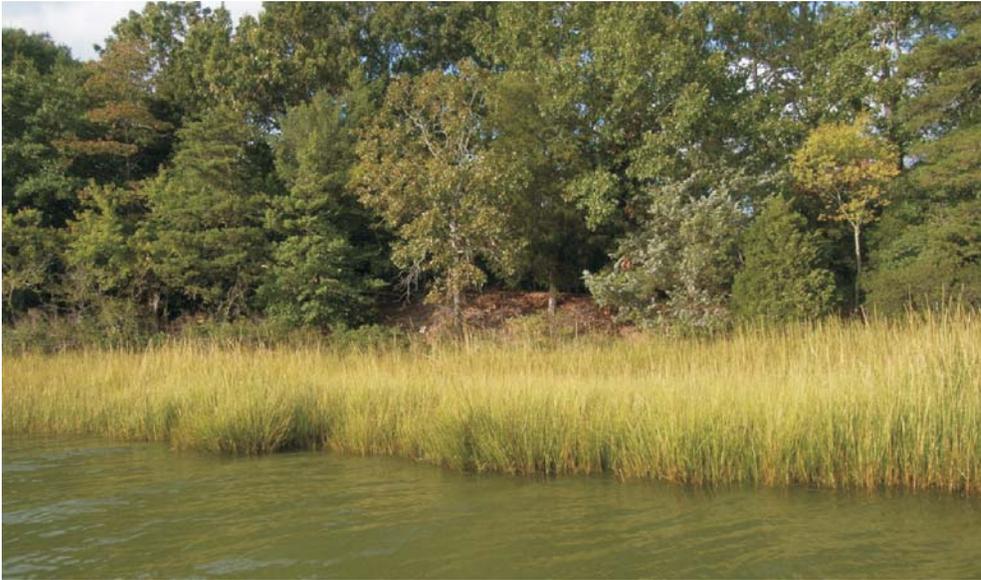
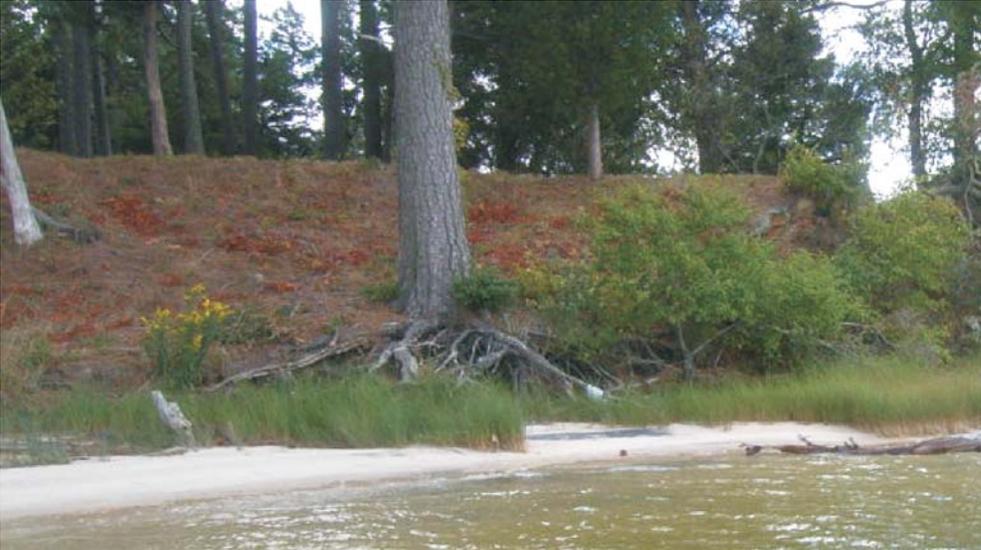
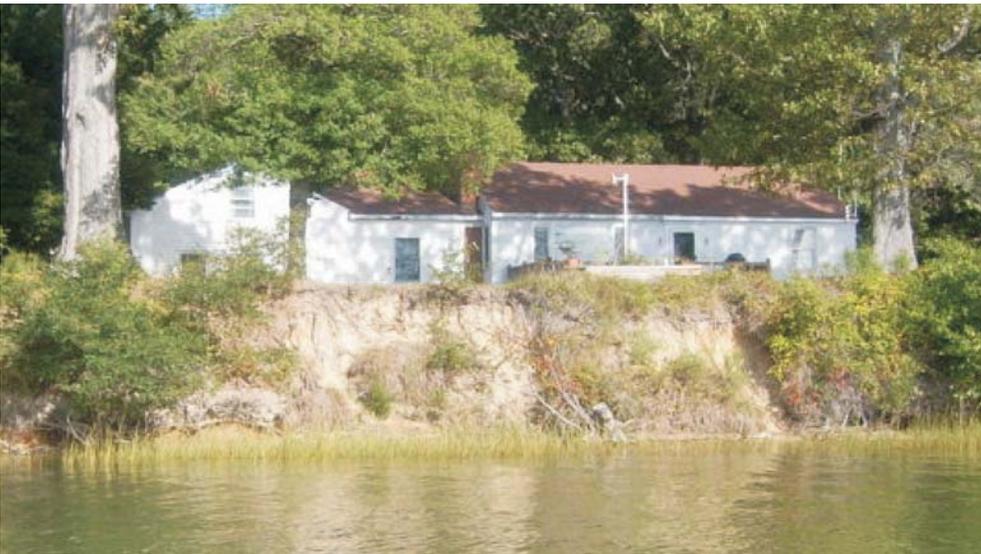
Figure 13. Photos depicting a stable, transitional, and erosional bank in Occohannock Creek.

is probably active erosion. If there is no undercutting at the base of the bank, and the bank face is fully vegetated, then both are likely stable. These two extremes are readily identified. It is intermediate or transitional cases that are harder to determine. Generally, along the main stem of Occohannock Creek, the wider the marsh/beach fringe, the more stable the upland bank. Narrow (<5 ft) marshes or beaches have less ability to absorb wave energy than wide (>15 ft) marshes or beaches. Some action to manage the shoreline is recommended where the banks are actively eroding and the marsh or beach fringes are narrow.

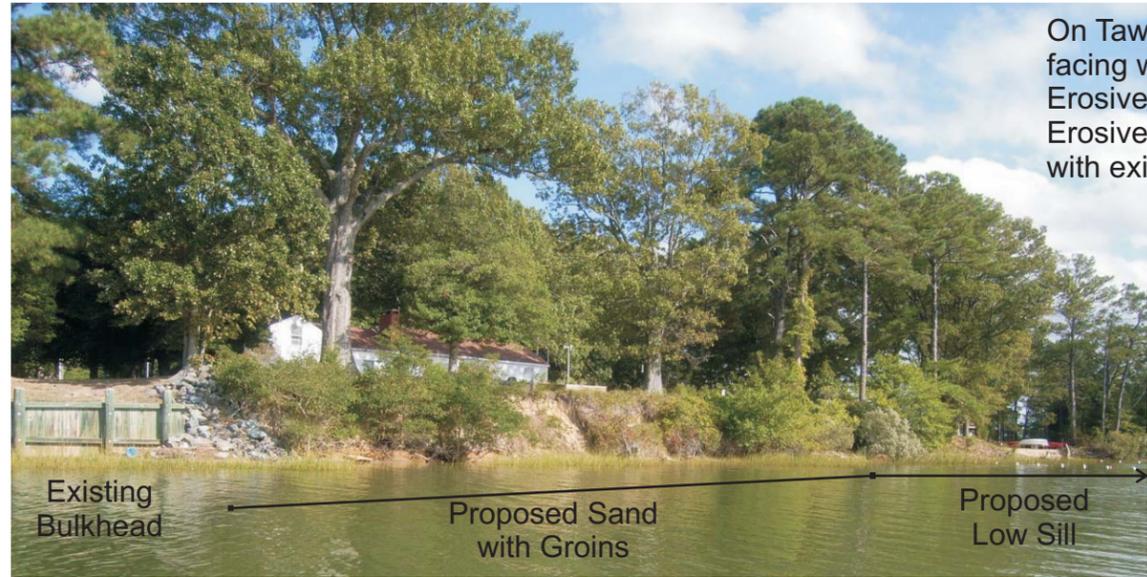
On Tawes Creek
facing west to southwest
Erosive bank face
Erosive base of bank
with existing marsh fringe

Figure 17. Example photos of existing shoreline conditions with the proposed management strategy noted. Location of proposed management strategies are approximate.

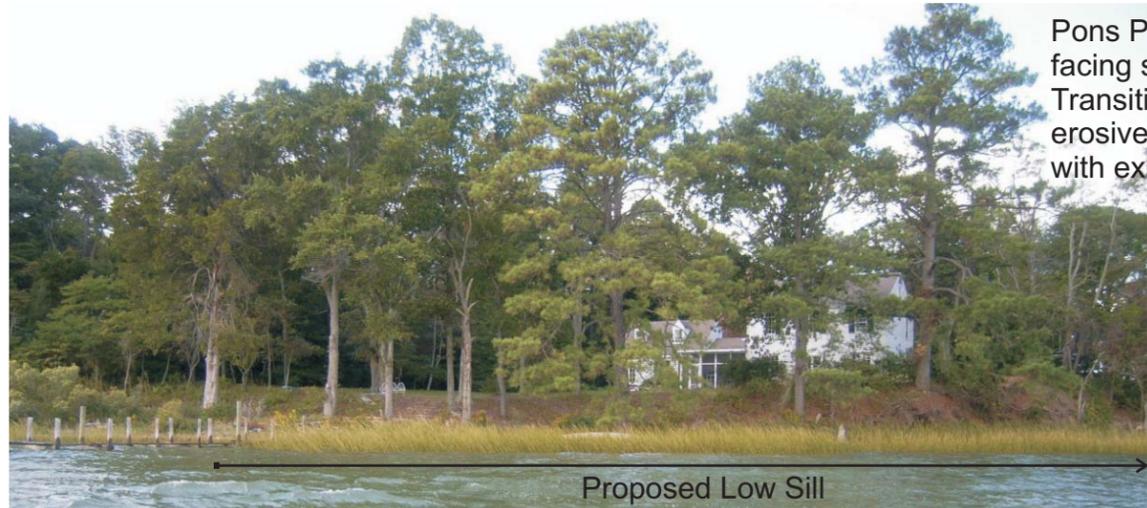
Pons Point
facing southeast
Transitional bank face
erosive base of bank
with existing marsh fringe

Proposed Low Sill

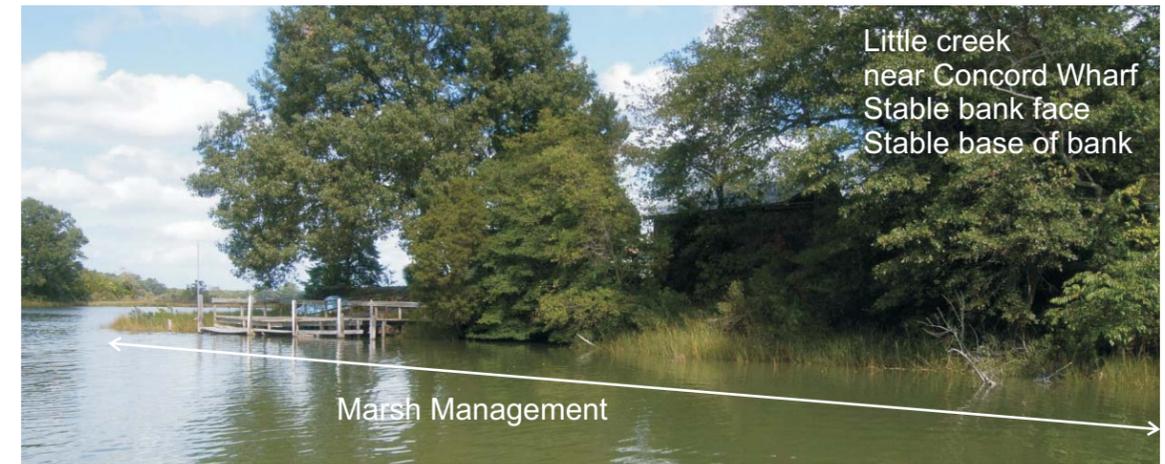
Little creek
near Concord Wharf
Stable bank face
Stable base of bank

Marsh Management

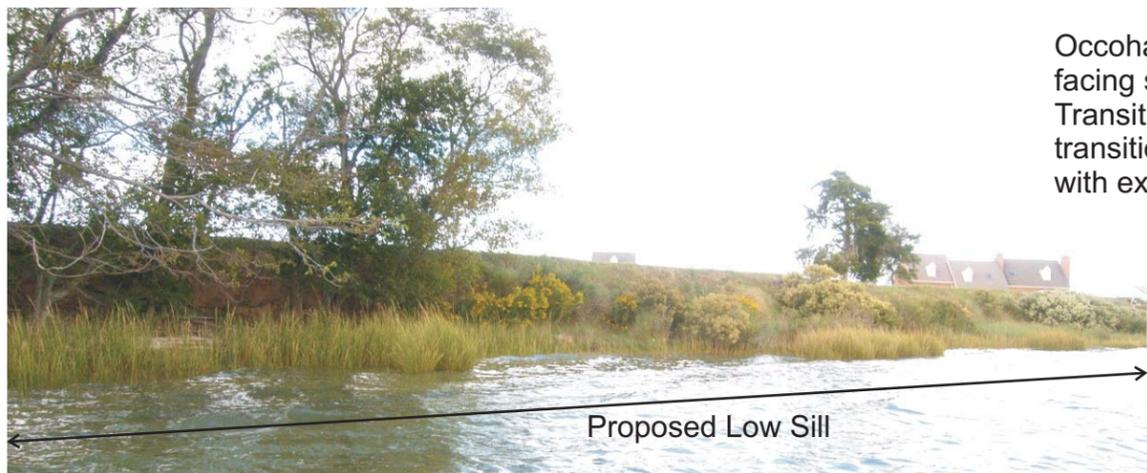
Occohannock Creek
facing southeast
Transitional bank face
transitional base of bank
with existing marsh fringe

Proposed Low Sill

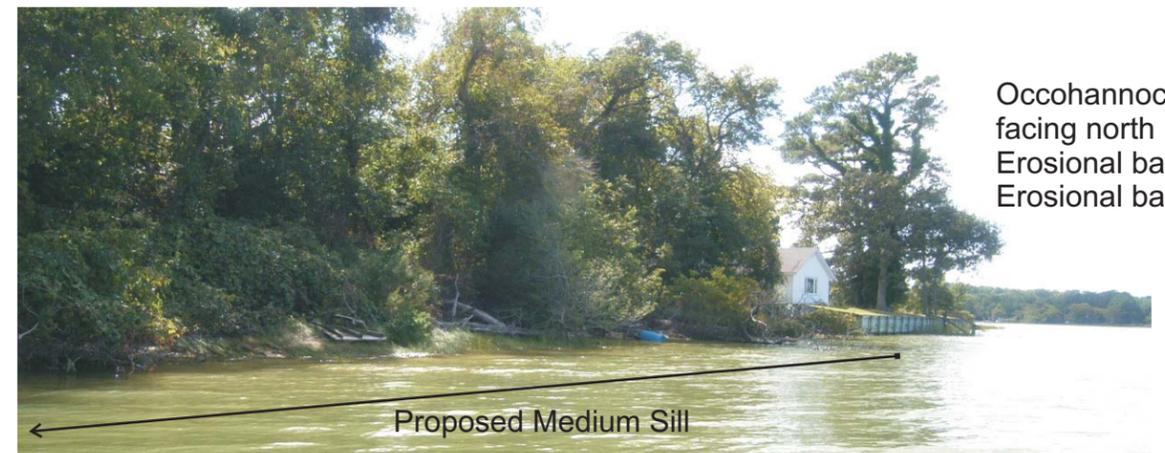
Occohannock Creek
facing north
Erosional bank face
Erosional base of bank

Proposed Medium Sill

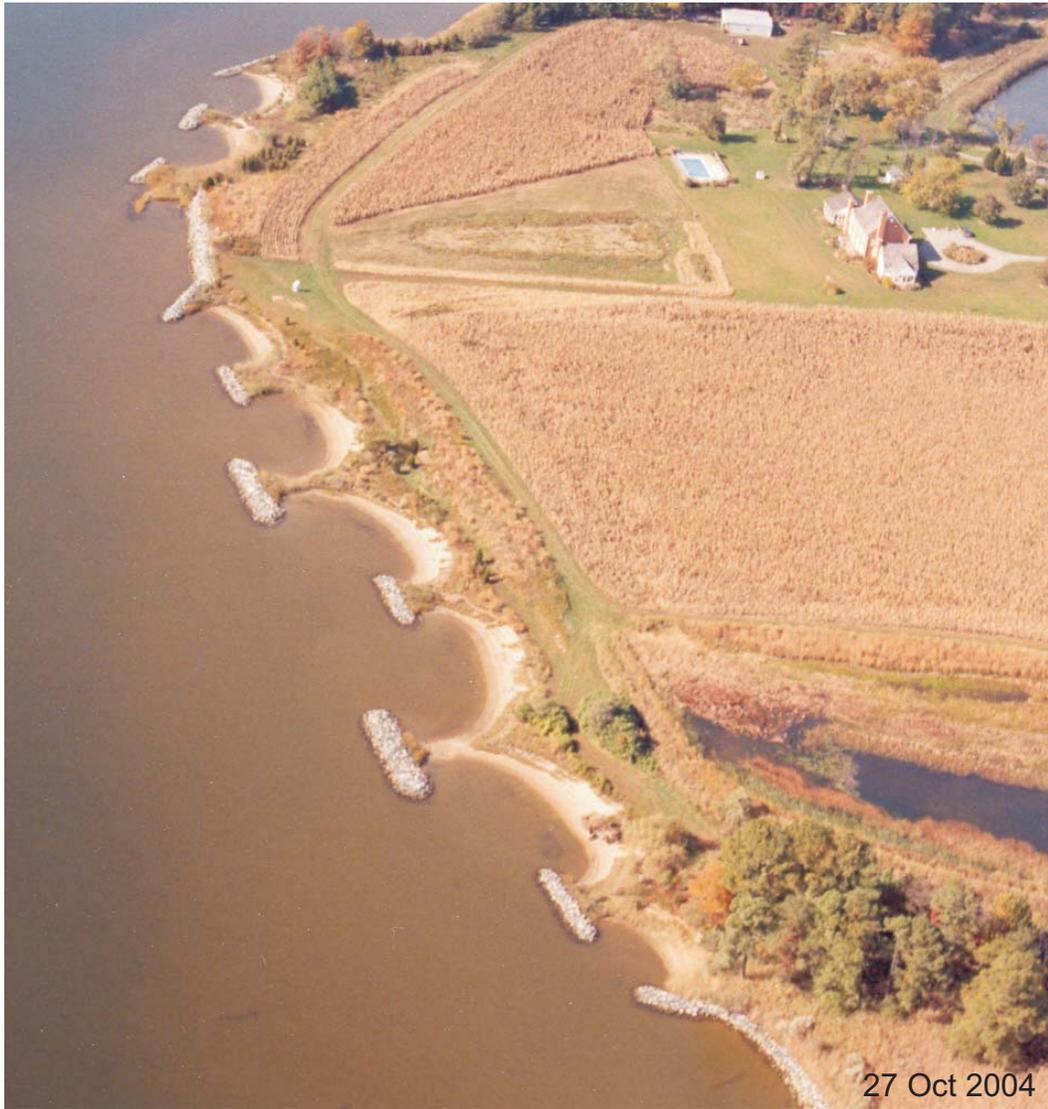
Figure 18. Photo of Knott in Kent County, Maryland on the Chester River showing an example of breakwaters that would be suitable for Occohannock Creek.

Two breakwater systems were recommended, one along an eroding upland bank with an existing groin field and another along the west coast of Morley's Wharf. A typical breakwater system for this type of coastal setting is made of 60 foot breakwater units, 60 feet offshore with 60 foot gaps. Three sand with groin segments were recommended, one up Shields Cove where the narrow intertidal width needs enhancement.
