SHORELINE EROSION SEMINAR

Galveston County, Texas

Quantitative Analysis and Design Aspects

December 14, 1991

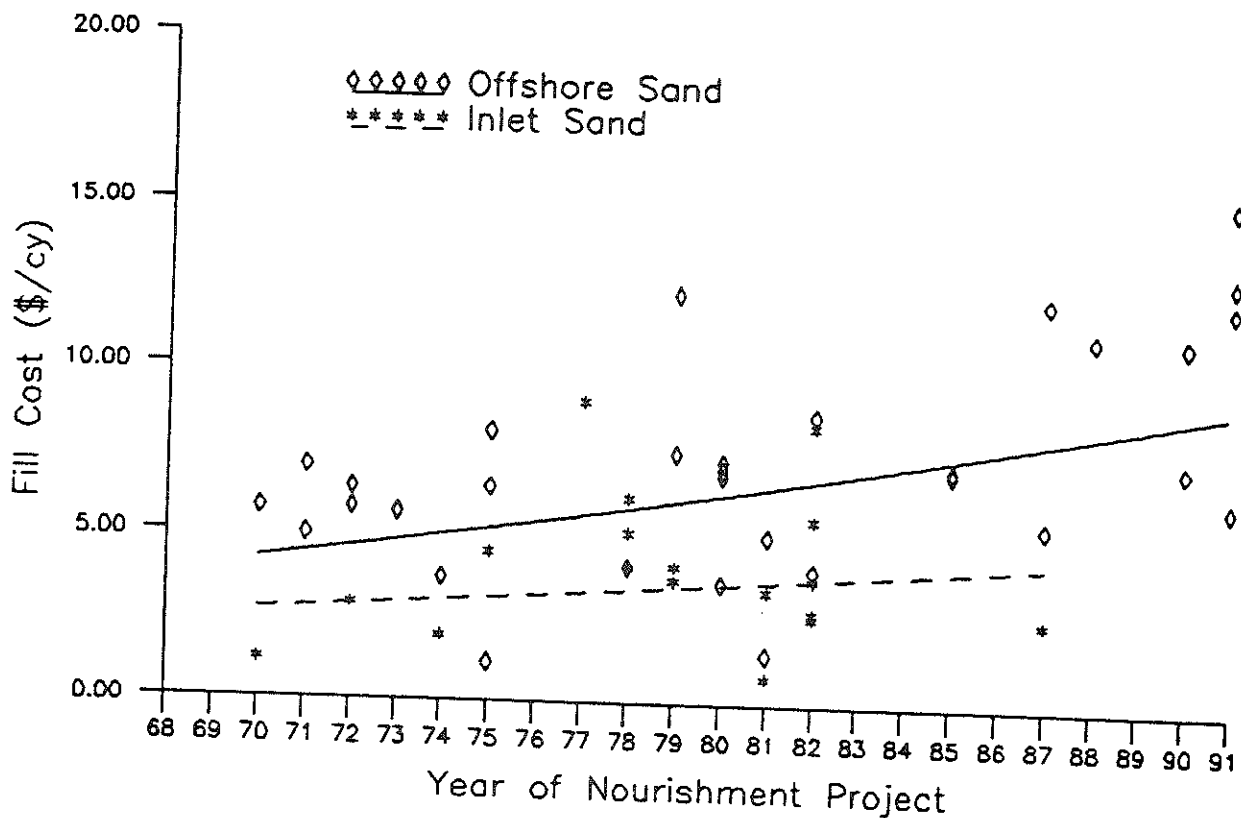
Figure 5. Cost Comparison of Nourishment from Inlet and Offshore Sources

with costs for nourishment from offshore sources and found the unit cost of nourishment for the inlet sand, in general, to be significantly lower than for the offshore sand. An illustration of such a cost comparison is given in Figure 5. The costs of placement of the inlet sand contained in Figure 5 reflect, in most cases, the added costs for placement of the inlet sand on adjacent beaches instead of in offshore sites. They also do not reflect any Federal 50/50 cost sharing discussed earlier, but only added costs which were provided 100% by non-Federal (State and local) sources.
