BEACH NOURISHMENT FOR HURRICANE PROTECTION: NORTH CAROLINA PROJECT PERFORMANCE IN HURRICANES DENNIS AND FLOYD

Spencer M. Rogers, Jr.
North Carolina Sea Grant
5001 Masonboro Loop Road
Wilmington NC 28409
910-962-2491, rogerssp@uncwil.edu

National Beach Preservation Conference, Maui, HI Aug. 7-10, 2000
American Shore and Beach Preservation Association

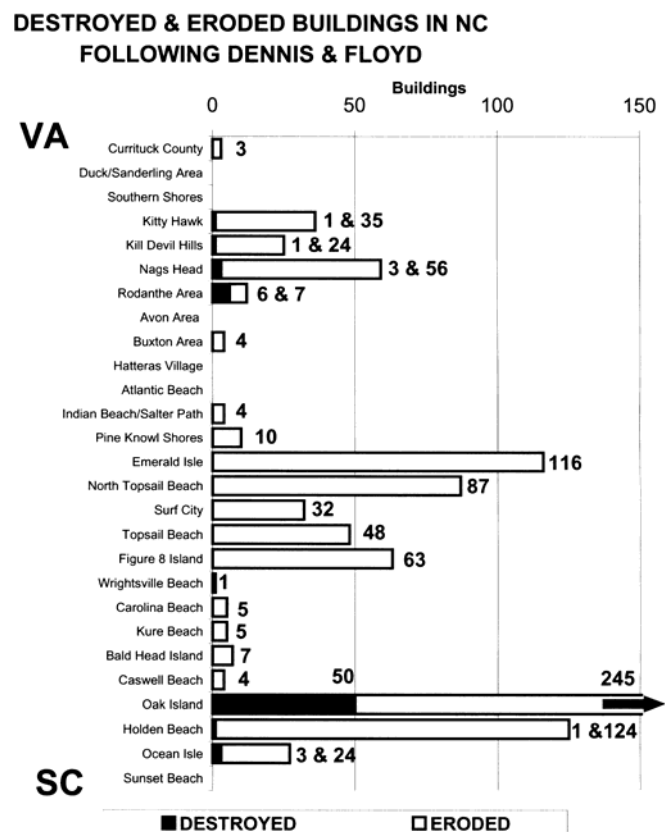
The survey results are summarized in Figure 2. Communities are listed from north to south. Dennis and Floyd combined to cause damage along the entire North Carolina oceanfront, from Virginia to the South Carolina border. Statewide, local governments determined that 65 buildings were destroyed or substantially damaged. The survey identified 903 additional oceanfront buildings as erosion-threatened. Although the buildings affected by Dennis and Floyd are scattered down the coast, they generally cluster near historical problem areas for long-term erosion. The storms significantly broadened the previous problem areas and damaged many buildings that previously had been only close to the edge.

Figure 2 Locations of destroyed and threatened buildings

The inventory of destroyed and threatened buildings can be used as a simple measure of the effectiveness of the beach nourishment projects. Wrightsville, Carolina and Kure Beaches appear to have received Floyd's highest storm surges, yet show marked reductions in threatened and destroyed buildings compared to unnourished communities both north and south.

The benefits are actually more dramatic than implied in the figure. All of the threatened buildings listed for the three communities were located outside the nourishment project limits or in transition areas at the ends of the projects where the dunes were not constructed. Hurricanes Floyd and Dennis threatened or destroyed 968 buildings outside the three Corps-designed nourishment projects' manmade dunes. Remarkably, not even one building behind the project dunes was threatened by erosion — that's ZERO.
