BEACH EROSION AND BEACH NOURISHMENT

CAPE HATTERAS
NORTH CAROLINA

ROBERT DOLAN

DUNE STABILIZATION STUDY
NATURAL RESOURCE REPORT NO.
1972

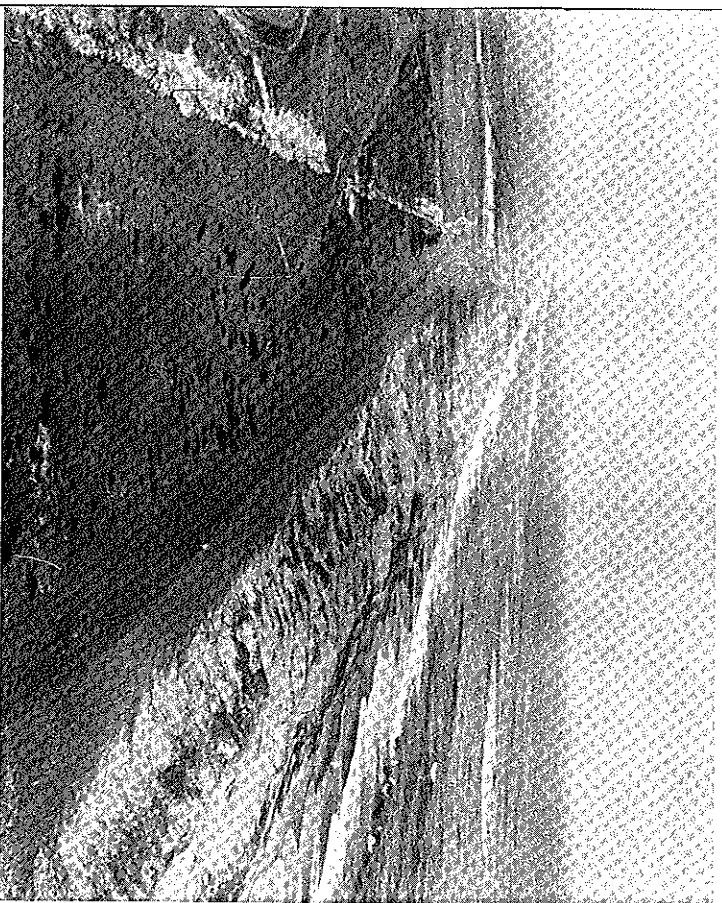
1940

Buxton, N.C. – The Problem

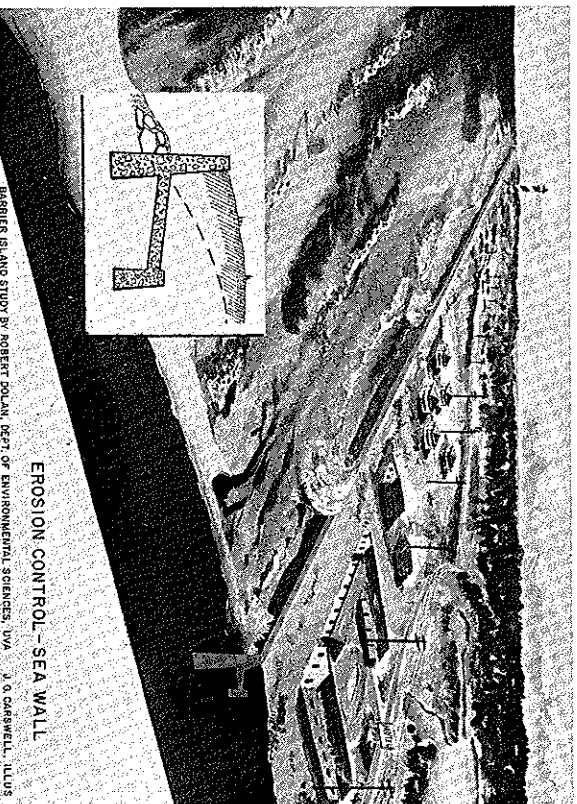
SEA WALL

Sea walls are designed to absorb and reflect wave energy, but they do not prevent the loss of sand in front of the structures. They may, in fact, accelerate the loss of sand as the wall deflects the wave forces downward into the beach deposit.

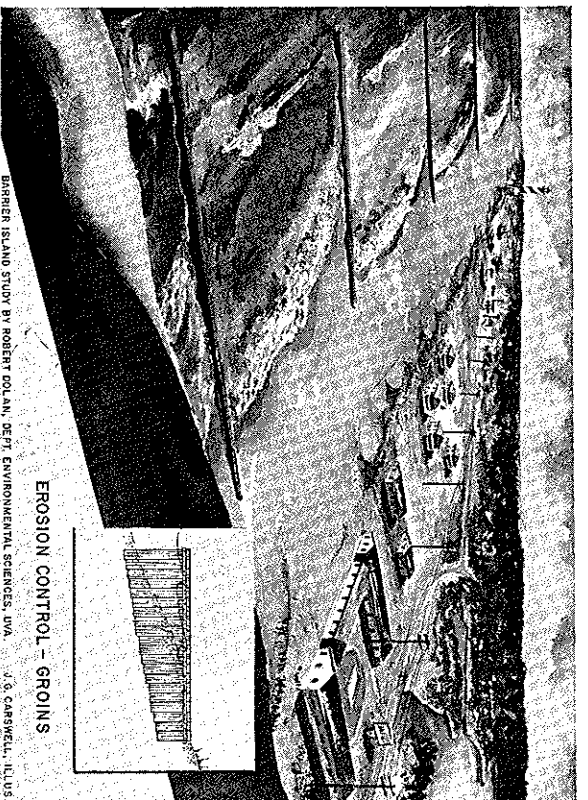
GROIN FIELDS

Groins are obstructions placed in the path of the longshore currents for the purpose of trapping littoral drift. These structures work only when [1] littoral drift sediment is significant in volume, [2] the material is at least sand size, and [3] only when the land down the beach from the groin is considered expendable. The best method of beach restoration is any method that is similar to the natural process. Structures are designed to alter the energy flow, interfering with the natural equilibrium of the beach. Rebuilding beaches artificially, by placing sand in the system, permits the natural process to continue essentially unhampered.

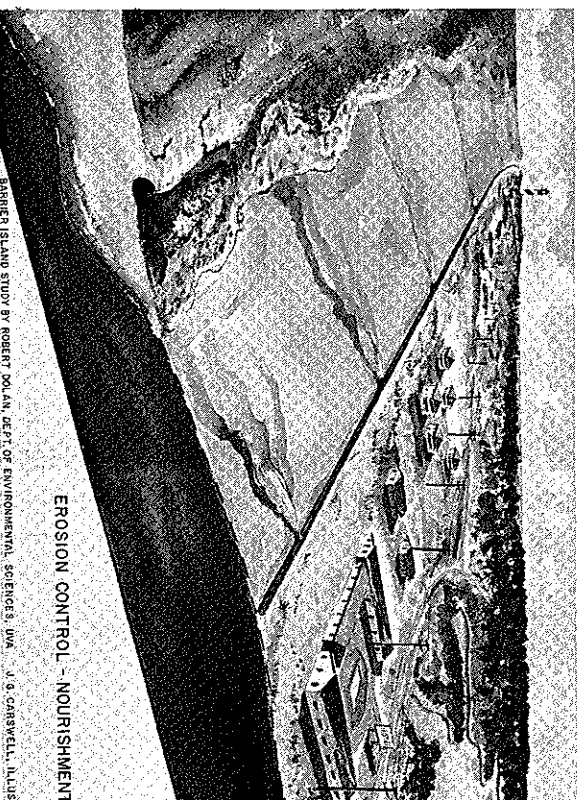
NOURISHMENT

Artificial beach nourishment is considered the most desirable method of protection because:

- [1] The placement of sand in the beach-energy system results in a beach suitable for recreational purposes.
- [2] Beach nourishment not only checks the effect of erosion in the problem area, but also supplies sand to adjacent beaches.
- [3] It is the most economical method if large quantities of sand are available.
- [4] It does not require a major long-term management commitment. If the beach nourishment does not produce the desired result, it is not as permanent as sea walls or groins.

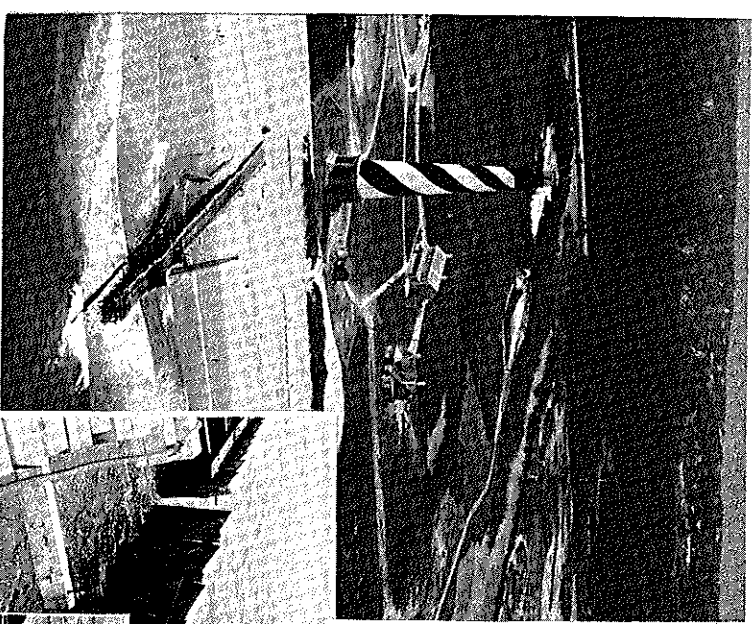
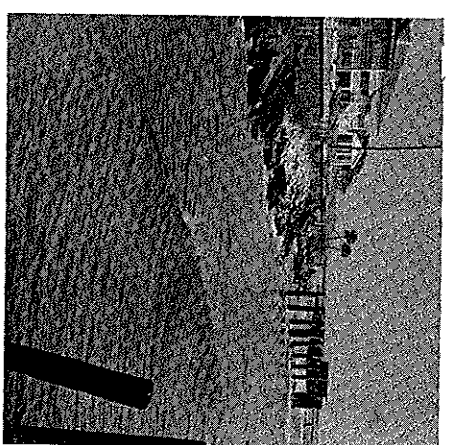
GROIN FIELD — HATTERAS

Although the design of the groins was modified, they do provide protection for the U.S. Navy Facility and the Lighthouse. However, areas adjacent to the groin field, both to the north and to the south, continue to erode at rates equal to, or in excess of, rates recorded before 1969. Therefore, the National Park Service was forced into a "hold-the-line" strategy, using sand bags and spot dune construction, for these newly created problem areas.

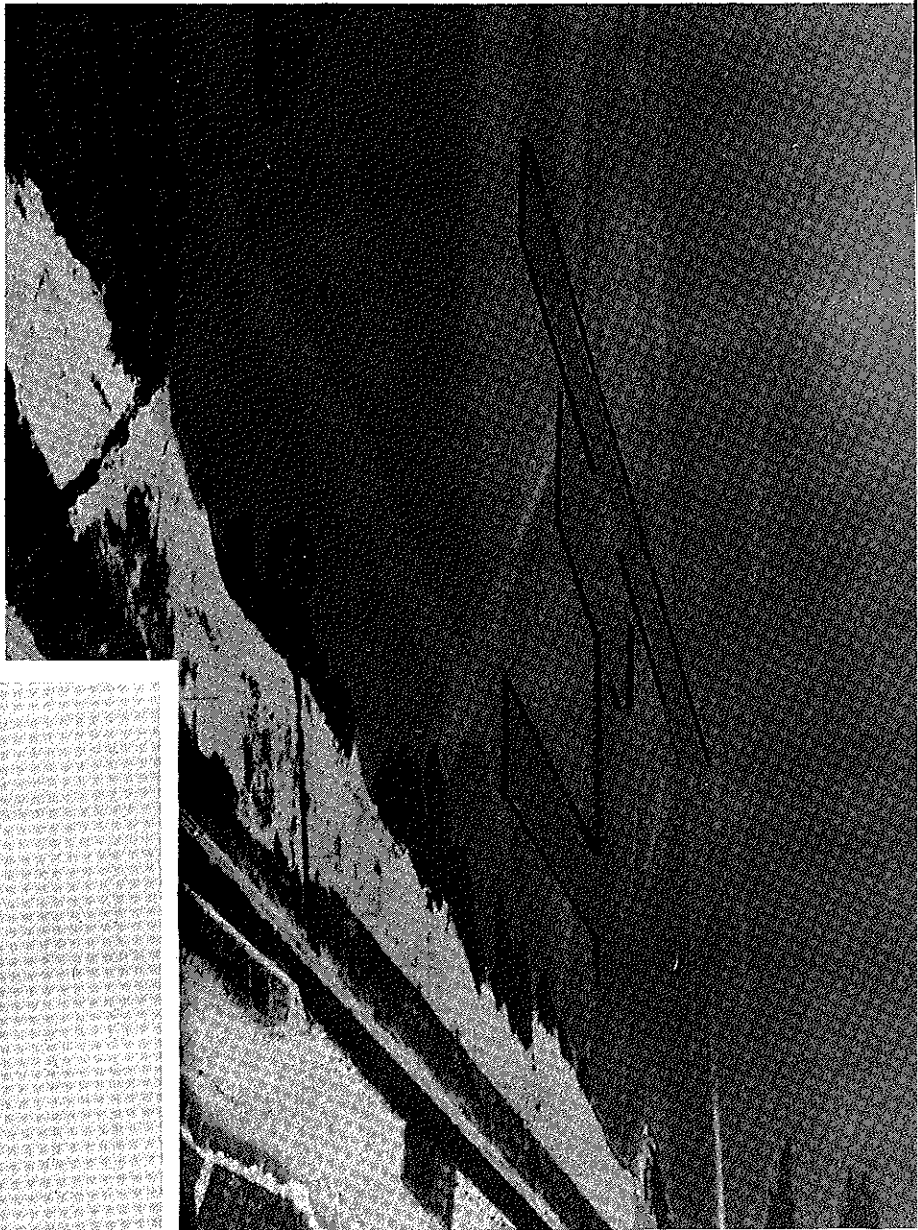
SOUND EXCAVATION

The major disadvantage in artificial nourishment is that great quantities of sand of suitable quality (type and size) may not be available near the problem beach. In the past, sands were dredged from sounds and bays immediately inland from the beach, or transported from inland sources. With the recent concern about estuarine ecology, and the fact that sound materials are usually much too fine to be effective as beach nourishment, estuarine and bay sources are less desirable and no longer as available. The future prospect for large enough quantities of sand to be effective for large beach restoration projects will probably be offshore sources, and materials dredged from the coastal inlets. For example, along the Outer Banks alone, great quantities of high grade beach sediment are dredged from Oregon and Hatteras Inlets and dumped into deep water offshore. Diamond Shoals also represents a major source for beach nourishment--perhaps in excess of ten billion cubic yards.

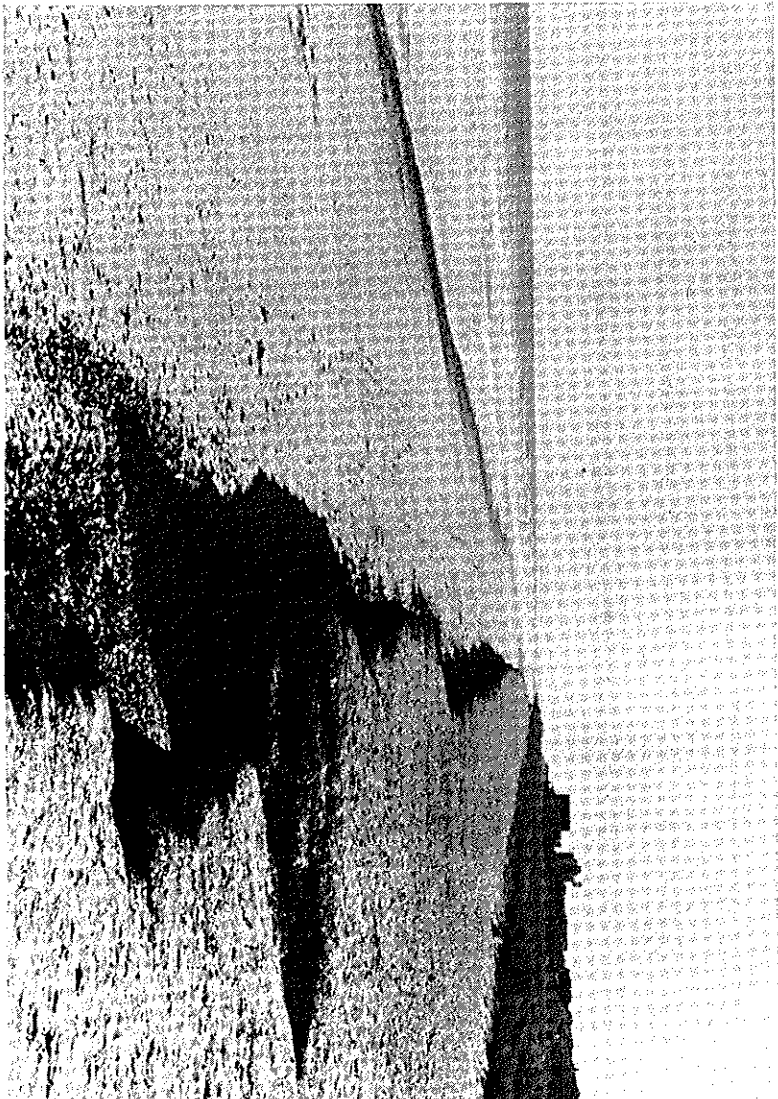
IMPROPER
MATERIAL

The borrow material was taken from Pamlico Sound. It was too fine to remain as part of the subaerial beach system and the quantity, 312,000 cubic yards, was too little to have significant impact on the inshore bar-trough system to provide even temporary protection.

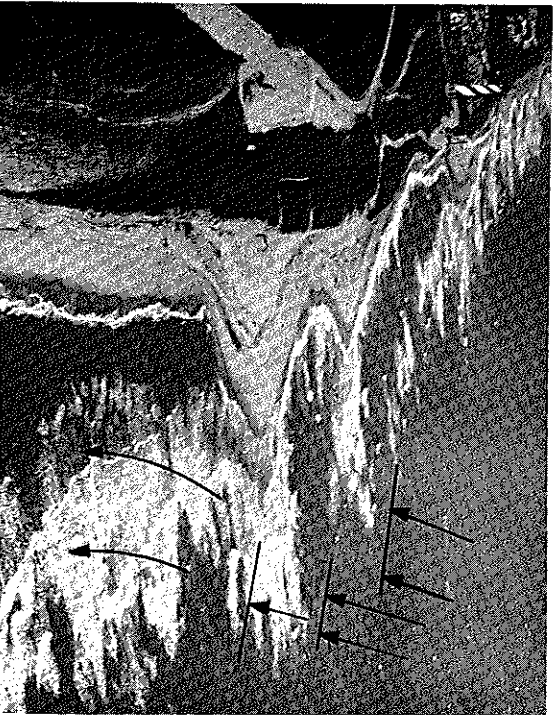
THE DEPOSIT

Therefore, material added to the subaerial beach as nourishment should be expected to become part of the natural onshore-offshore sediment exchange process. Within a short period of time, following a nourishment program, it might be difficult to detect the original mass of sand on the subaerial beach. This does not mean that the nourishment project failed, but rather that the sand added to the beach system has been redistributed by the natural onshore, offshore, and along-shore processes.

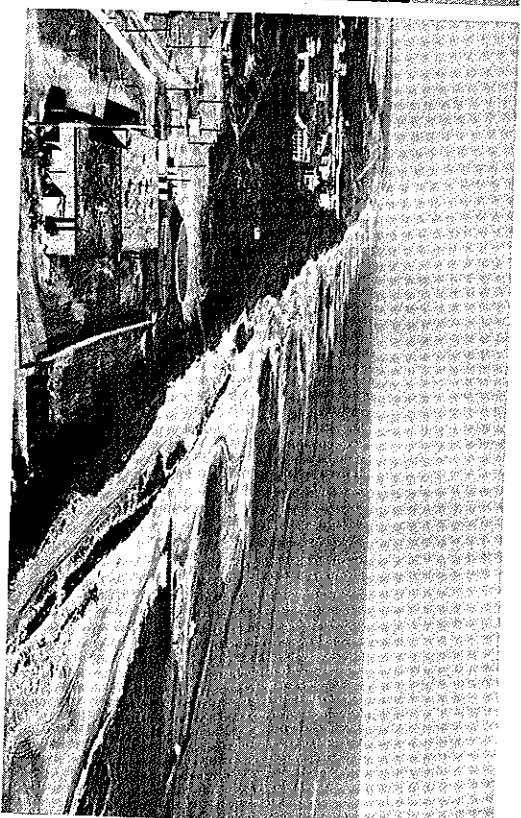
IDENTICAL LOCATION - 1972

DUNE DESTRUCTION
