Pupukea-Paumalu (Sunset Beach Park) Beach Maintenance Guidelines

Prepared By
Dolan Eversole, Coastal Geologist
University of Hawaii Sea Grant College Program

State of Hawaii
Hawaii Department of Land and Natural Resources
Office of Conservation and Coastal Lands
1151 Punchbowl. Room 131
Honolulu, HI 96813
(808) 587-0377

November, 2009

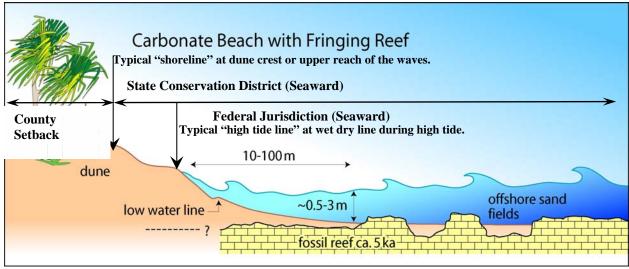
Figure. 1 Conceptualized Shoreline Jurisdiction. Base Image: Chip Fletcher, UH

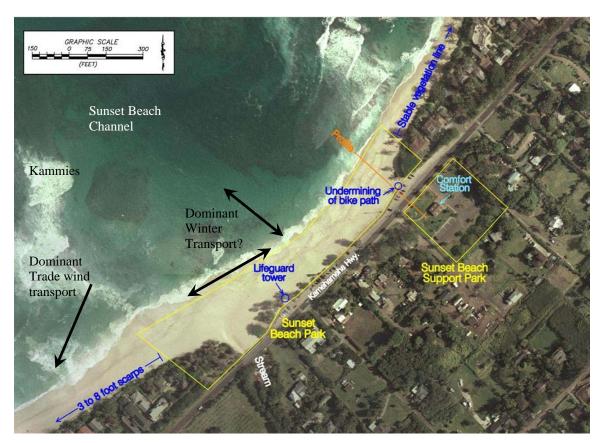
Figure 2. Sunset Beach Park and Beach Area (Base Image: Sea Engineering, Inc.)

Sand pushing is a common remedial erosion mitigation measure at the beach park. This can be an effective beach maintenance technique in which sand is taken from lower sections of the beach profile and pushed into an artificial protective berm higher on the beach profile. This technique can be especially useful for areas that experience high foot traffic erosion of the beach. A bike path runs between the park and Kamehameha Highway. A small area of erosion caused by precipitation runoff was noted west of the lifeguard stand, and an area where the bike path was undermined was found in the eastern portion of the park¹. The beach width was measured to be more than 150 feet from the bike path to the top of the foreshore slope near the lifeguard stand.

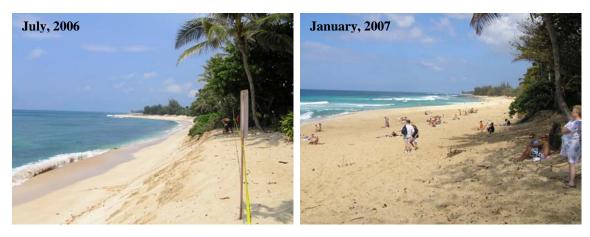
Dramatic seasonal variation in beach with is common in Pupukea-Paumalu and requires sitespecific understanding of coastal processes in order to respond to beach maintenance and management issues.

Based on these empirical observations, Sunset beach is dominated by a bi-modal longshore seasonal transport mechanism driven by wave direction displacing large sand volumes in a very short time period under high-energy, acute angle swell energy. The westerly transport of sediment is driven by swells from the north-northwest, while the easterly transport is driven by swells from the west to north west (Figure 2). These swell directions are typical of winter conditions and tend to accumulate sediment in the Sunset Beach region during the winter months. Typical trade wind swell out of the east to northeast dominates the summer months and tends to transport sediment to the west towards Rocky Point. The summer months tend to be erosional in nature at Sunset Beach and is particularly pronounced at the exposed section of residential properties immediately to the east of Sunset beach park fronting the "Kammies" Surf break. It is unknown what role the Sunset Beach channel plays in the function of sediment transport in the region but is likely to be a significant sediment pathway in the nearshore.

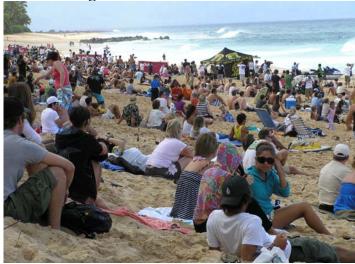
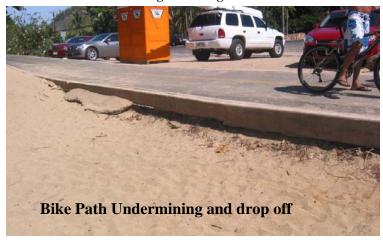
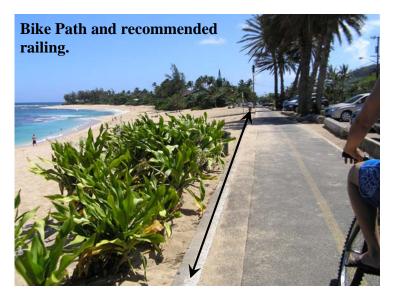
Figure 3. Foot Traffic Erosion

High volume foot traffic associated with surf contests can contribute to beach erosion and damage dune vegetation.

- 1. Continued localized erosion in Ehukai and Sunset Beach Park region due to a lack of a public access plan and coordinated sand management practices related to large foot traffic loads (Figure 3).
- 2. Diminished coastal access due to seasonal beach erosion and human-induced erosion.
- 3. Haphazard, ad-hoc dune protection and emergency erosion control measures that often result in unintended consequences.
- 4. Unauthorized landscaping, and erosion control measures that can result in the loss of access the shoreline area by aggressively overtaking portions of the beach and dune.
- 5. Increased exposure of beachfront residents to coastal hazards due to human-induced and natural shoreline modifications.
- 6. Insufficient shoreline construction setbacks to guarantee beach and dune conservation and hazard mitigation.

The Pupukea-Paumalu area offers a unique environmental and recreational setting as well a demonstrated interest and community participation in the coastal land use and beach conservation. One unique resource management aspect of the Pupukea-Paumalu area is the tremendous amount of foot traffic it receives during high surf and associated surfing contests. It is not uncommon to have over 5000 people visit Ehukai beach park during a major contest with similar volumes at Sunset beach. This volume of foot traffic contributes significantly to the deflation of the beach profile and necessitates costly sand pushing by the City and County of Honolulu to restore the beach to a normal volume. The University of Hawaii conducted a Topographic Lidar survey of Ehukai beach in the winter of 2007. This ongoing beach volume study reveals significant upper beach profile volume loss during periods of heavy foot traffic. The study confirmed local resource managers understanding that pedestrian foot traffic accounted for the primary mechanism for beach deflation and dune degradation. The lack of dedicated public access corridors at Sunset and Ehukai beach parks may be contributing to the need to maintain the upper beach volume through mechanical means and highlights the need for a comprehensive beach maintenance plan with specific BMPs.

- a. Provide several dedicated beach access points with stairs to minimize foot traffic erosion over the reach of the bike path at Sunset Beach park.
- b. Install pedestrian guard rails along the bike path to reduce the public hazard exposure from the bike path drop offs (Figure 3).
- c. Dedicating access ways will reduce the frequency and scale of regular sand pushing.
