# Bogue Banks Beach and Nearshore Mapping Program Hurricane Irene Post-Storm Impact Evaluation

Final Report | September 2011

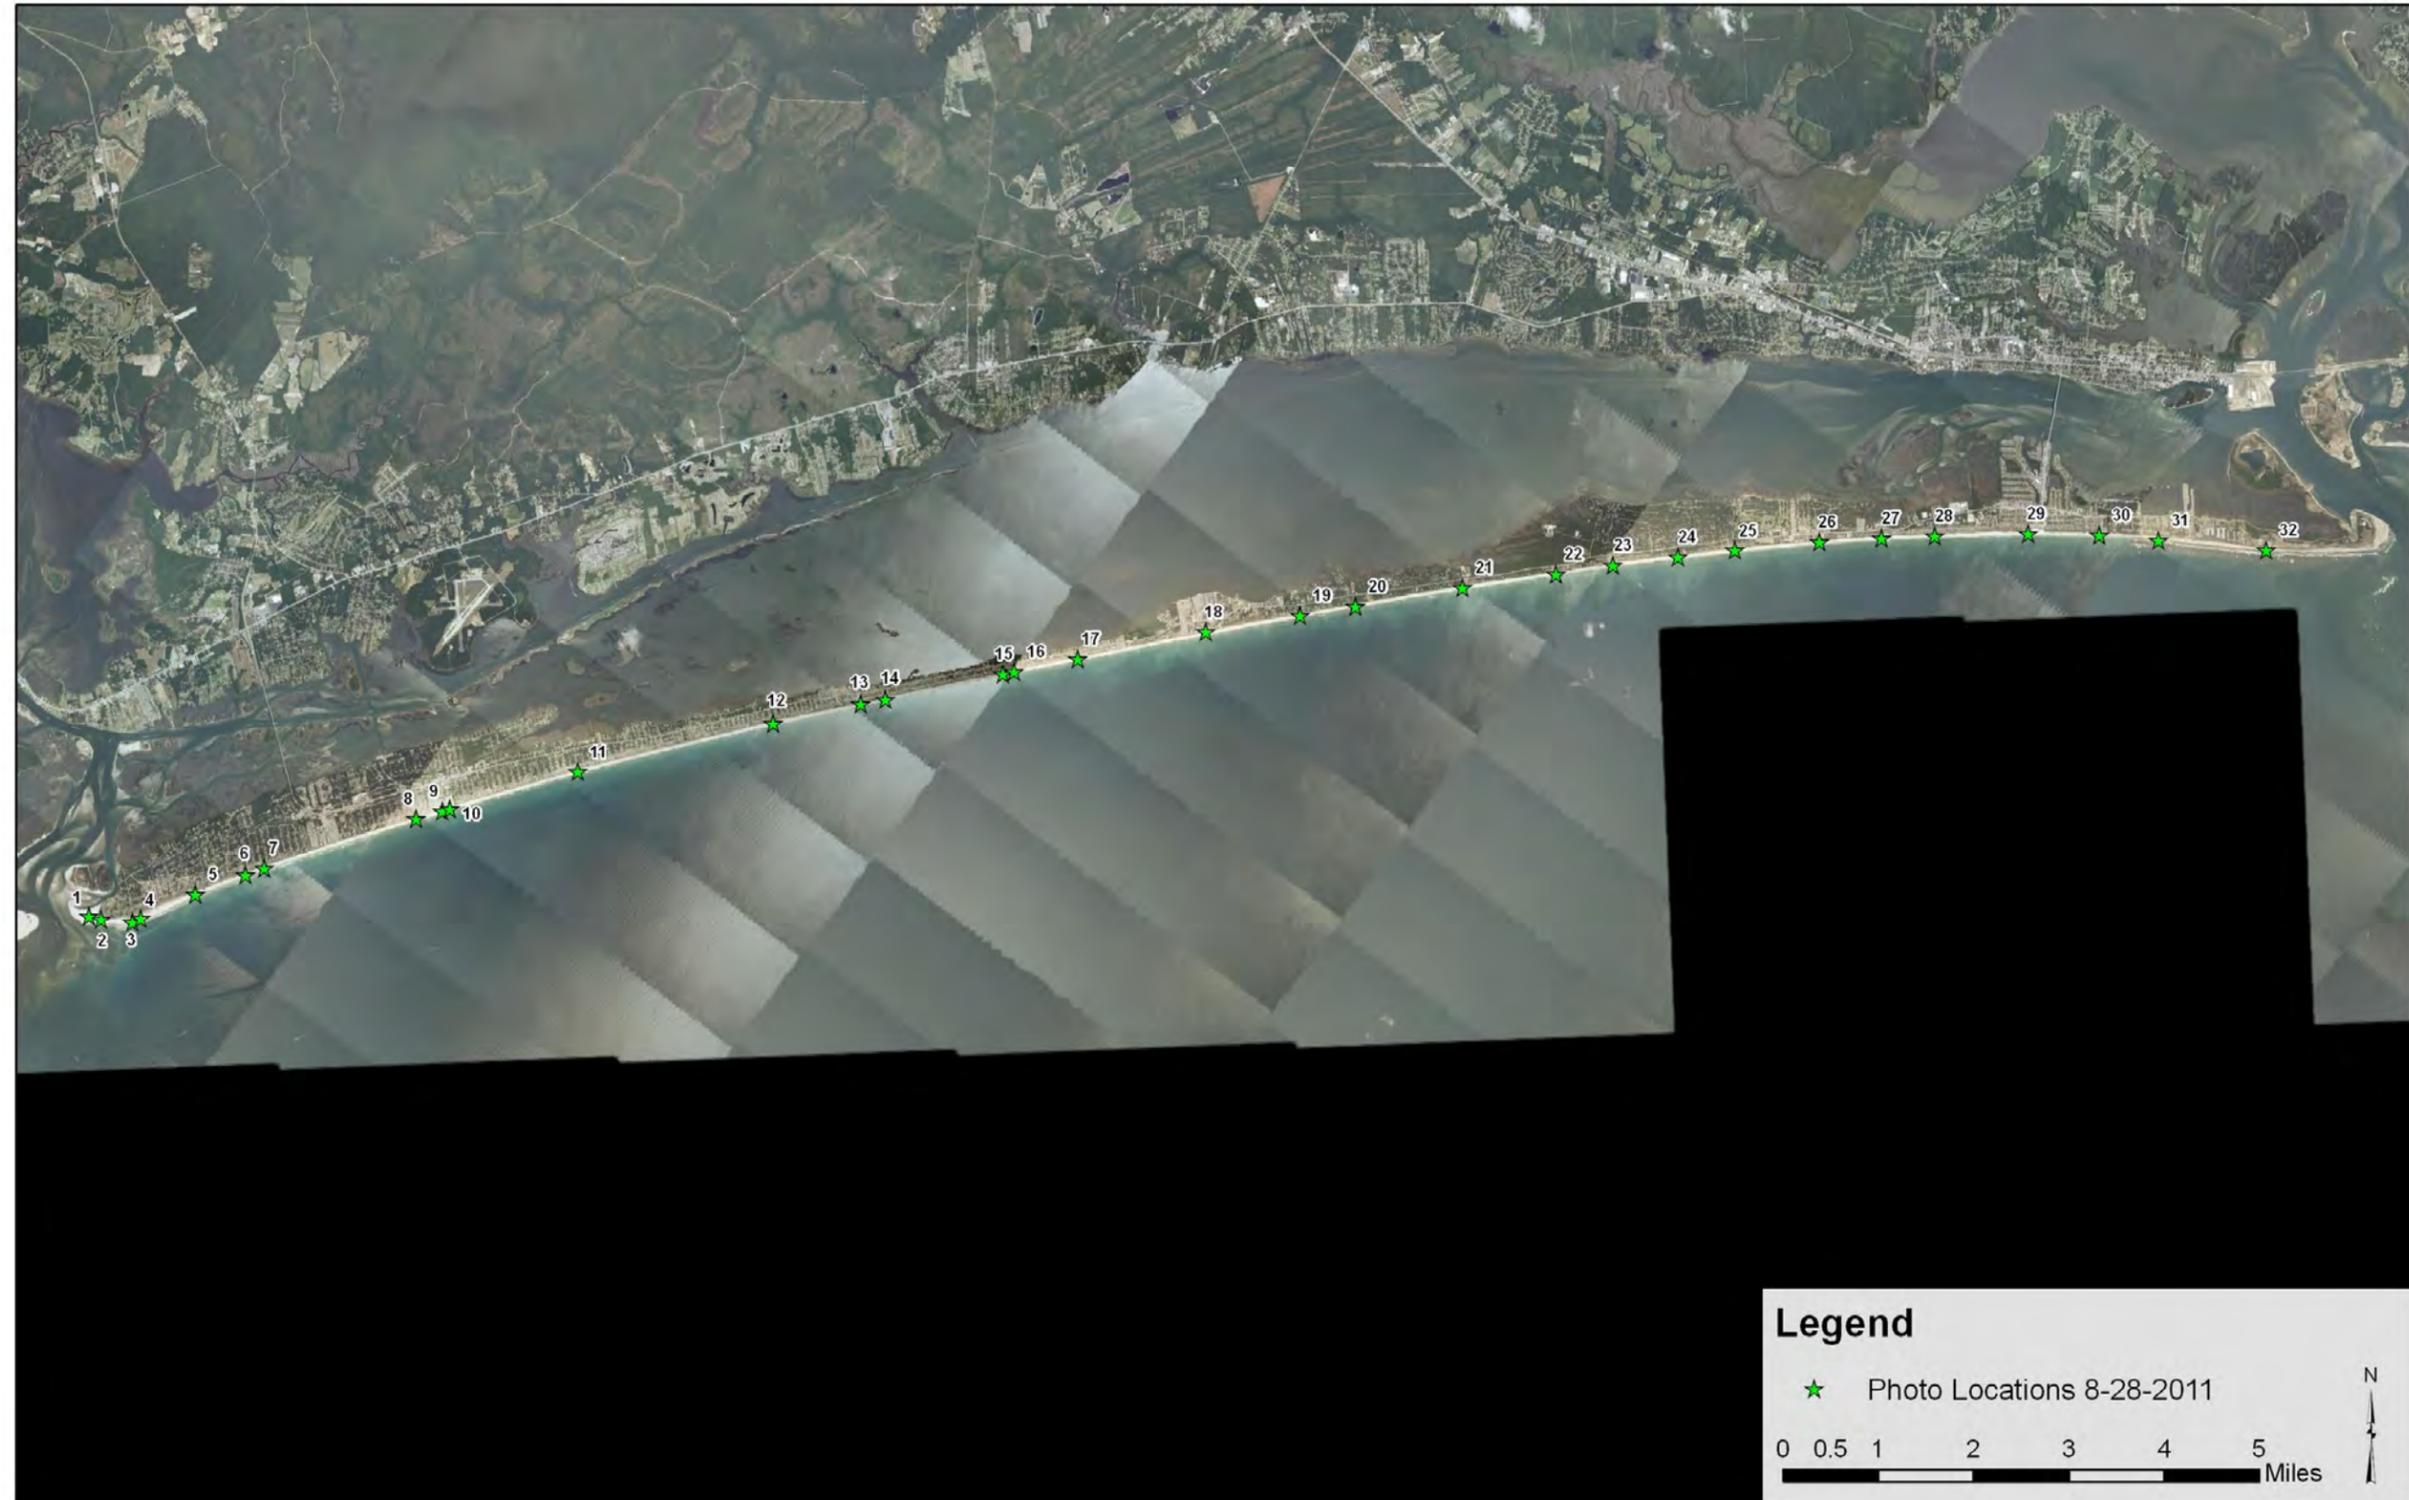
Figure 9. Map of Field Inspection Observation Locations

After Hurricane Irene passed, a post-storm field inspection was completed by County and M&N staff during August 28-29, 2011. On August 28, a post-storm photo and visual observation survey was completed at 32 locations along Bogue Banks. **Table 3** outlines the locations, photos taken and notes describing the visual observations in the field. **Figure 9** shows the locations where the photos were taken and observations made. A video of the entire oceanfront shoreline was also recorded on August 28<sup>th</sup>. Links to the photos and videos can be found at <http://www.protectthebeach.com/temp/irene.html>. Detailed discussion of the observations as

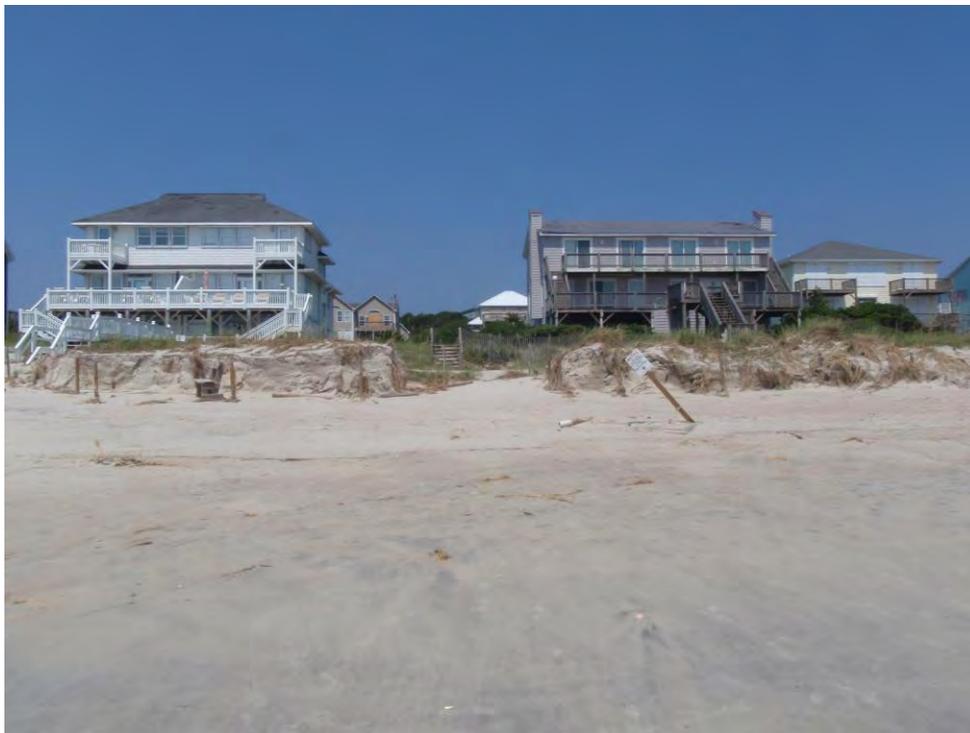
**Photo 1. In front of Ocean Oaks looking north**

The field inspection showed that storm impacts in this reach are generally characterized by significant erosion of the incipient vegetated dunes, with complete removal of incipient dunes and erosion of the primary frontal dune at some locations. At Randy’s Way and Ocean Oaks (Transects 6 through 10), the frontal dune shows a 4 to 6 ft scarp as illustrated by **Photo 1**. The survey profiles at these locations show significant volume loss between 0 and -12 ft NAVD88, with some gain seaward of -12 ft NAVD88.

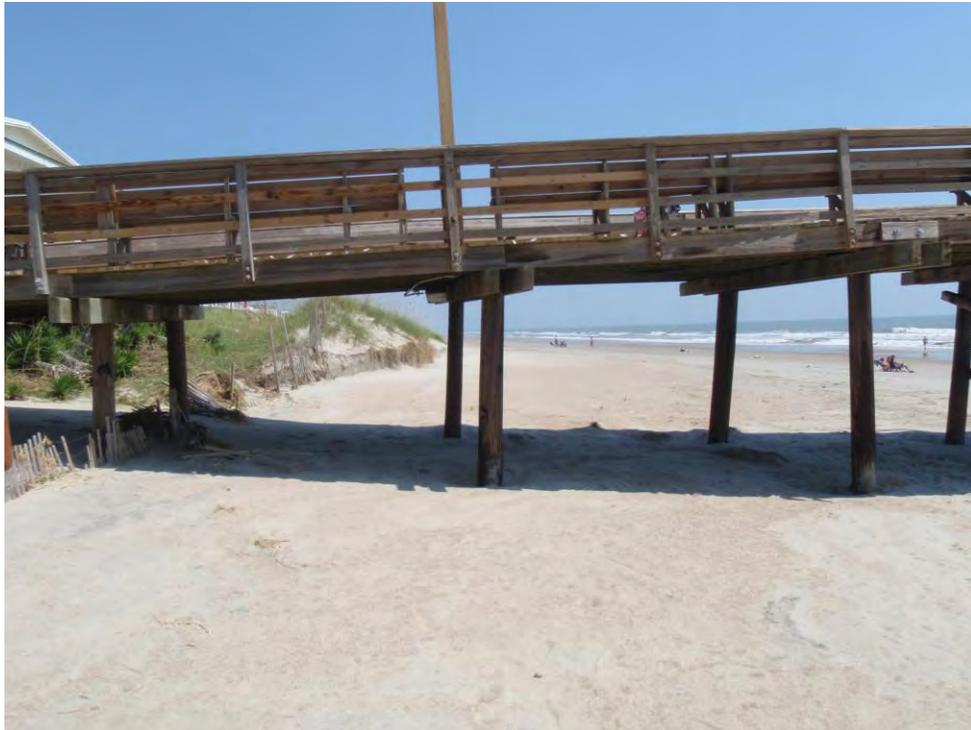
**Photo 2. Bogue Inlet Pier looking east**

Similar impacts were noted near the Bogue Inlet Pier (Transects 17 and 18 - **Photo 2**) and Pinta Drive (Transects 23 and 24), with a 2 to 4 ft scarp of the frontal dune. The survey profiles at this location are similar to the previous location, with obvious profile steepening and significant volume loss between approximately +2 and -15 ft NAVD88. The pier also suffered serious structural damage (**Photo 3**).

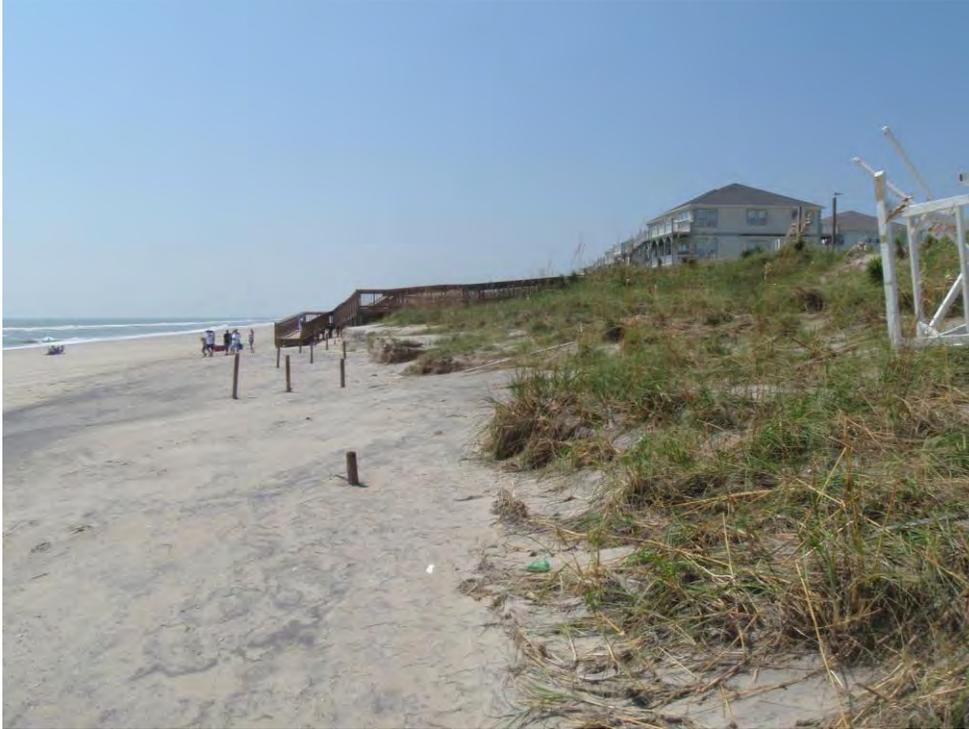
**Photo 4. Former Old Emerald Isle Pier location looking west**

Near the former Old Emerald Isle Pier location (Transects 34 through 37), the frontal dune shows a 2 to 4 ft scarp (**Photo 4**) with retreat of the dune to landward of the dune overwalk and sand fencing. The survey profiles at these locations show retreat and steepening of the beach between +6 and -8 ft NAVD88 and significant volume loss between -10 and -16 ft NAVD88.

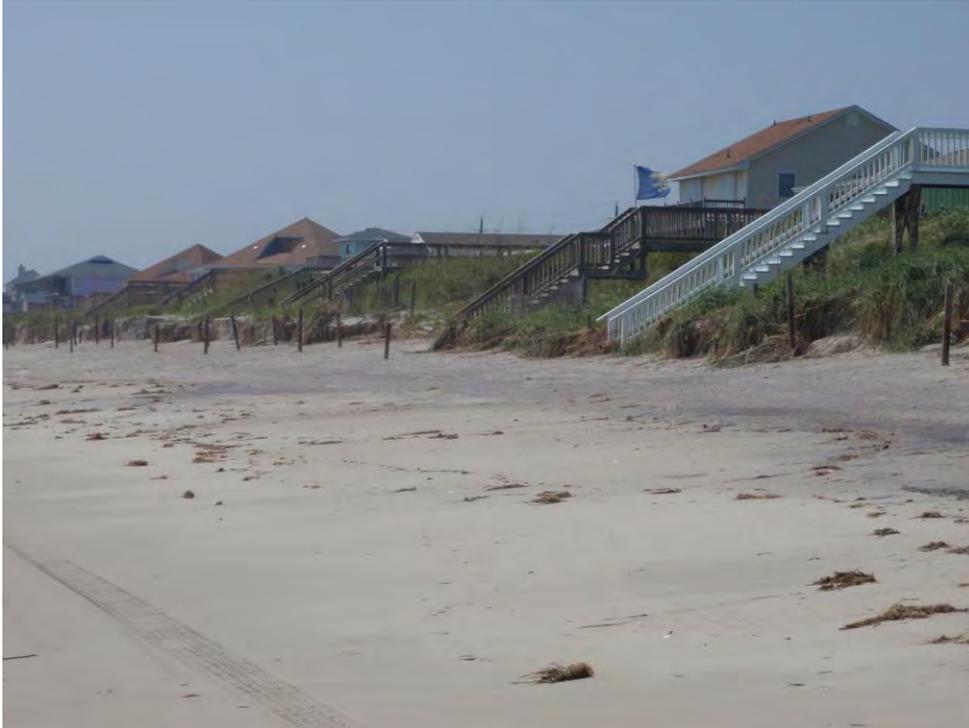
Photo 5. Near 12<sup>th</sup> Street in Emerald Isle, looking west

Between 12<sup>th</sup> Street and 4<sup>th</sup> Street in Emerald Isle (Transects 41 through 46), the frontal dune shows a 4 to 6 ft scarp of the incipient dune (**Photo 5**) transitioning to a 6 to 9 ft scarp of the primary frontal dune (**Photo 6**). The survey profiles vary considerably among each other landward of -10 ft NAVD, but all show an obvious net loss of volume landward of -12 ft NAVD.

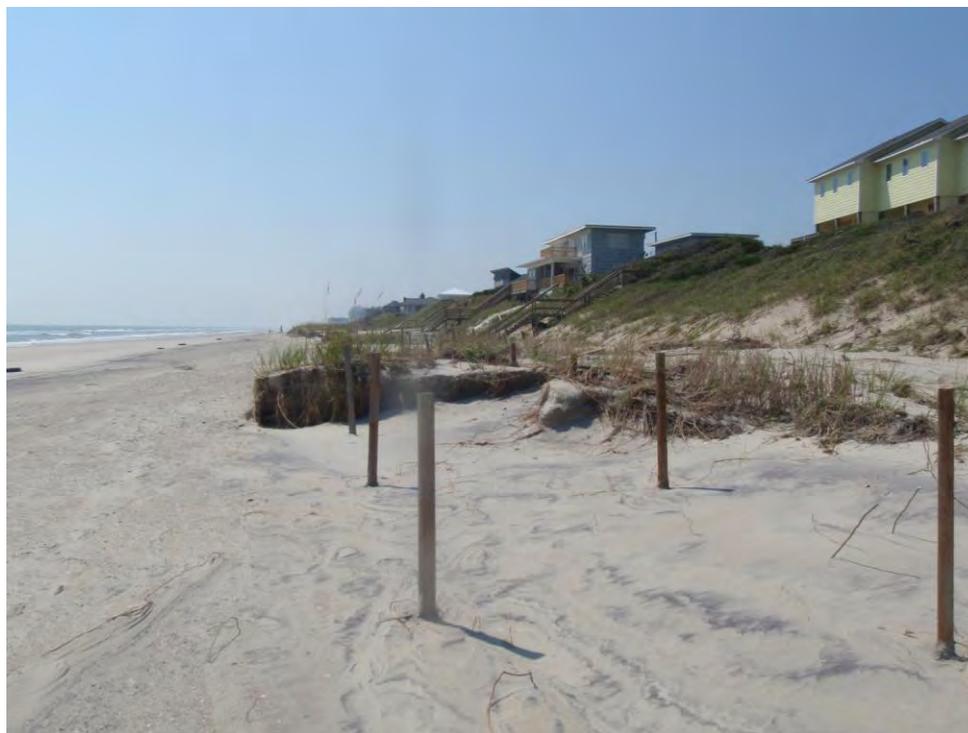
Photo 7. Colony by the Sea looking west

At post-storm inspection locations in this reach (Transects 49 through 58), the incipient dune generally shows a 2 to 4 ft scarp, though a slightly larger scarp and greater landward impact to the incipient dune was noted in front of the Colony by the Sea (**Photo 7**) near Transect 56.

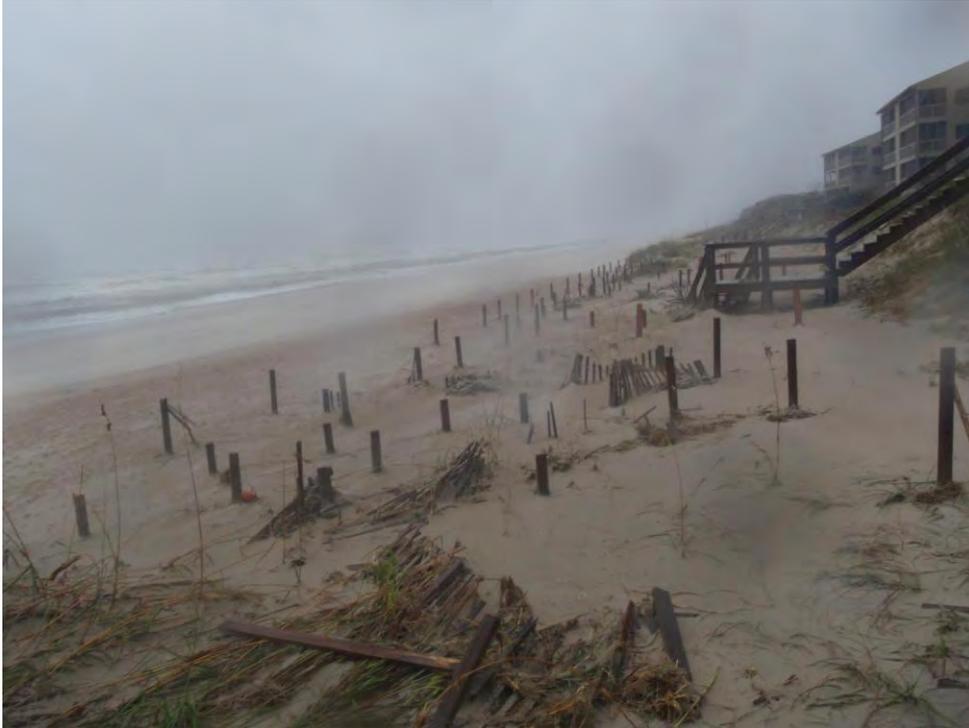
**Photo 8. Clamdigger looking west**

Post-storm inspection shows damage to the incipient and/or primary frontal dunes was generally consistent with impacts described for Indian Beach / Salter Path. The post-storm inspection indicated severe scarping (4 to 6 ft vertical) to complete removal of the incipient dune, with slight damage to the frontal dune in some locations. At the Clamdigger Hotel (**Photo 8**) and Memorial Park (**Photo 9**), the incipient dune was completely removed and the frontal dune was slightly damaged. However, between these locations at the Pine Knoll Townes condos the primary dune was within 3 ft of breaching (**Photo 10**).

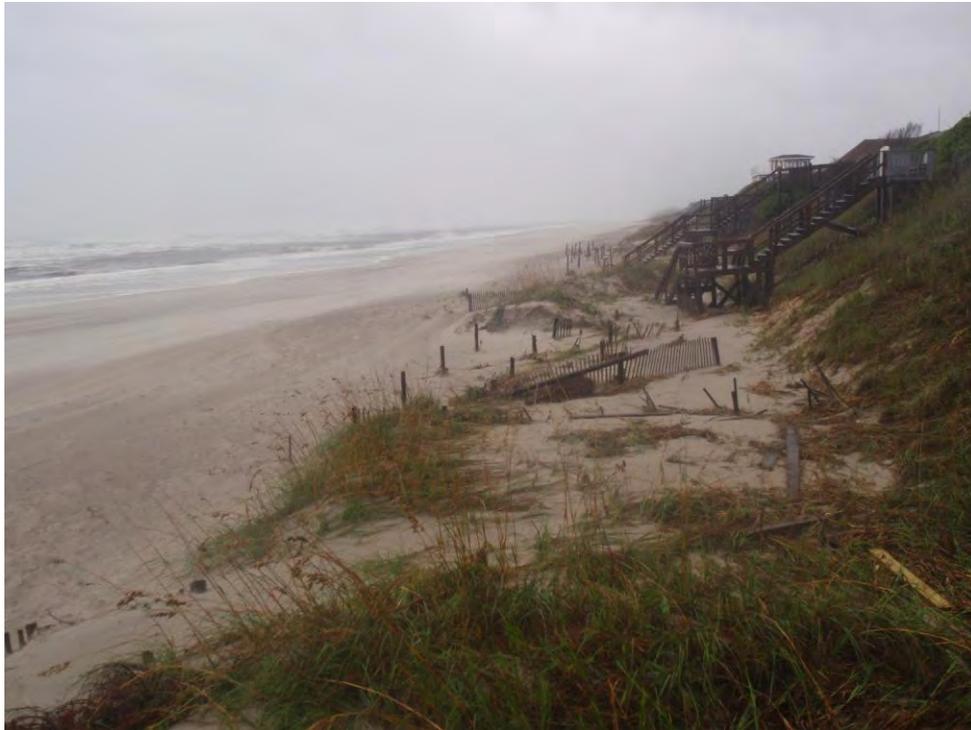
**Photo 9. Memorial Park looking west**

At Pine Knoll Townes and Memorial Park (Transects 69 through 73) the profiles indicate less volume loss than in the more western reaches of Pine Knoll Shores (e.g. near and west of Clamdigger).

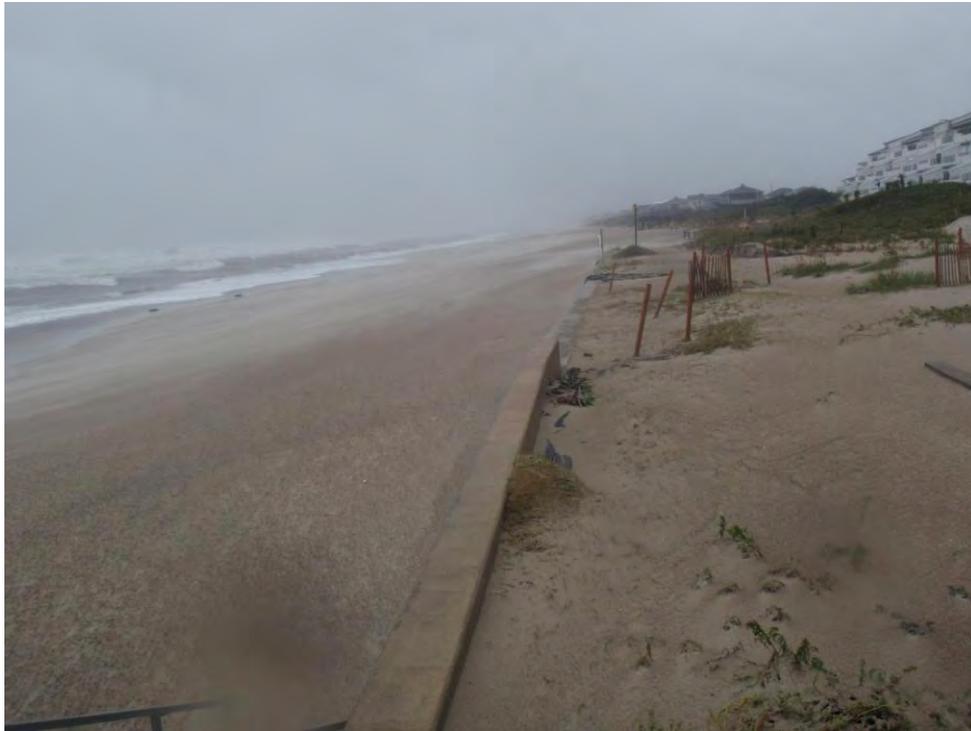
Photo 11. Iron Steamer looking west

A low-crested concrete seawall exists at the Iron Steamer, near Transect 66 between the Clamdigger and Pine Knoll Townes condos. The post-storm inspection showed that the wall was clearly overtopped and the incipient dune was removed (**Photo 11**). The primary dune was also damaged somewhat (**Photo 12**, background), and the overwalk was lifted off its vertical supports. Interestingly, the survey profiles in this vicinity (Transects 65 through 68) show comparatively less net volume change between +4 ft and -12 ft NAVD88 than transects to the west.

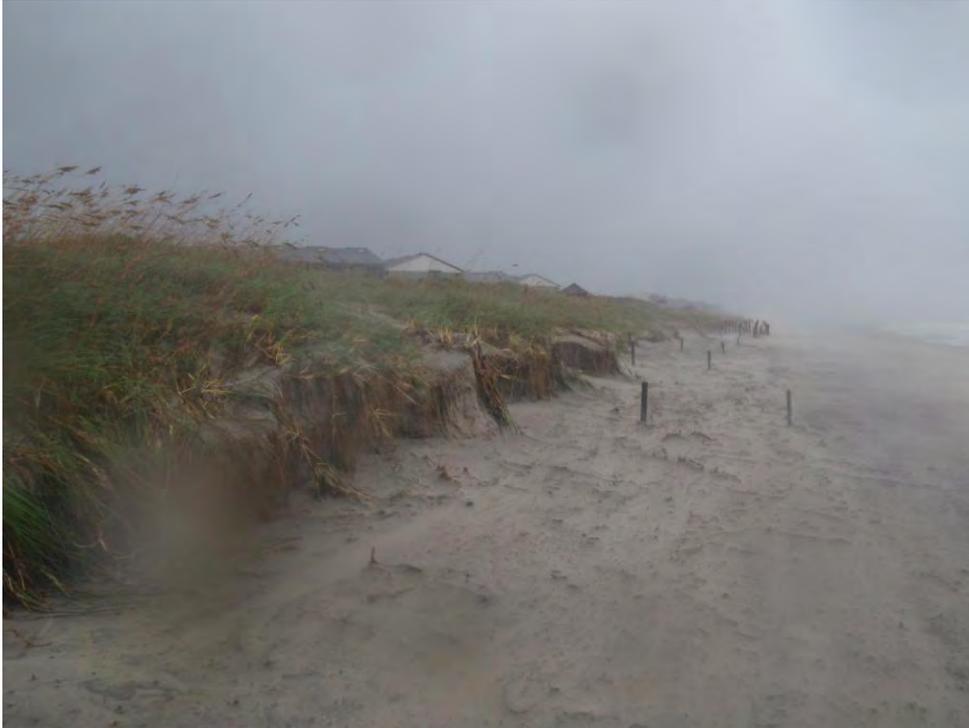
**Photo 13. Sheraton beach access looking east**

Observations from the post-storm field inspection include the following. Near the Sheraton in Atlantic Beach (transects 78 and 79), the incipient dune was removed and the primary dune showed a scarp of 2 to 4 ft vertical (**Photo 13**). The Sheraton pier also sustained damage during the storm (**Photo 14**) with the ocean end being completely removed.

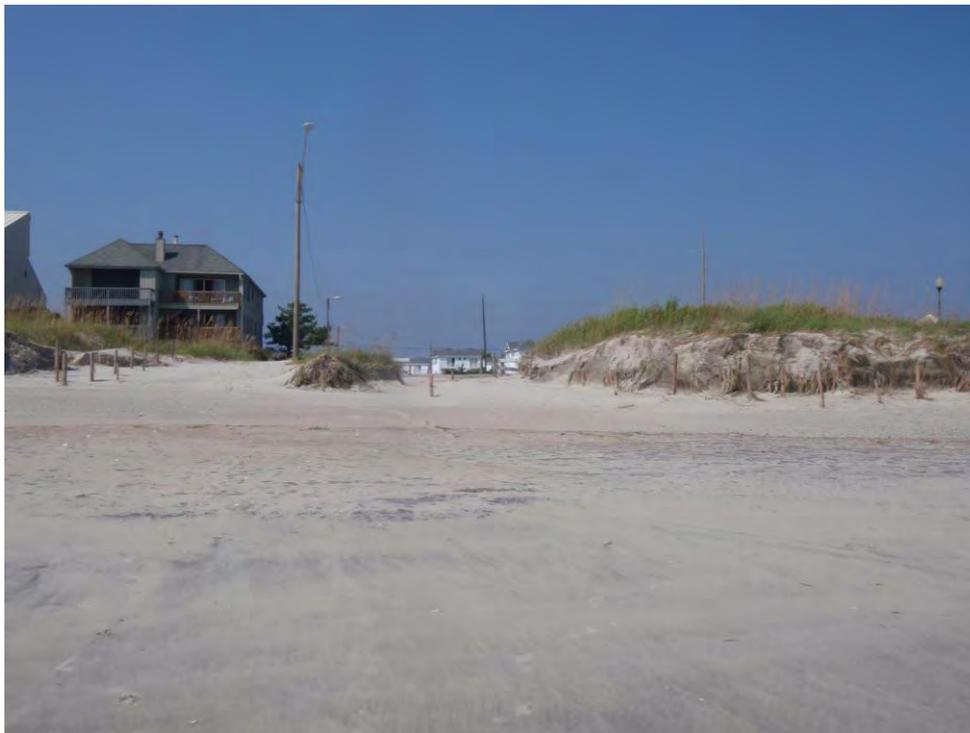
**Photo 15. Coral Bay Club looking north**

The pre-storm frontal dune between the Coral Bay Club and the Club Colony Drive (Transects 80 through 100) was generally low-crested and wide, in contrast to some further western areas of Bogue Banks with steeper, higher frontal dune profiles. The impacts of the storm at Coral Bay Club (Transect 80) included a 4 to 6 ft scarp (**Photo 15**) and overwash of sand into the parking lot behind the frontal dune (**Photo 16**).

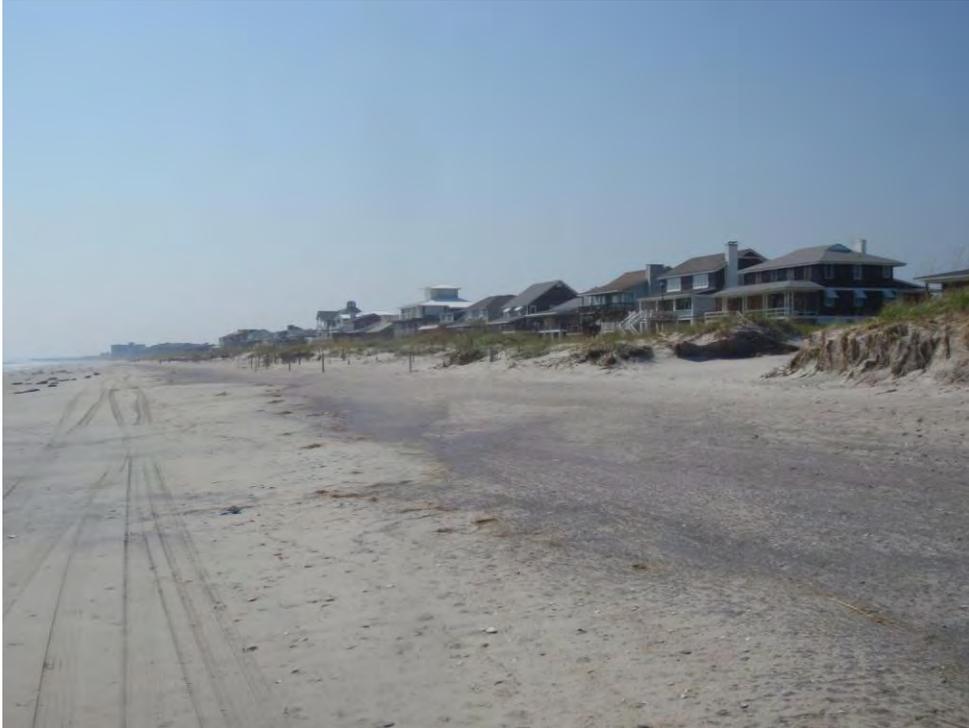
**Photo 17. Ocean Ridge looking west**

At Ocean Ridge (Transect 85), the Circle (Transect 90) and Oceanna Pier (Transect 95), the storm caused a 2 to 4 ft scarp to develop along stretches of the primary dune (**Photo 17** and **Photo 18**). Waves appear to have impacted the dune to within 3 ft (vertical) of the dune crest, and the survey profiles 90 and 95 indicate net volume loss landward of -10 ft NAVD88.
