Geologic Site of the Month  
June, 2006

***Beach Nourishment at Western Beach  
Scarborough, Maine:  
Benefits for the Beaches and the Birds***

Text by  
Peter Slovinsky

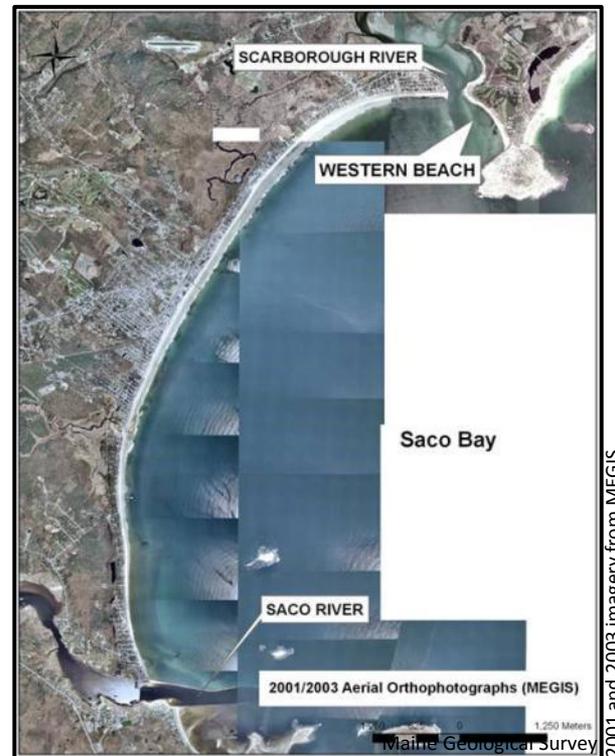
**Figure 1.** Saco Bay has the largest contiguous beach system in the state.

Saco Bay, an arcuate embayment of approximately 7 miles, is located in southwestern coastal Maine, and contains the longest stretch of contiguous sandy beaches within the State of Maine (Figure 1). Western Beach is a small stretch of sandy pocket beach located along the south side of the Prouts Neck headland in Scarborough, at the northern end of Saco Bay and adjacent to the Scarborough River (Figure 2).

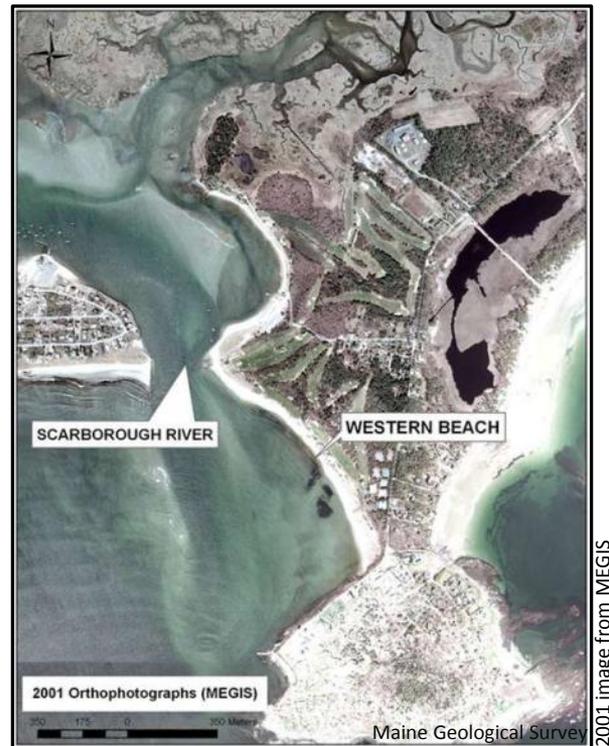
**Figure 2.** Aerial image of the Prouts Neck headland and Western Beach, adjacent to the Scarborough River. Note jetty and sand shoals extending offshore on the western side of the river.

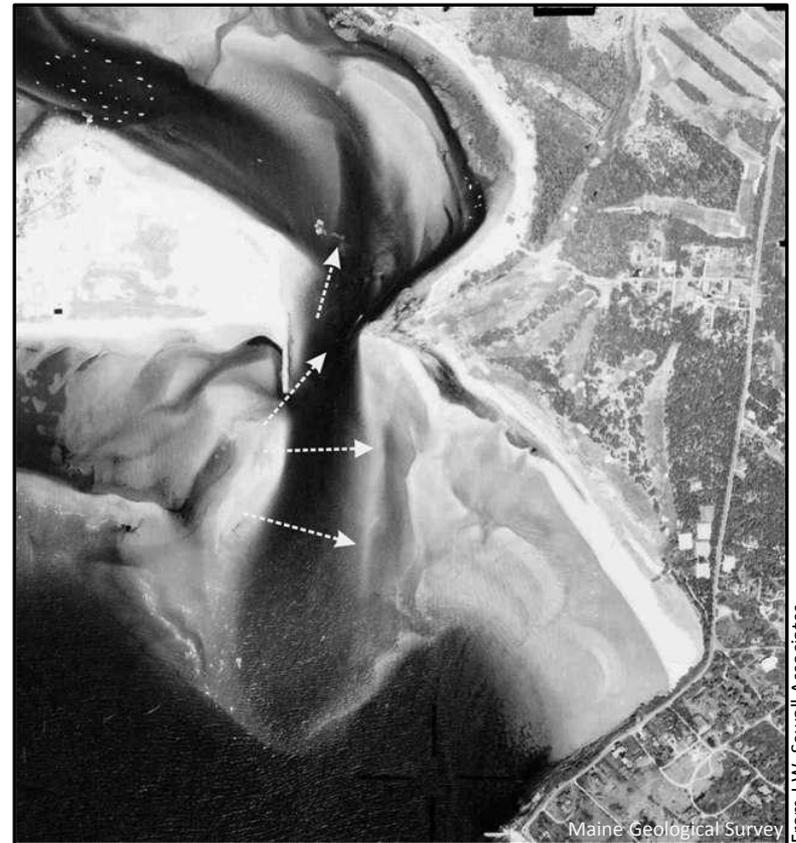
**Figure 3.** Aerial image from 1962 showing the morphology of the Scarborough River ebb tidal shoals and the newly built jetty. White arrows show the direction of shoal bypassing prior to the 1962 stabilization.

Some of the recent erosion seen at Western Beach may possibly be attributed to the stabilization and subsequent maintenance dredging of the Scarborough River by the U.S. Army Corps of Engineers (USACE) in 1962 (Figure 3). Prior to 1962, the main channel of the river migrated regularly in response to changes in wave climate, sediment supply, and storm events. These migrations changed the size and orientation of the river's main channel through the ebb-tidal delta, thus abandoning sand shoals and causing them to bypass former channel areas and provide sediment to both the Pine Point and Western Beach shorelines.

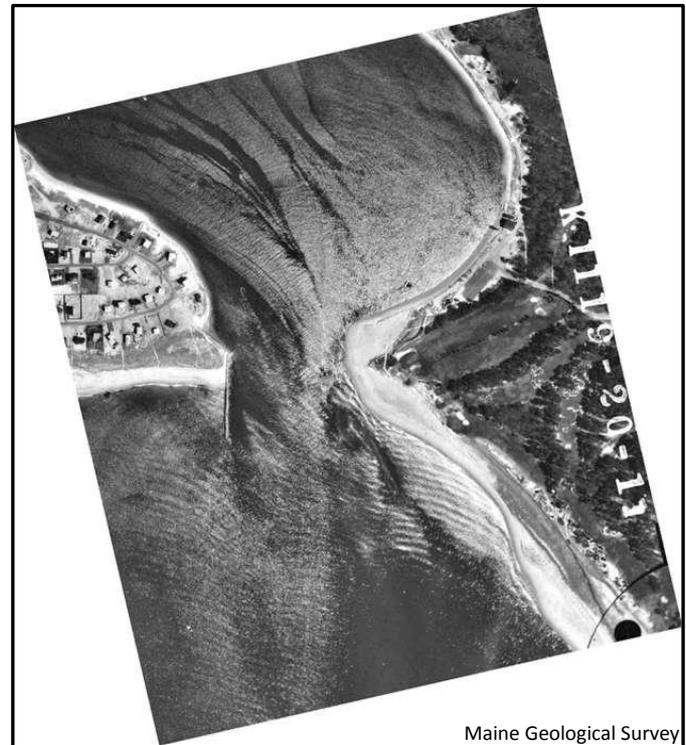
**Figure 4.** 1978 aerial photograph of Western Beach, taken during a higher tide. Note the increased width of Western Beach and the evident waves moving along the beach at its central portion

Since the main channel was stabilized in 1962, it has remained relatively stationary, aside from the need for repetitive maintenance dredging by the USACE in order to maintain a navigable channel for both recreational and commercial vessels. As a result of the stabilization of the river, Western Beach underwent progradation for almost 20 years, until its most seaward extent in 1978 (Figure 4; Timson, 2003; Timson, 1989).

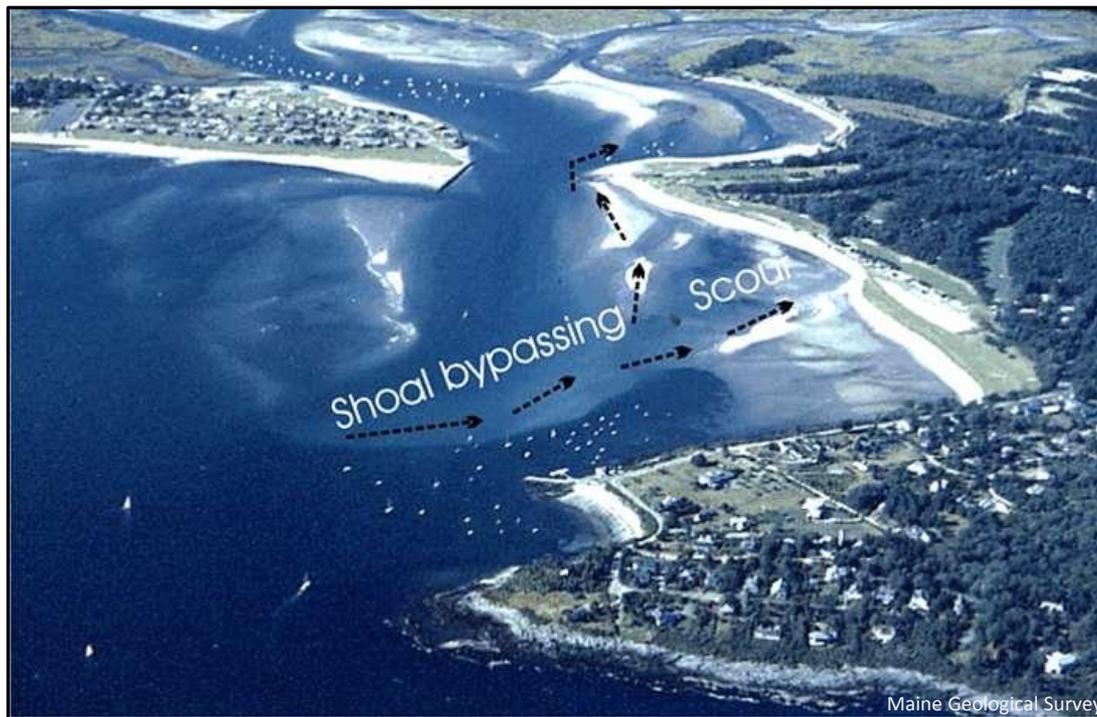
**Figure 5.** Oblique aerial photograph from 1987 showing shoal bypassing occurring, but farther offshore. The jetty causes the buildup of a sand bar that acts as a littoral barrier, and shoals must come around this barrier in order to migrate to Western Beach. Note the shoal locations off of Western Beach.

Additionally, in response to river stabilization and dredging, it appears that the ebb-tidal delta has migrated in a southeasterly direction, farther offshore (Timson, 2003; Timson, 1989). This may be due to the stabilization, sand bar buildup, and regular maintenance of the main channel of the river, which can no longer naturally shoal and migrate at the previous location, closer to shore (Figure 5).

This offshore migration of the ebb delta has, in turn, led to shoaling at the Prouts Neck Yacht Club and subsequent minor bypassing that continues to occur, but well offshore (Figure 5 and Figure 6).

Flood tidal currents also appear to play a role in erosion at Western Beach. Along the central-to-northwestern portions of the beach, it appears that this portion of the beach is fronted by a deeper scour channel (see Figure 5 and Figure 6). Sediment in this section of the shoreline appears to be scoured by flood tidal currents, with some moved towards and onto the beach, while much appears to be transported past Ferry Rocks and into the river, shoaling the anchorage at Ferry Beach.

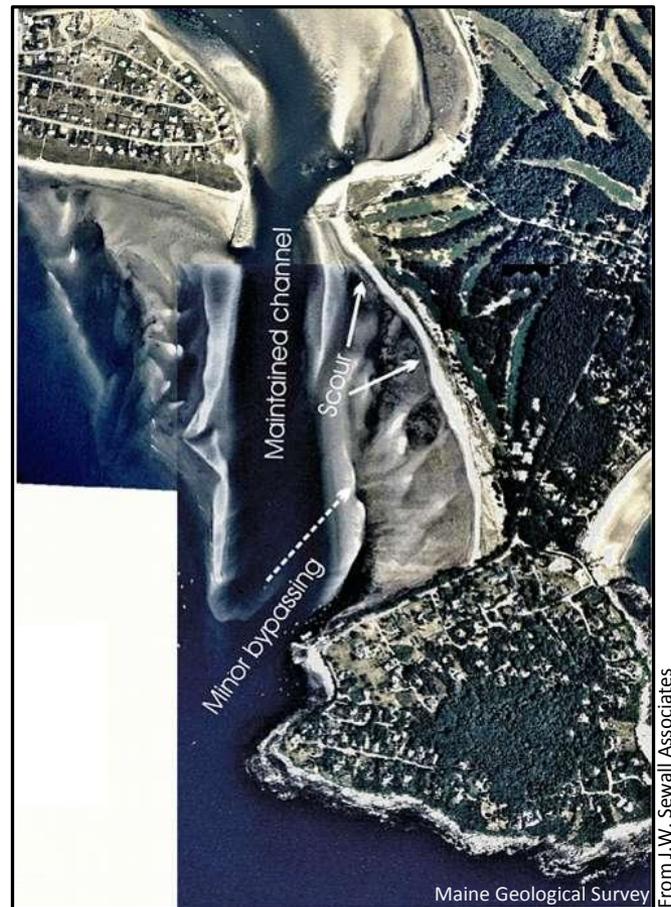
**Figure 6.** Aerial photograph from 1995 showing the Western Beach, Scarborough River, and Pine Point area.

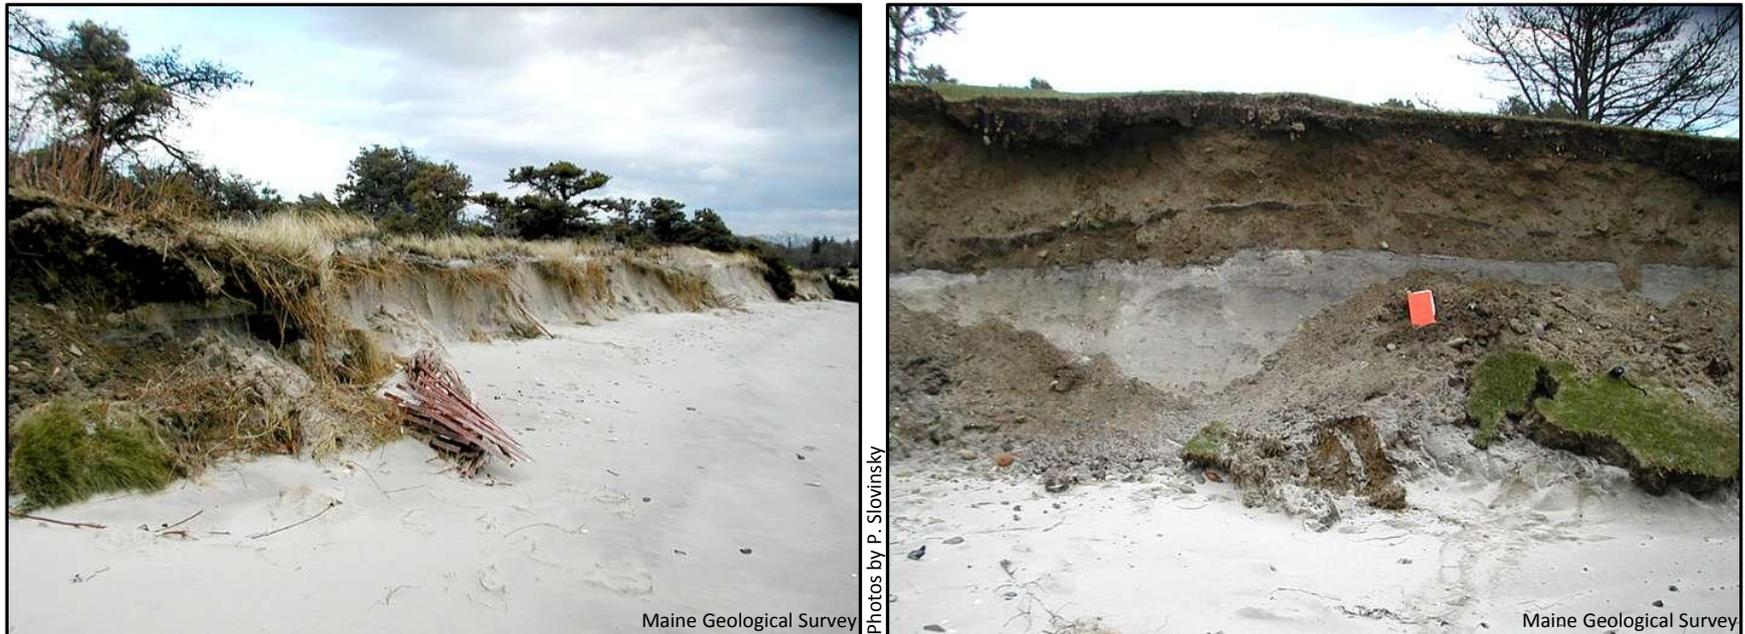
**Figure 7.** Photographs from November 2002 show the field condition of the vegetation line and beach. The beach has been eroded back into the golf course such that course greens were being undermined and scarped. (Left) Looking northeast along the scarp cut into the dune and green. (Right) Close up of scarping and undermining of green.

MGS has been monitoring the Western Beach shoreline using field photography, aerial photography and GIS, and Real Time Kinematic (RTK) Global Positioning Systems (GPS). Photographs from November 2002 show the field condition of the vegetation line and beach (Figure 7 and 8).

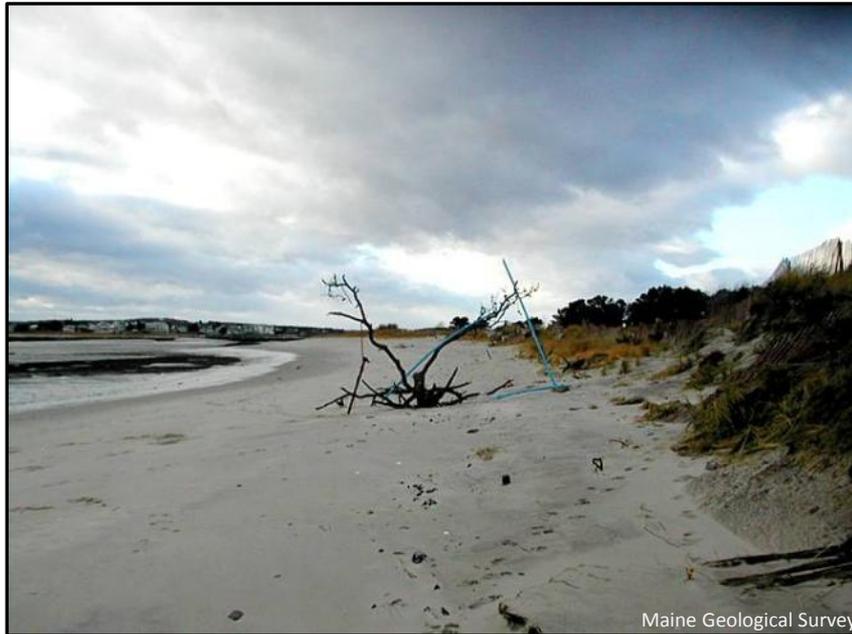
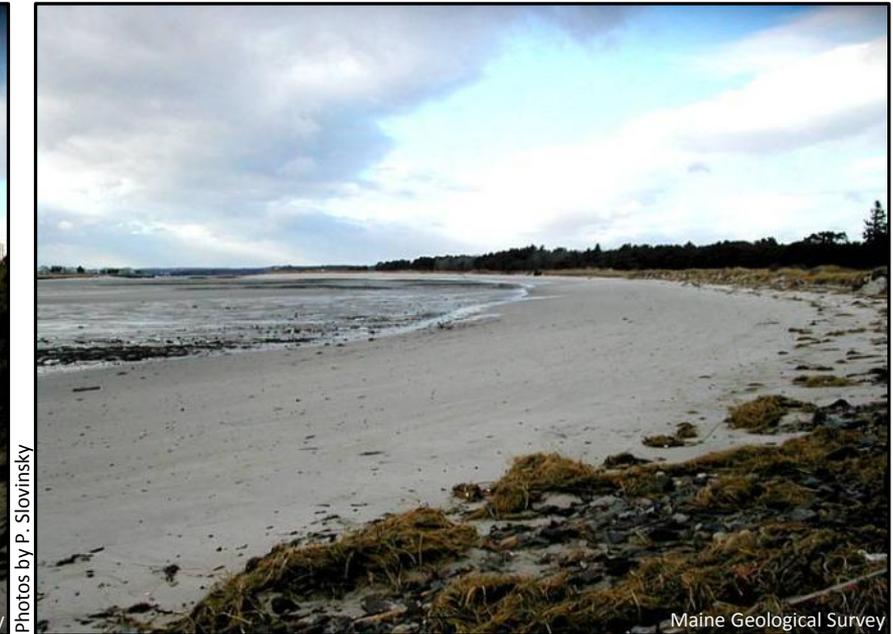
**Figure 8.** (Left) Looking northwest along Western Beach of tree that has been undermined and now sits on the beach and in the swash zone. (Right) Looking northwest along Western Beach.

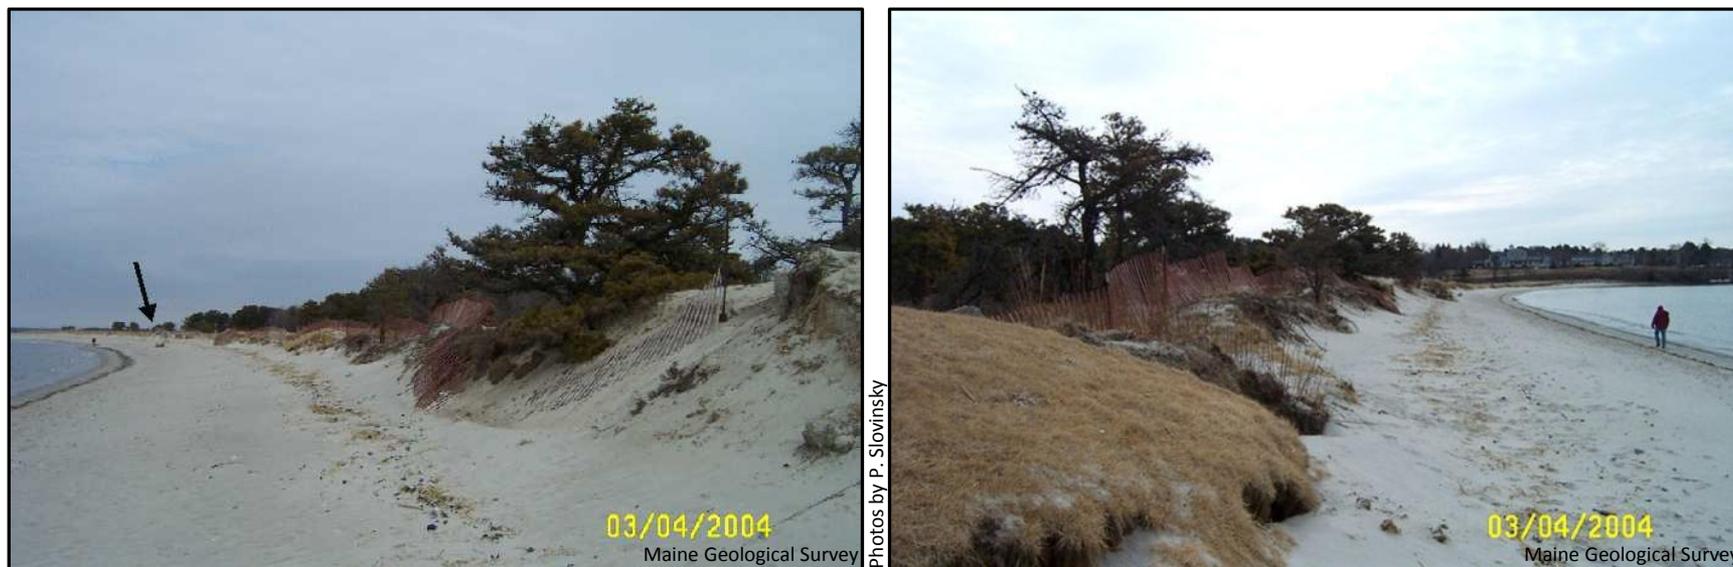
**Figure 9.** Photographs in the months prior to nourishment, from March 2004, show continued erosion of the beach and undermining of the course. (Left) Looking northwest along Western Beach. Note the stump in the left hand portion of the photograph; this is what remains of the tree in Figure 8. (Right) Looking southeast along Western Beach.

The beach has been eroded back into the golf course such that course greens were being undermined and scarped. Photographs in the months prior to nourishment, from March 2004, show continued erosion of the beach and undermining of the course (Figure 9). MGS was also able to compare Light Detection and Ranging (LIDAR) topographic data from flights in 2000 and 2004, available from the National Oceanic and Atmospheric Administration's Coastal Services Center.

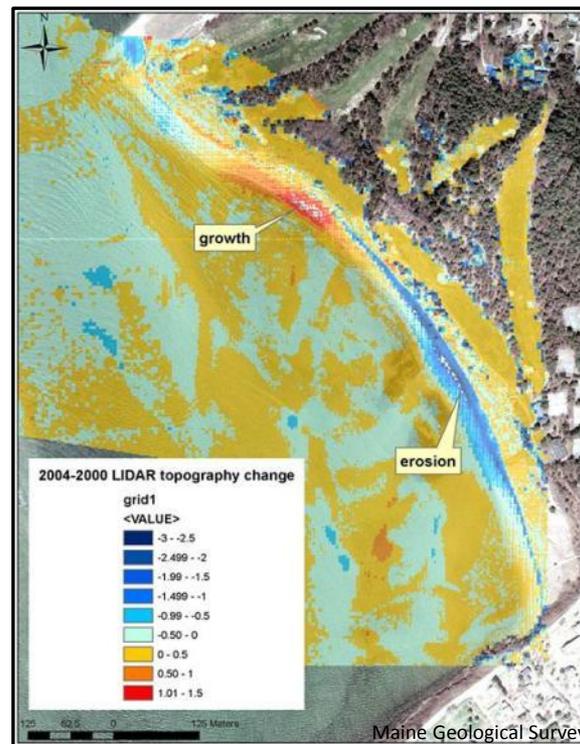
**Figure 10.** Results from grid subtraction of 2000 LIDAR topographic data from 2004 LIDAR data. Areas of orange and red along the beach mark growth (accretion), while areas in blue generally mark erosion. Elevation changes are in meters

Applicable grids were created and subtracted (i.e., topography from the 2000 LIDAR was subtracted from the 2004 LIDAR), resulting in the data shown in Figure 10. By comparing these snapshots of topography, it appears that intertidal and berm growth occurred along the northwestern portion of the beach (red shading), while beach and dune erosion dominated along the central to southeastern portions of the beach.

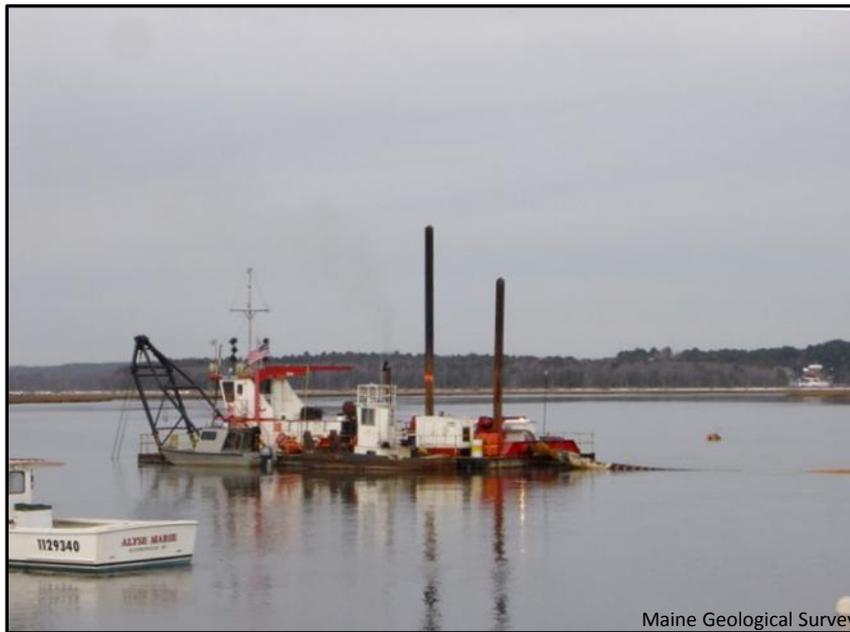
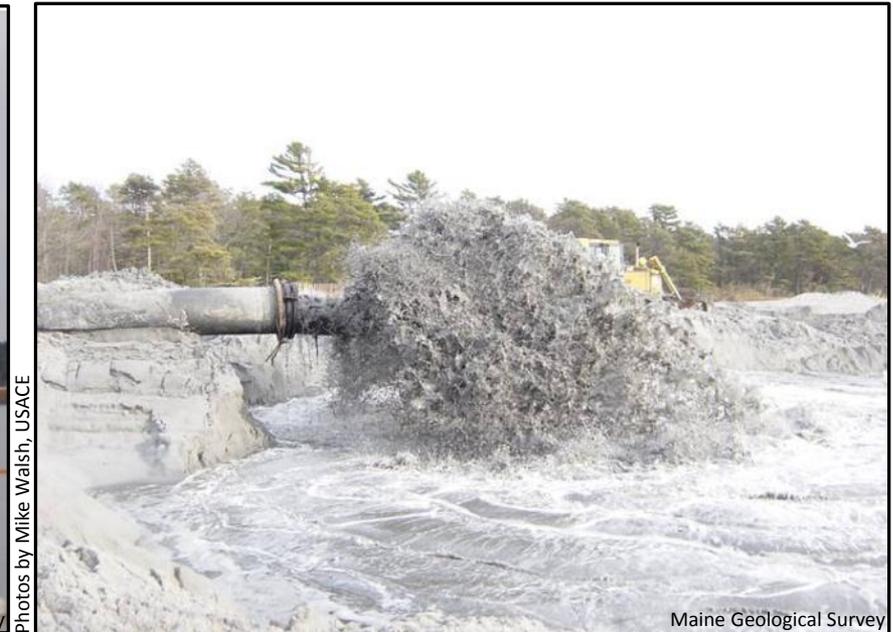
**Figure 11.** (Left) Photograph showing the dredge working within the federal anchorage area of the Scarborough River. (Right) Photograph of the dewatering of dredged material on Western Beach.

In December 2004, the USACE dredged 90,000 cubic yards of sediment from the main channel and anchorage area of the Scarborough River, and placed the material at Western Beach as the beneficial reuse of dredged material using hydraulic pumps.

MGS helped designate the areas for fill placement in order to maximize the lifetime of the beachfill. The design of the fill was to increase the dry beach width by adding elevation and width to the berm, the relatively flat area between the edge of high water and the dune vegetation line. Figures 11 and 12 includes photographs, taken by the USACE, showing the nourishment process at Western Beach.

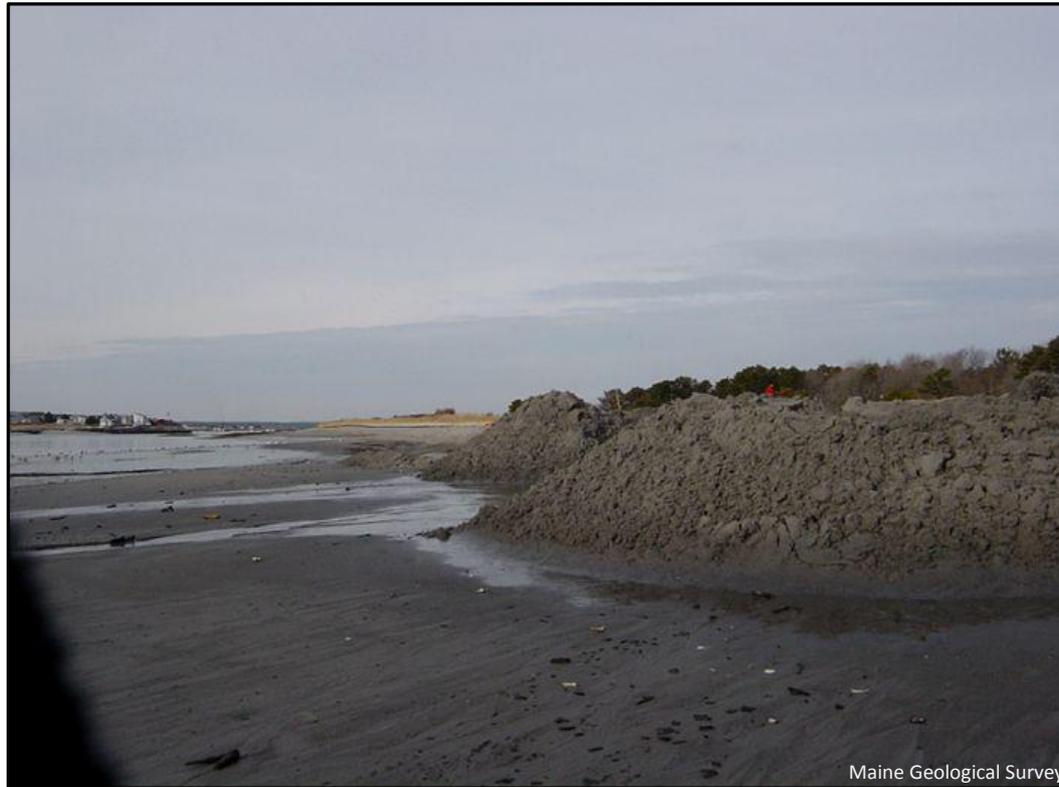
**Figure 12.** Photograph of mounds of dredged material on Western Beach prior to grading with equipment.

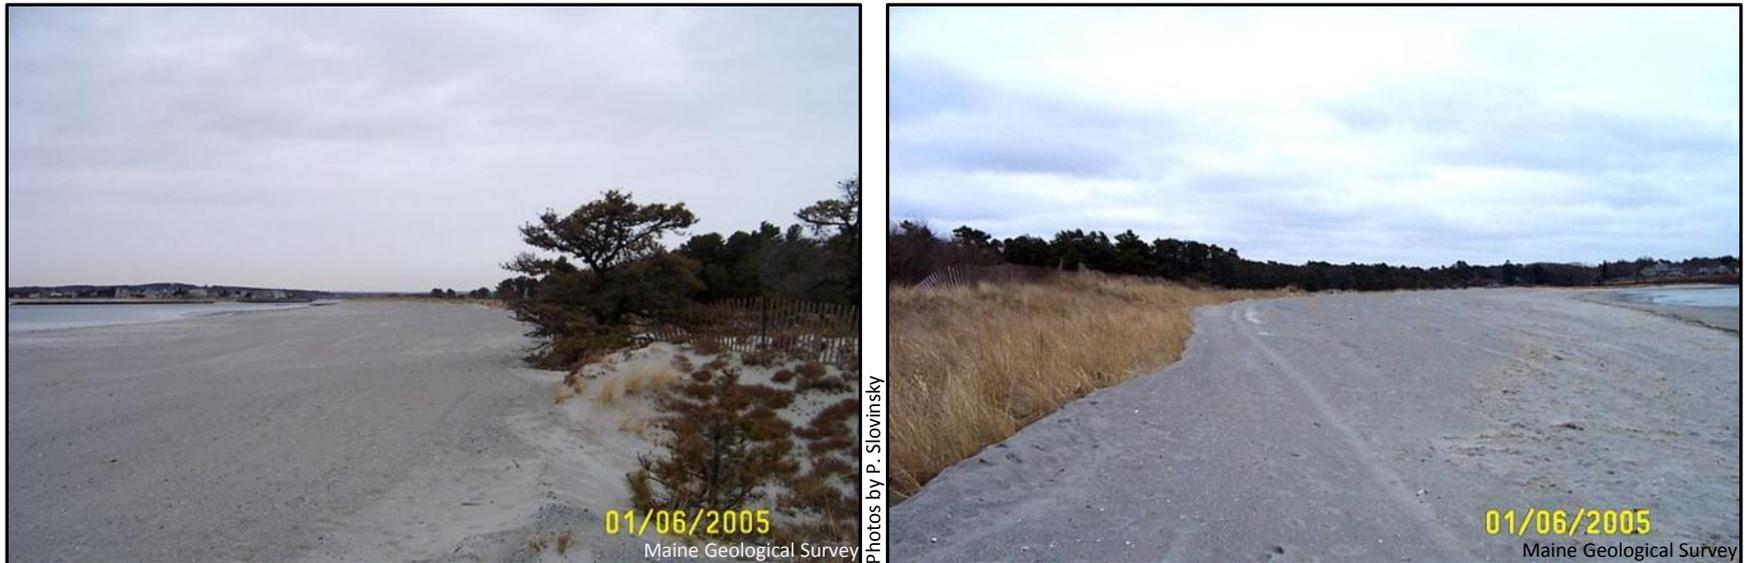
**Figure 13.** (Left) Photograph looking northwest along the nourished portion of Western Beach. Note the dramatic increase in beach width. (Right) Photograph looking southeast along the nourished beach.

Post-nourishment photos showing the completed berm are shown in Figure 13 (January 2005) and Figures 14-15 (April 2005).

It is apparent from the photographs that the dry beach width was dramatically increased.

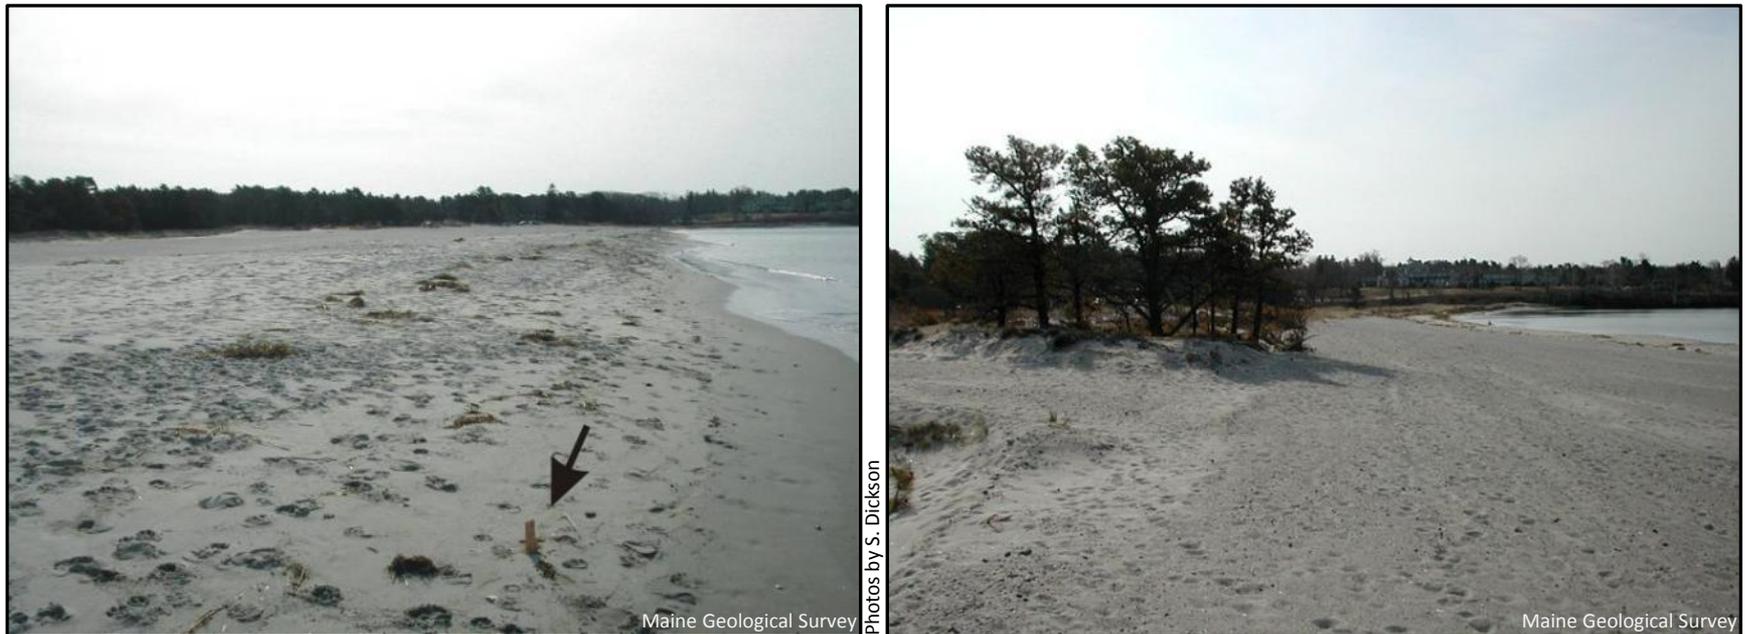
**Figure 14.** (Left) Photograph looking southeast from the northwestern seaward limit of the beach nourishment. Note stake in foreground. (Right) Photograph looking southeast from near the vegetation line showing width and depth of nourishment fill.

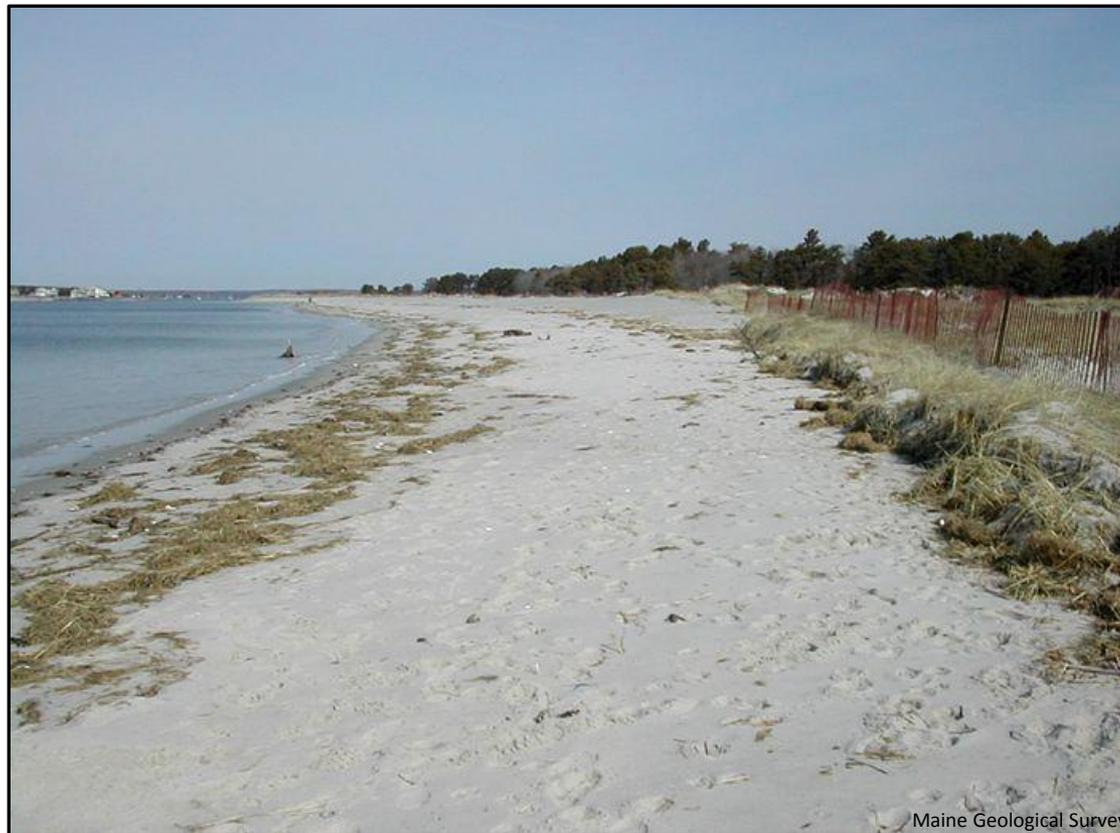
**Figure 15.** Photograph looking northwest near the southeast corner of Western Beach.

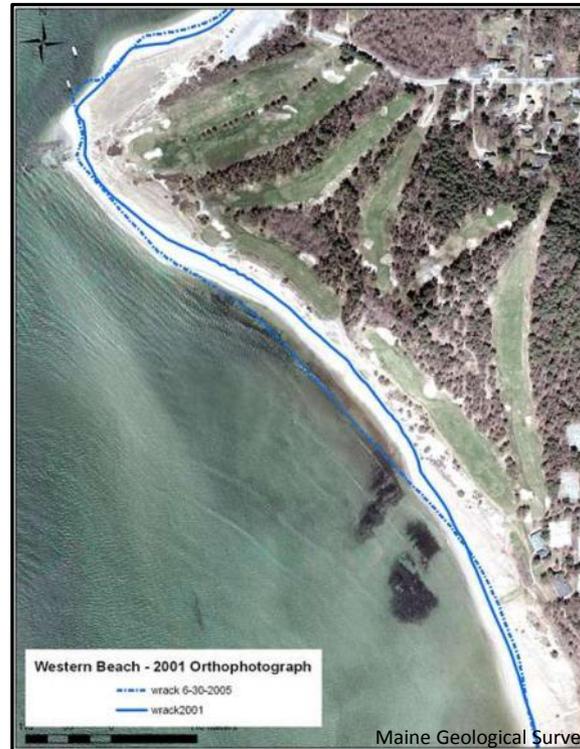
**Figure 16.** Aerial orthophotograph (2001) showing the position of the wrack line in 2001, and post-nourishment, as located in the field by MGS using RTK-GPS in late June, 2005

MGS was able to use this data within a Geographic Information System (GIS) to quantify the growth of the beach at Western Beach using the pre- and post-nourishment vegetation and wrack lines. Figure 16 shows the evolution of the wrack line from pre (2001) to post (June 2005) nourishment beach conditions and the dramatic increase in the dry beach, which went from approximately 69,000 square feet to over 335,000 square feet (an almost five-fold increase).

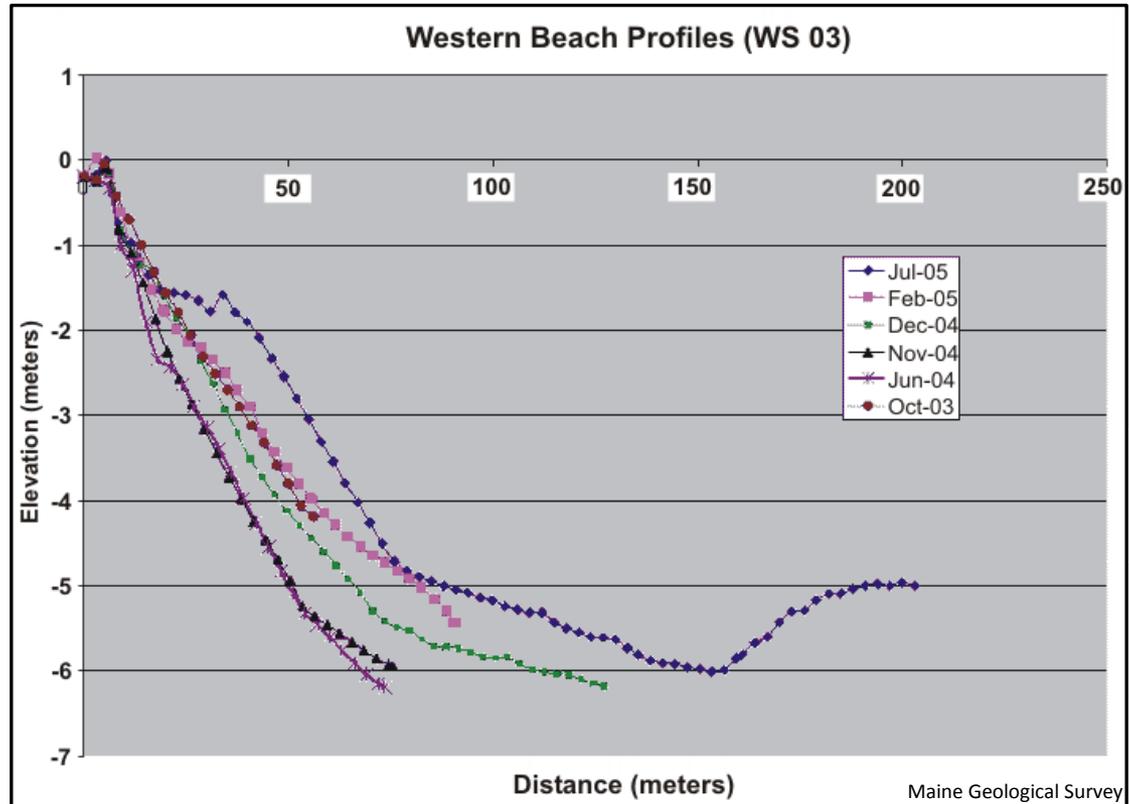
**Figure 17.** Figure showing the differences in pre- and post-beachfill beach profiles. Note the increase in both the elevation and width of the beach in July 2005

This resulted in an approximate 6-acre gain in the dry beach. Pre- and post-nourishment beach profiles, collected by volunteers in the Maine Beach Profiling Monitoring Project are shown in Figure 17. Note the increase in the height and width of the beach by July 2005.

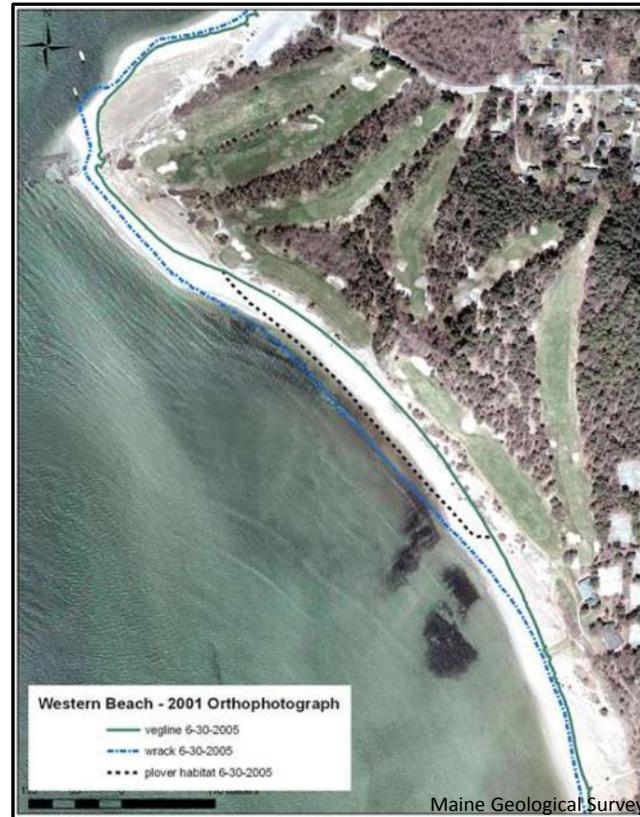
**Figure 18.** 2001 aerial orthophotograph with the field surveyed location of the vegetation line, wrack line, and fenced shorebird nesting area from June 2005.

The identified nesting areas subsequently were fenced off and MGS surveyed the location of the fenced area in June 2005. Approximately 134,000 square feet of the newly created beach (40%) was designated as nesting habitat (Figure 18).
