Hampton Beachfront and Storm Protection Management Plan

FINAL • APRIL 2011

Surveys & Engineering, Ltd.

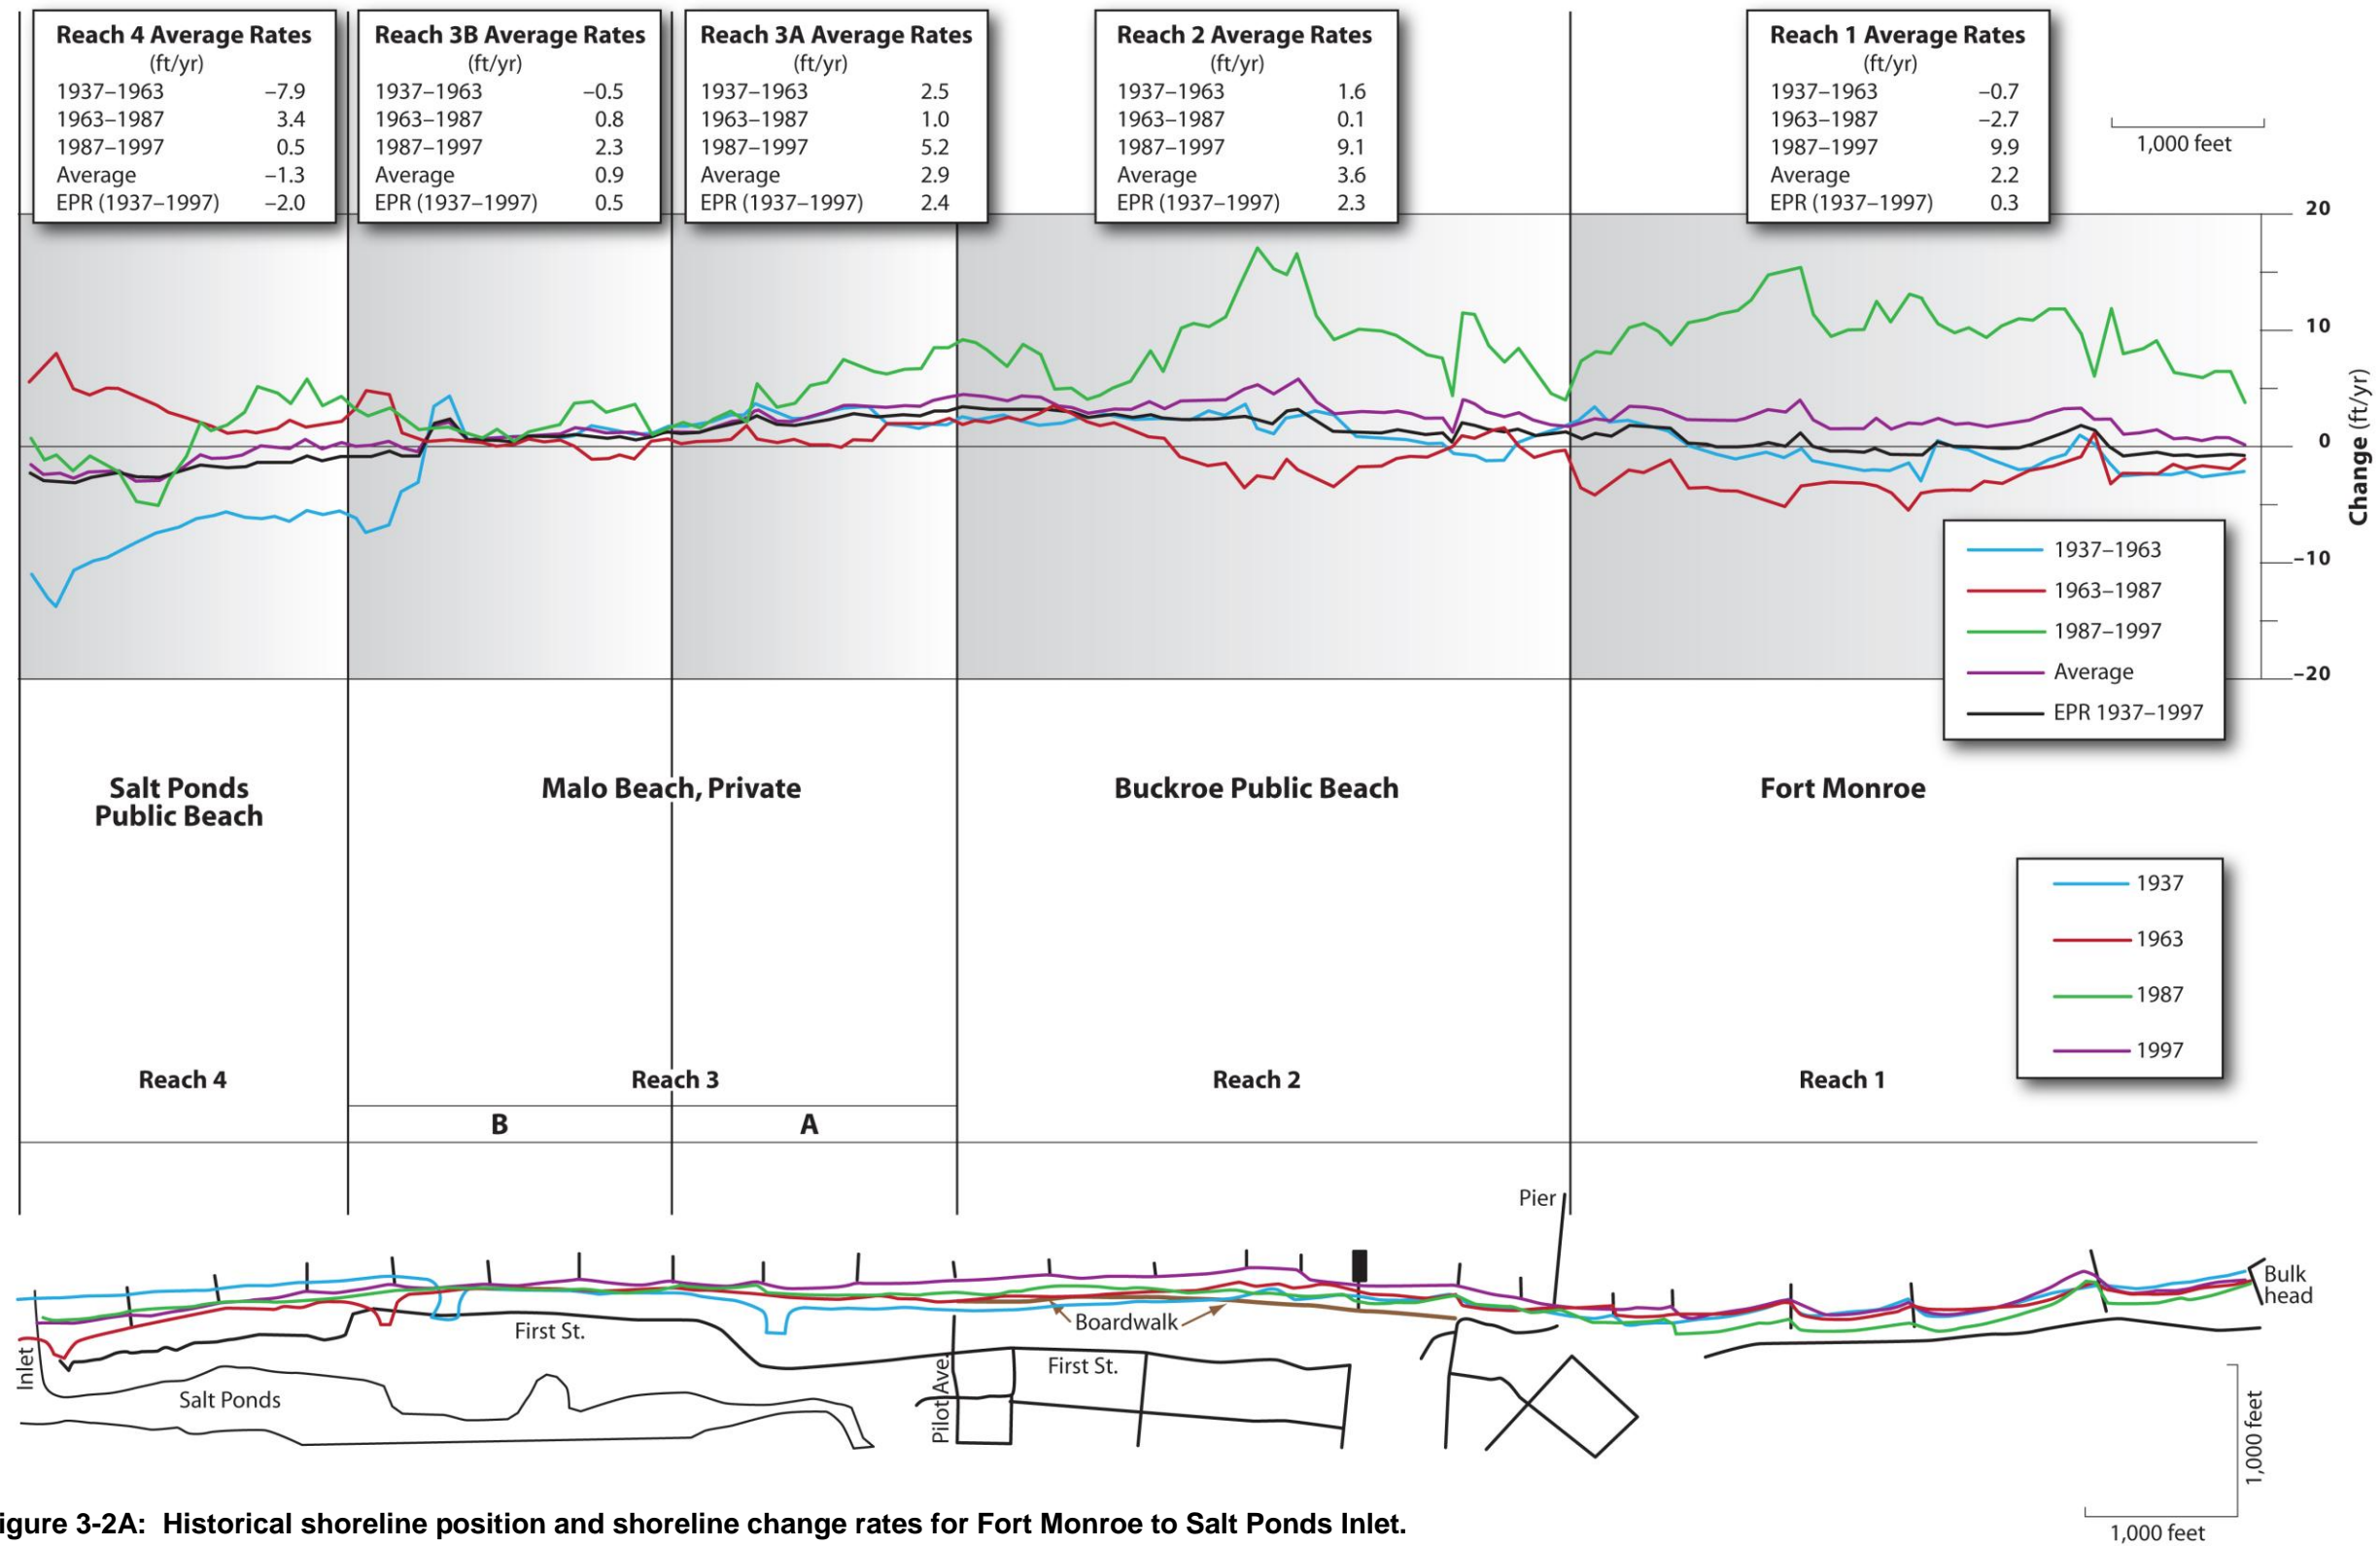
Figure 3-2A: Historical shoreline position and shoreline change rates for Fort Monroe to Salt Ponds Inlet.

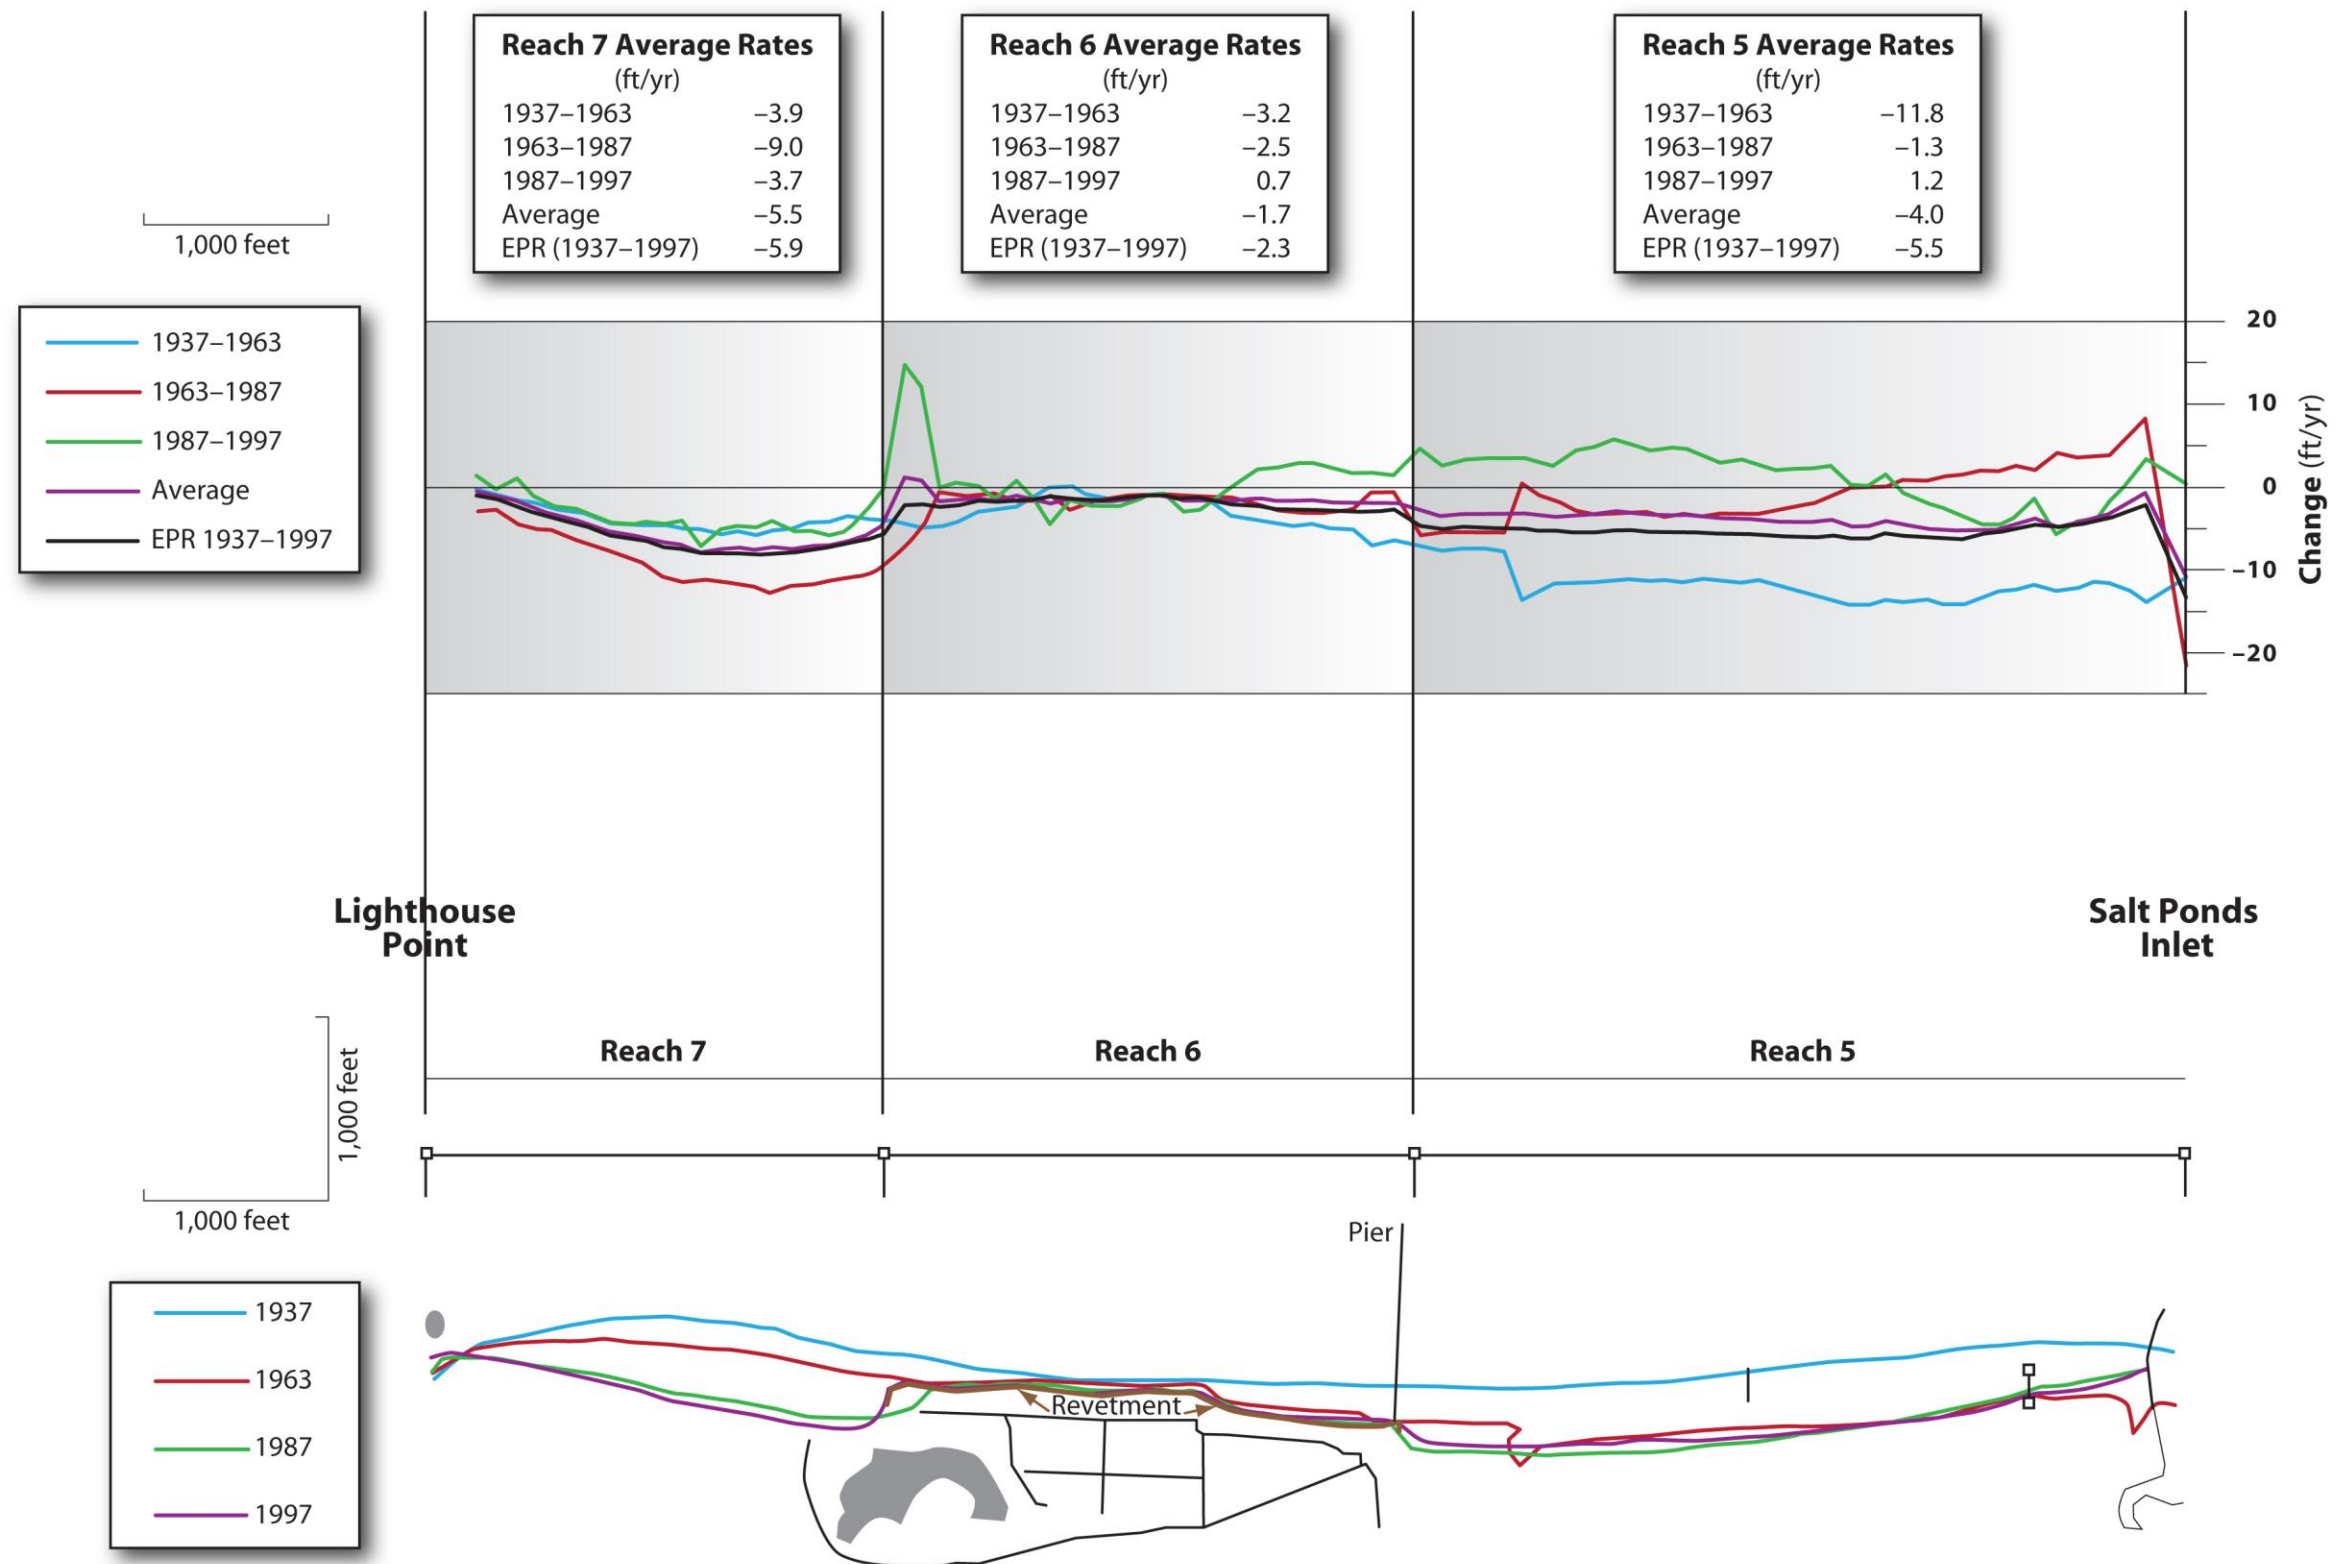
Figure 3-2B: Historical shoreline position and shoreline change rates for Salt Ponds Inlet to Lighthouse Point.

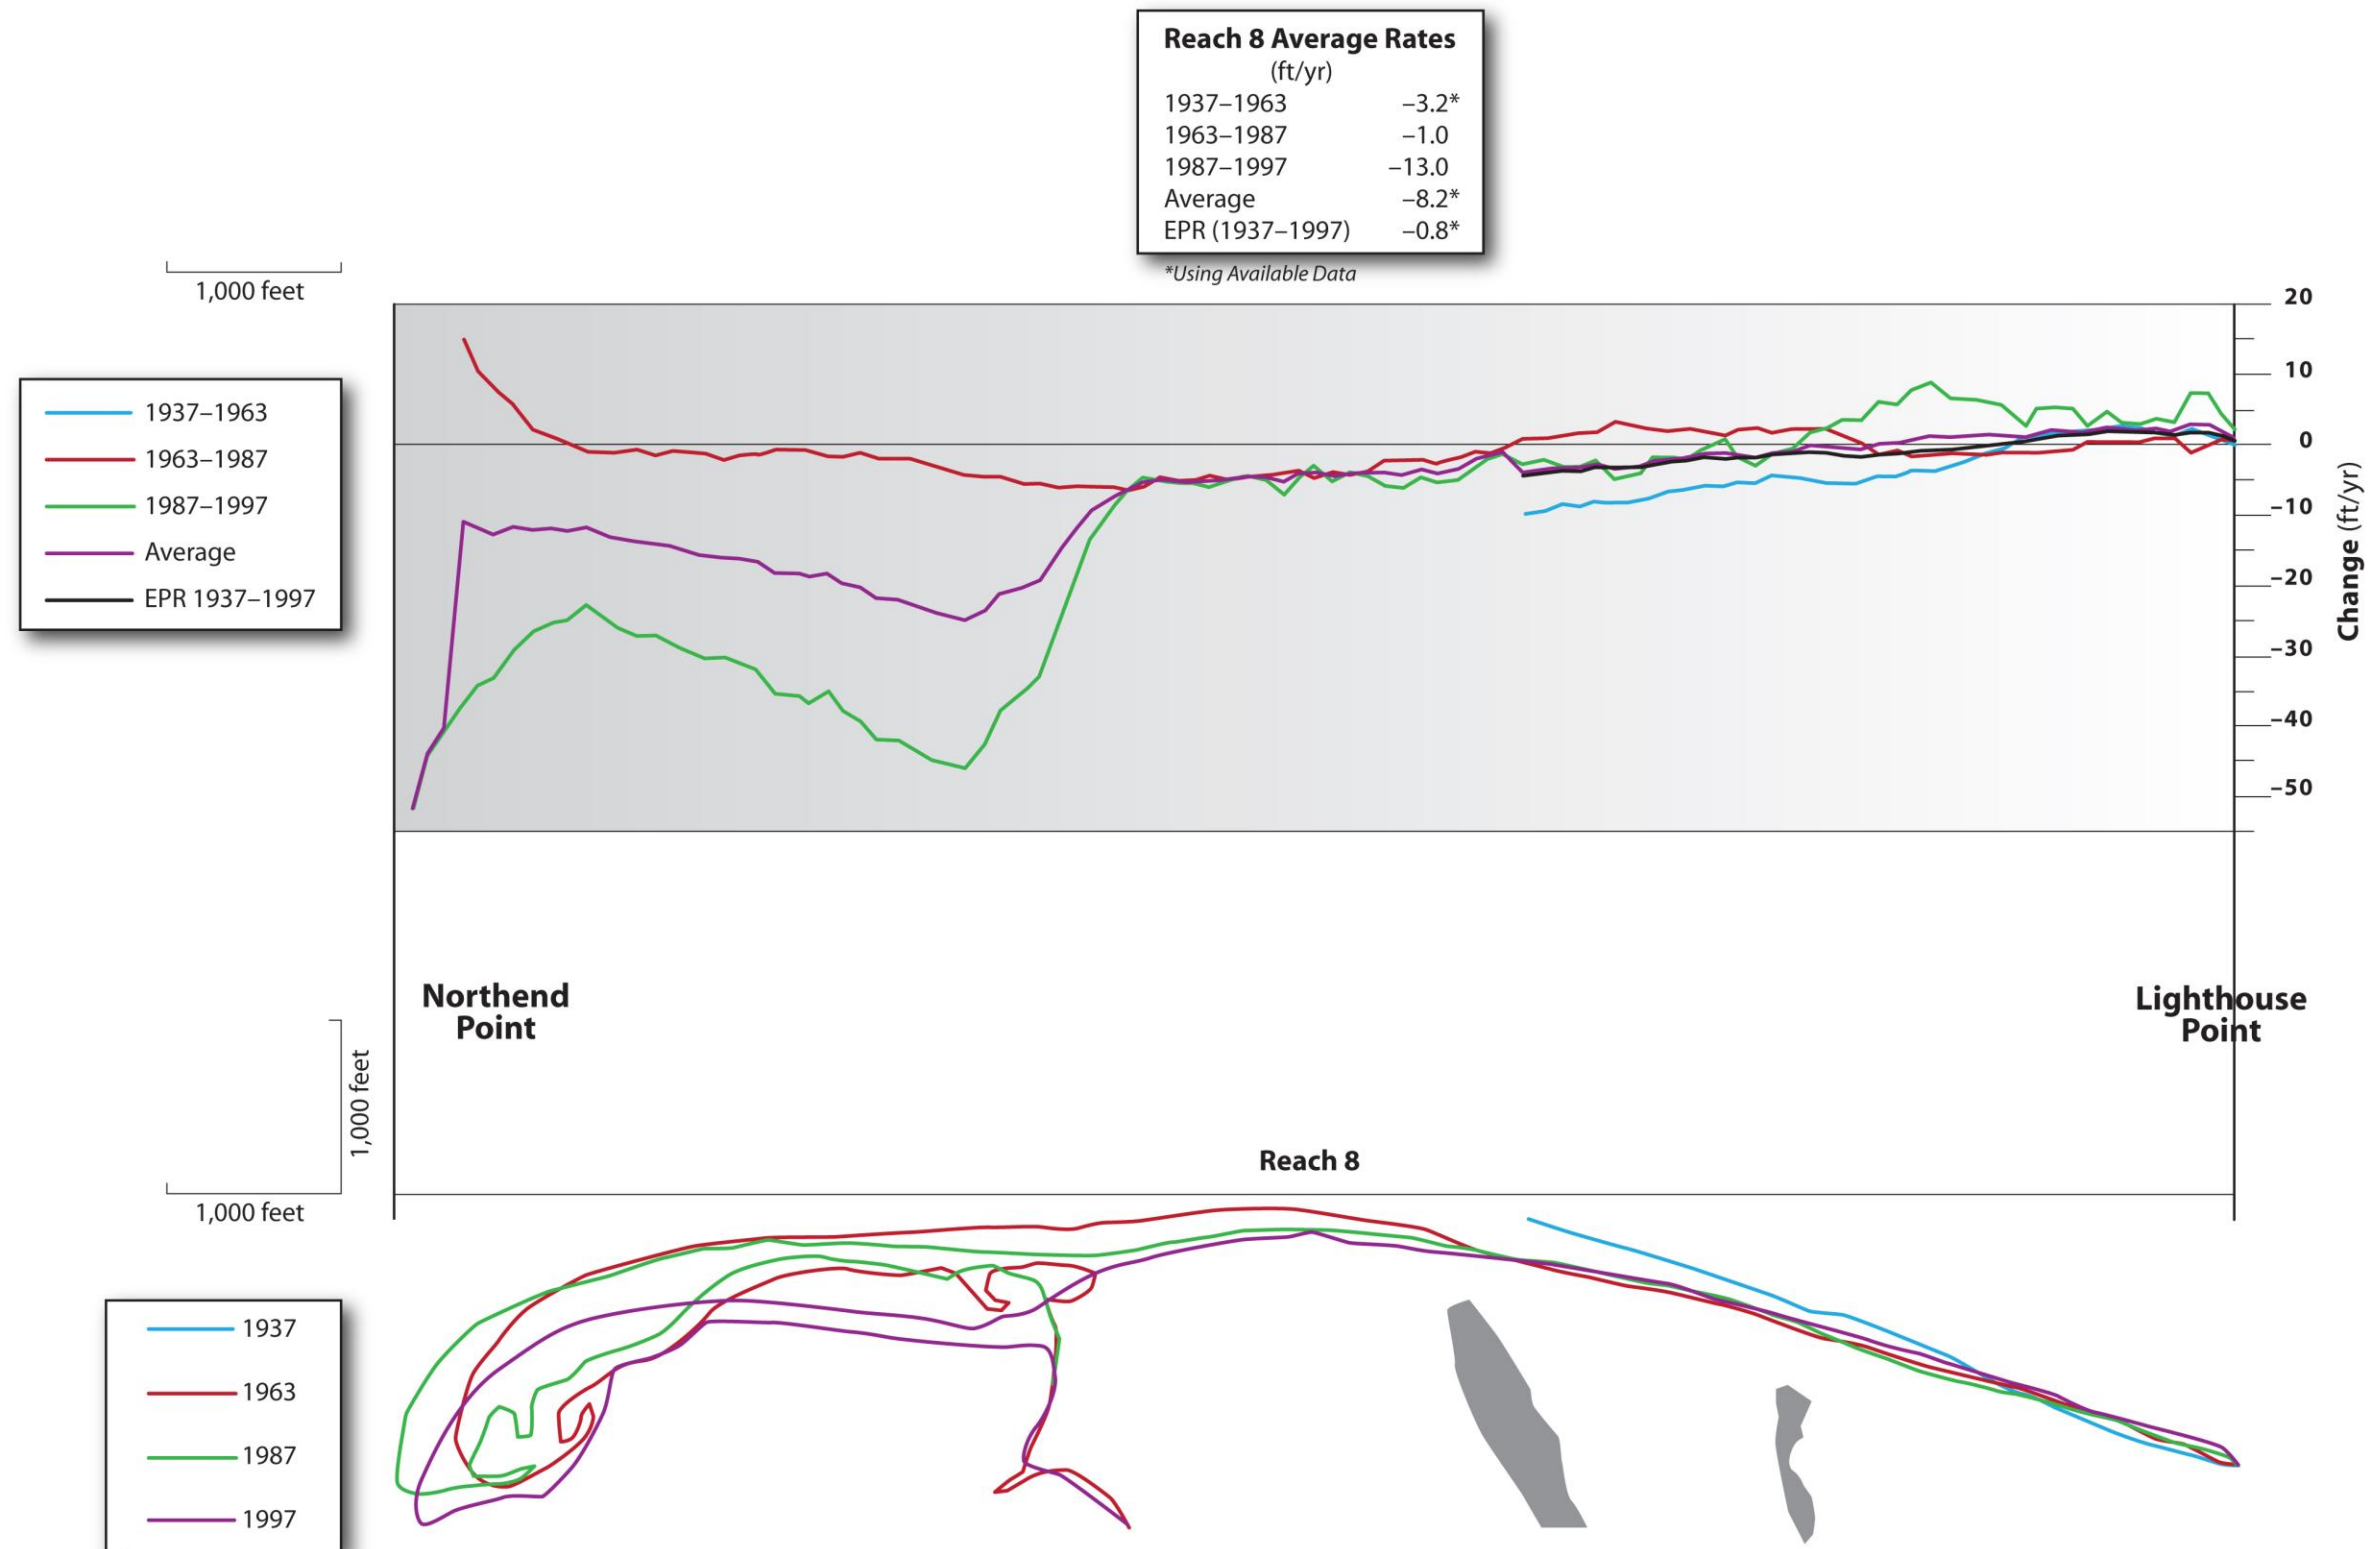
Figure 3-2C: Historical shoreline position and shoreline change rates for Lighthouse Point to Factory Point.

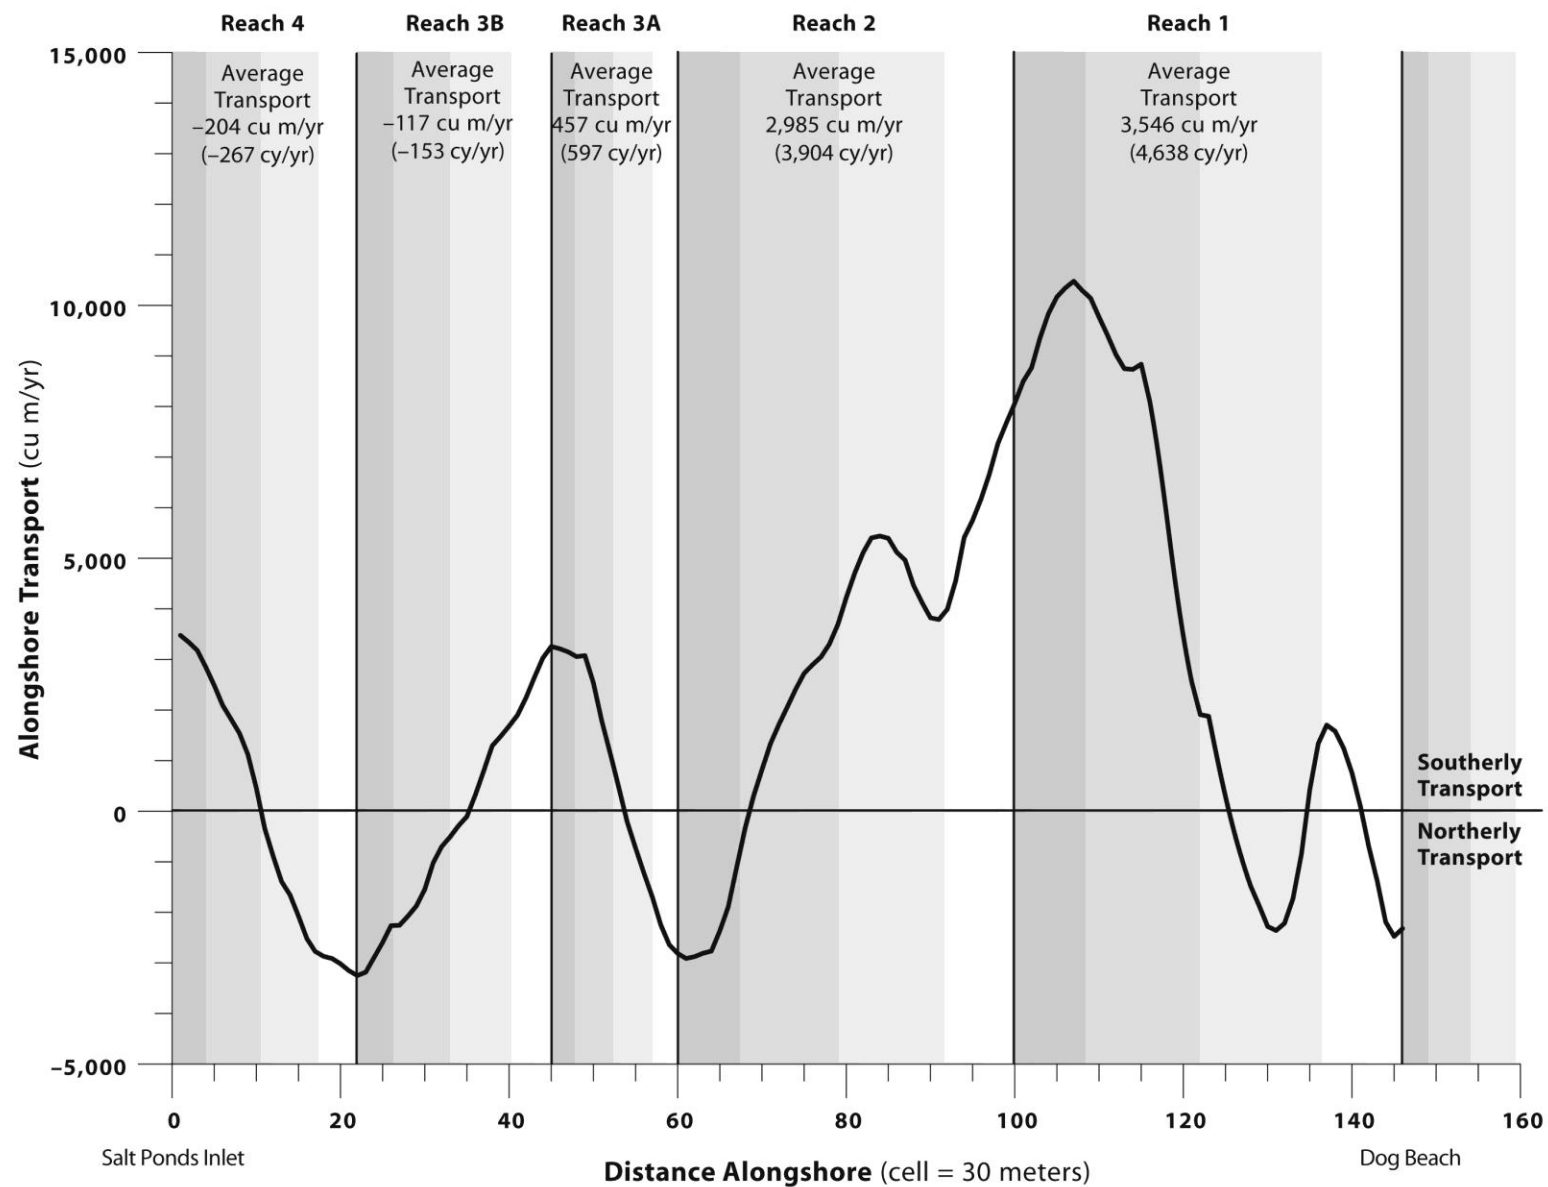
Figure 3-6A: Longshore transport potential for Reaches 1 to 4 (Fort Monroe to Salt Ponds Inlet).

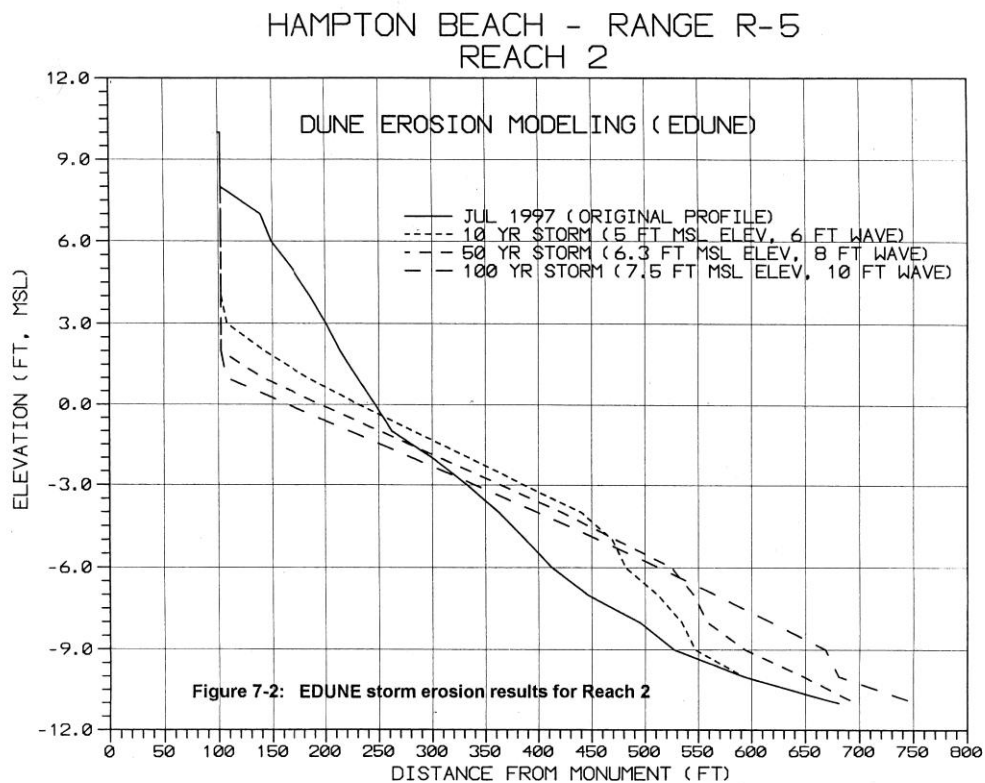
Figure 3-8: Dune erosion modeling results (EDUNE) for Reach 2 (Buckroe Beach).

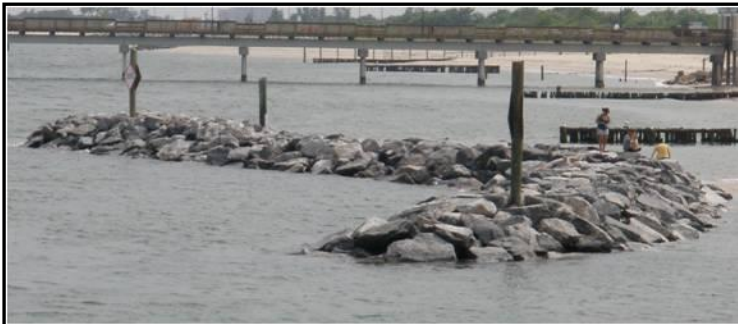
Figure 4-6: Cross-section and picture of a typical breakwater at Buckroe Beach.

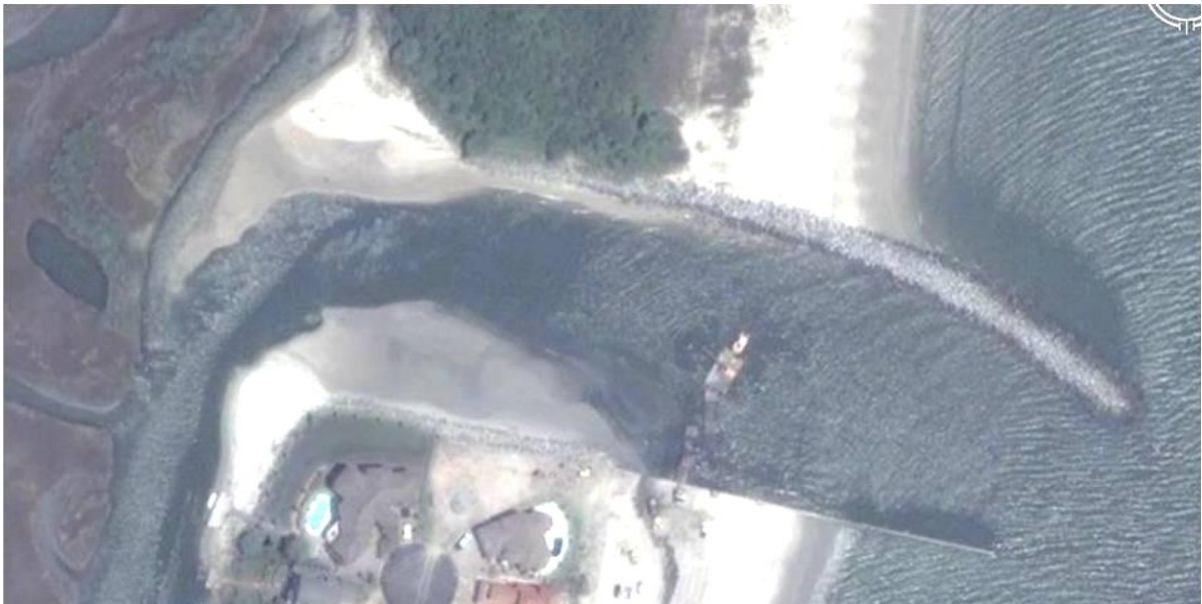
Figure 4-7: Stabilizing structures at Salt Ponds Inlet. The north structure is a rock jetty and the south structure is a sheetpile jetty. Note the shoaling inside the inlet.
