Study of Coastal Mangrove Forest Devastation and Channel Sedimentation: Community-based Solutions Koh Kong Province, Cambodia

INTERNATIONAL UNION FOR CONSERVATION OF NATURE (IUCN) – BUILDING COASTAL RESILIENCE

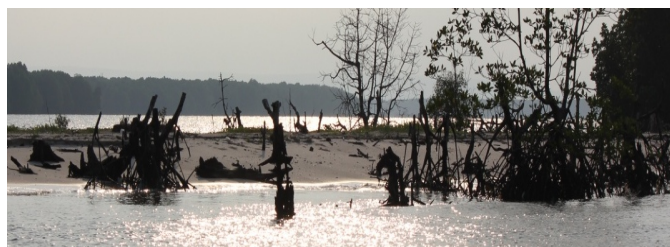
Figure 2: Dead trees that formerly thrived in the muddy mangrove environment prior to beach barrier migration.

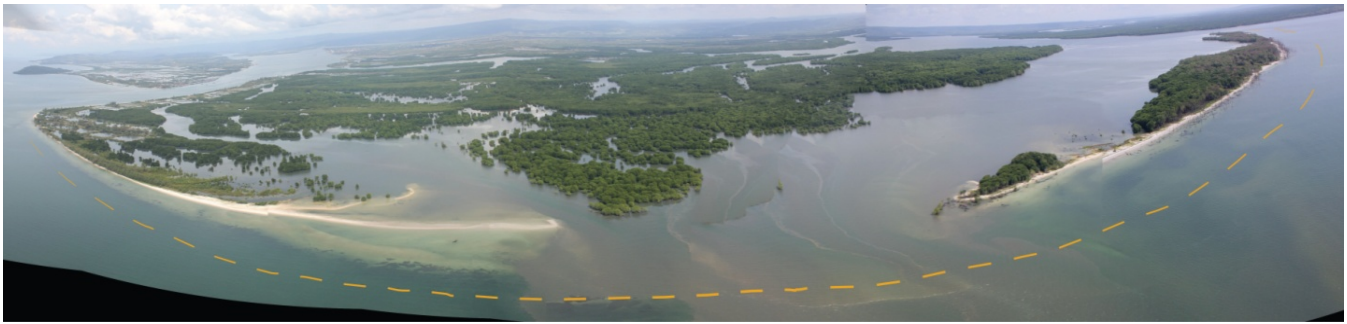
Figure 4: Aerial photograph of beach barrier captured 12 November 2012 by helicopter. The orange line represents the beach barrier location in 1994, during which time the beach was continuous without the current gap.

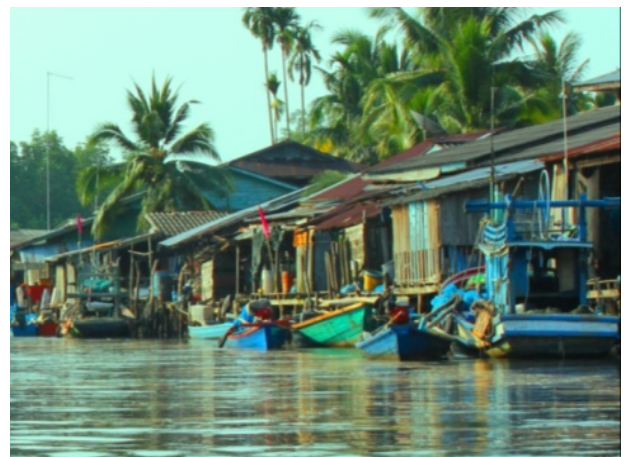
Figure 5: Koh Kapik channel. Due to infilling, dredging is planned and low-impact strategies should be used to minimize re-sedimentation.

contributes to and is harmed by the impacts of altered sediment transport dynamics. Sedimentation of silt over time in the Koh Kapik channel (Figure 5) has resulted in substantial infilling, which impairs the ability of the community to use boats to support their fishing livelihoods, access drinking water, and escape coastal hazards under recognizable climate change impacts. These problems will be temporarily resolved by dredging, which is planned.

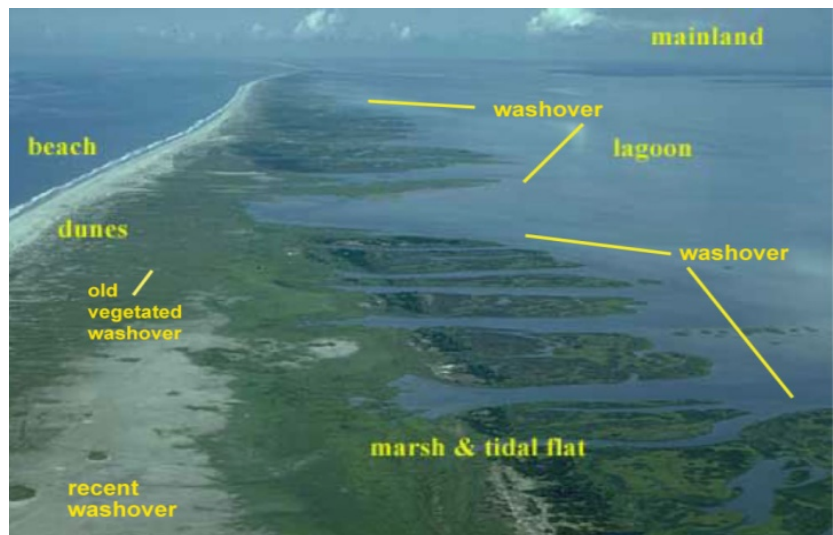
Figure 7: A typical sandy beach barrier (left) and associated features. Vegetation flourishes on the mainland side due to protection by the beach barrier.

Beaches are indicative of higher energy environments because sediment size is controlled by the intensity of wave energy by which the sediment is transported. Since mangroves are found between the mainland and ocean, where wave energy is high, beach barriers are critical for the protection of large mangroves areas (Figure 7).

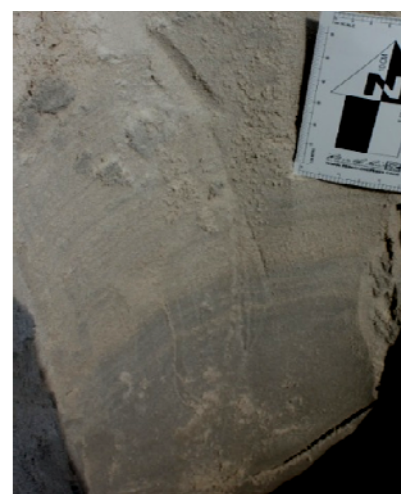
Figure 8: Sedimentary sequences contain millimeter-scale laminations, decreasing in silt content upwards, which is indicative of progressive landward beach migration.

Layers of sand and silt were exposed by digging during this study on the beach barrier. Consistent millimeter-scale parallel layering, with decreasing silt content upwards, indicated progressive beach barrier migration (Figure 8). Preliminary interviews indicated that single storm effects may have caused large scale migration. However, the sedimentary analyses indicate that frequent storms, even mild storms, cause migration. The layering was similar at all locations, suggesting that the direction of landward movement is generally consistent along the length of the beach barrier.

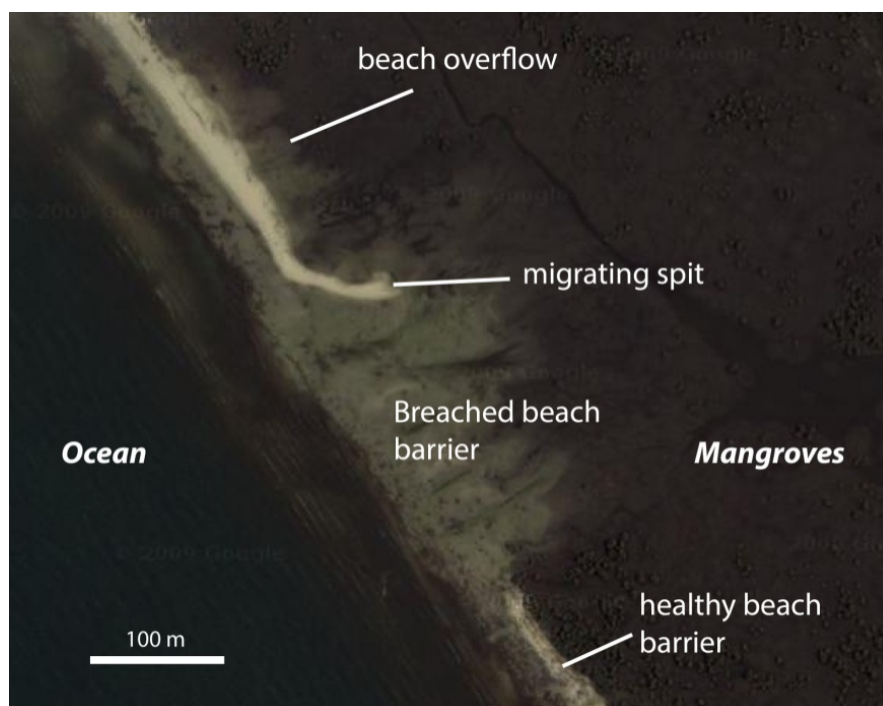
Figure 14: Aerial photograph of the Northern Priority zones in 2001, demonstrating the impacts of beach barrier migration and breaching (Google Earth Pro). Note the cloudy color of the sand suffocating mangroves.

Some beach barrier features are more susceptible to experiencing overflow, breaching, and migration. For example, the beach in the Northern Priority zone without vegetation (Figure 14) is not able to build up high elevation to prevent overflow. The down-current, growing edge of the beach barrier (known as a *spit*) faces more intense wave energy and therefore migrates more rapidly than other locations. The breached beach barrier has the largest impact on mangroves because the sand has been easily washed landward, suffocating mangrove tree roots. Supporting stable beach barriers with vegetation will prevent these vulnerable features from forming.

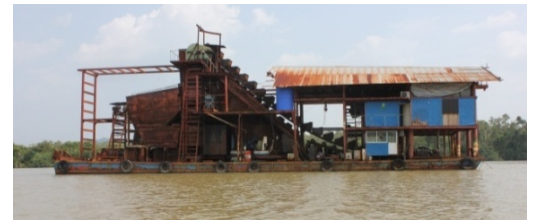
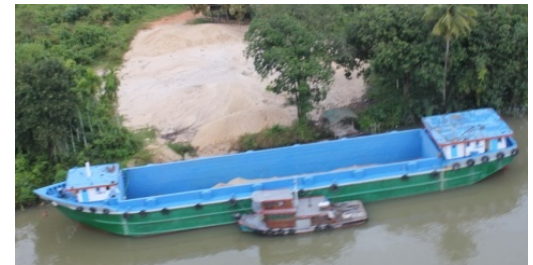
Figure 15: Photograph of sand mining vessel (top) and transport ship (bottom, from helicopter) 3 km south and 0.5 km south of Tatai commune, respectively.

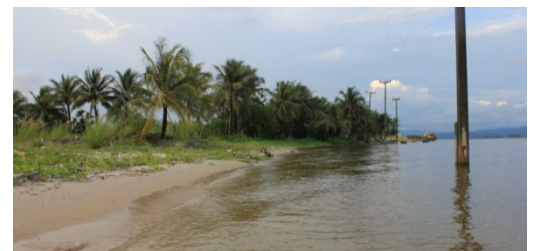
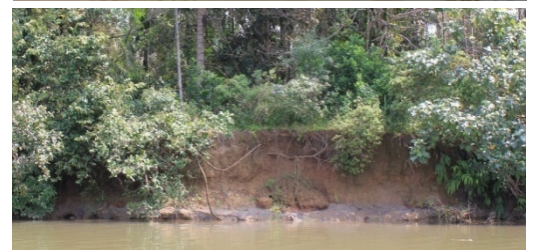
Figure 16: Estuary erosion (top) left power lines in the water 2 km west of Koh Kong city. River bank collapse 1 km north of KPWS in the sand mining region (bottom).

- Constant river bank erosion along the length of both rivers, reaching up to 100 m of river widening (Figure 16)
- River bank erosion caused the loss of hundreds of trees and loss of homes
- Cloudy water downstream of sand dredging, killing fish
- The tip of river island eroded away, due to sand starvation
- Death of a fisherman when his small boat was crushed by a sand mining vessel in the night
- Fish habitat loss
- Reduction in fish catches by 70 - 90%
- Displaced families from local company purchasing their land
- Loud noise from sand pumping scares fish away
- Pollution from mining vessels

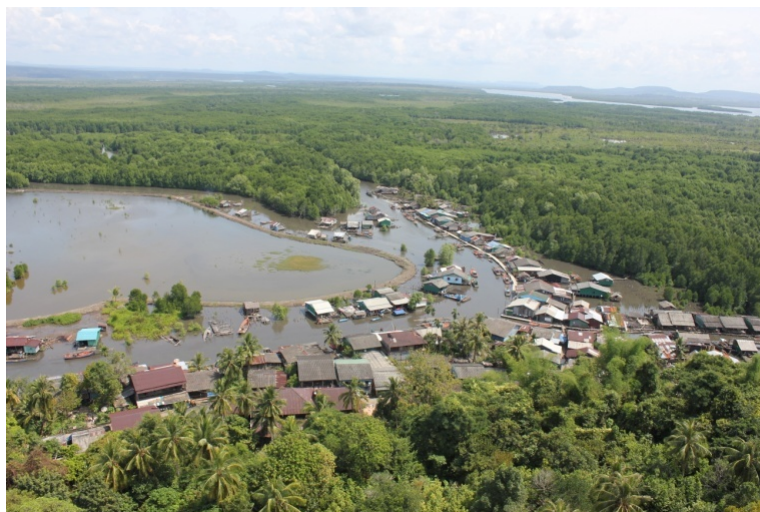
Figure 18: Koh Kapik commune. The channel wraps around the abandoned shrimp farm, which had a dike built around it in 2012 (left).

Disturbances in mangroves may prevent full soil stabilization, accelerating the transport of sediment into channels, thus causing rapid channel infilling. The abandoned shrimp farm adjacent to Koh Kapik commune left high volumes of mobile sediment that has contributed to the shallow depth of the eastern side of the channel, although a barrier was built in 2012 to reduce further sediment flow (Figure 18).

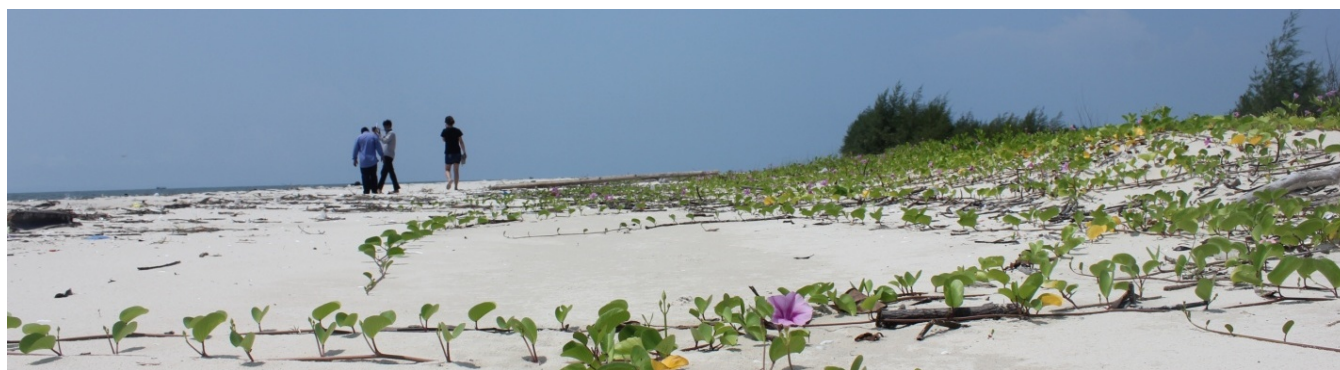
Figure 19: Vegetation on the beach barrier (the Beach Morning Glory *Ipomoea pes-caprae*, *Ipomoea biloba*), secures and traps sand, building up the height of the beach barrier (right).

Allowing the beach barrier to grow vertically will prevent further beach barrier breaches during storms. The beach barrier will additionally develop more mass this way, adding strength against landward push during storms. Vegetation traps sand on higher beach elevations when large waves and wind push sand landwards (Figure 19). Engineered structures on the coast would, in this way, be counterproductive because they would prevent this critical sediment movement and beach development.

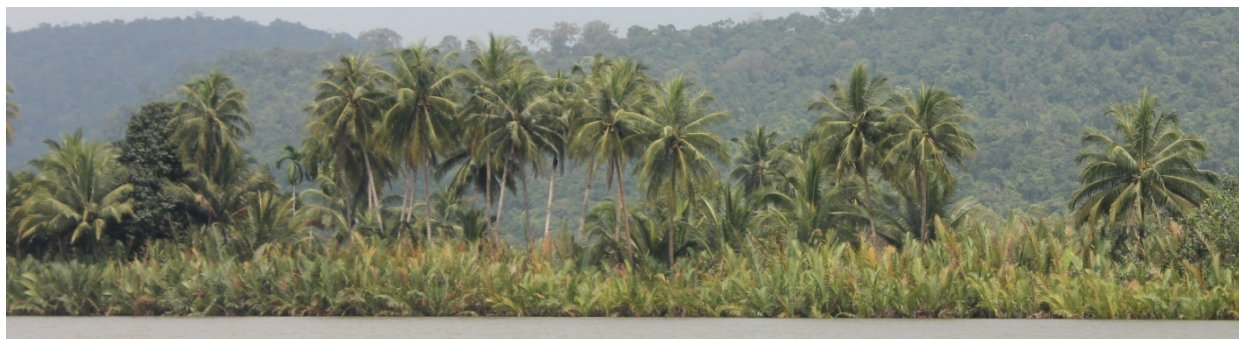
Figure 20: Water coconut trees (*Nypa fruticans*, fringing Tatai River) have been planted by locals to buffer shorelines from erosion and bank collapse.

The communes on the Tatai River recognize the value of riparian water coconut trees (Figure 20) in the prevention of river bank erosion. These trees grow naturally and the communities also plant the trees in target locations to protect their shorelines. They do not appear to be invasive, and protect shorelines particularly well where the water level is relatively shallow.

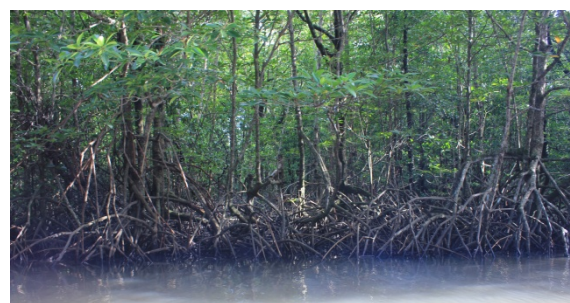
Figure 23: The root systems of *Rhizophora* species along Koh Kapik stream require exposure to oxygen for survival and should therefore have minimal root height covered by mud from dredging.

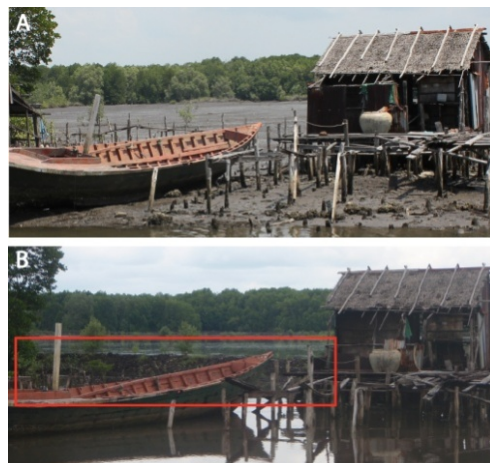
Figure 24: Koh Kapik channel, before (A) and after (B) dike construction (red box). The dike has successfully prevented loose sediment from the abandoned shrimp farm (background) from resedimenting in the channel.

Sediment containment constructions will be useful for areas of loose sediment that are created by the dredging process. They have already been built by the commune to prevent sediment of the abandoned shrimp farm from entering the channel (Figure 24).
