Impacts of Hurricane Charley
on the Southwest Florida Coastline
Focusing on Lee County

Prepared For: Florida Shore and Beach Preservation Association
National Conference on Beach Preservation Technology
February 2-4, 2005

Presented by: Robert Neal, P.E., Lee County Division of Natural Resources
Coastal Engineer
Lee County Division of Natural Resources
1500 Monroe Street
Fort Myers, FL 33901

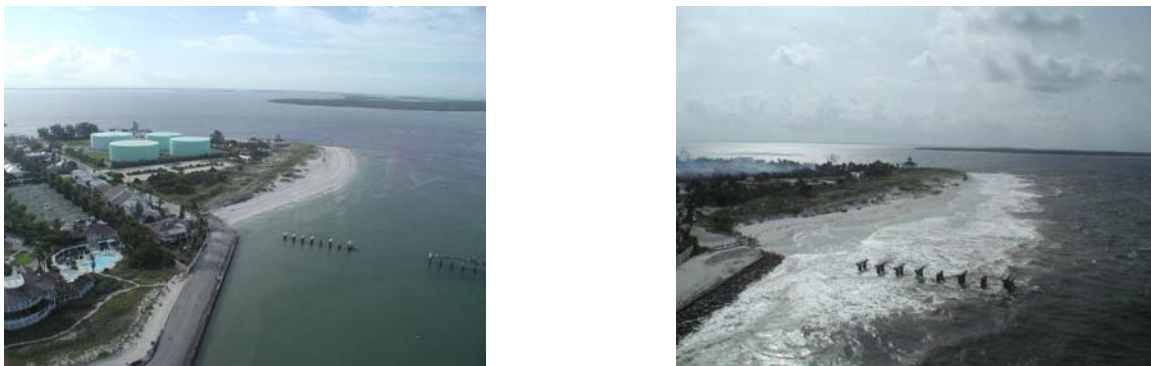
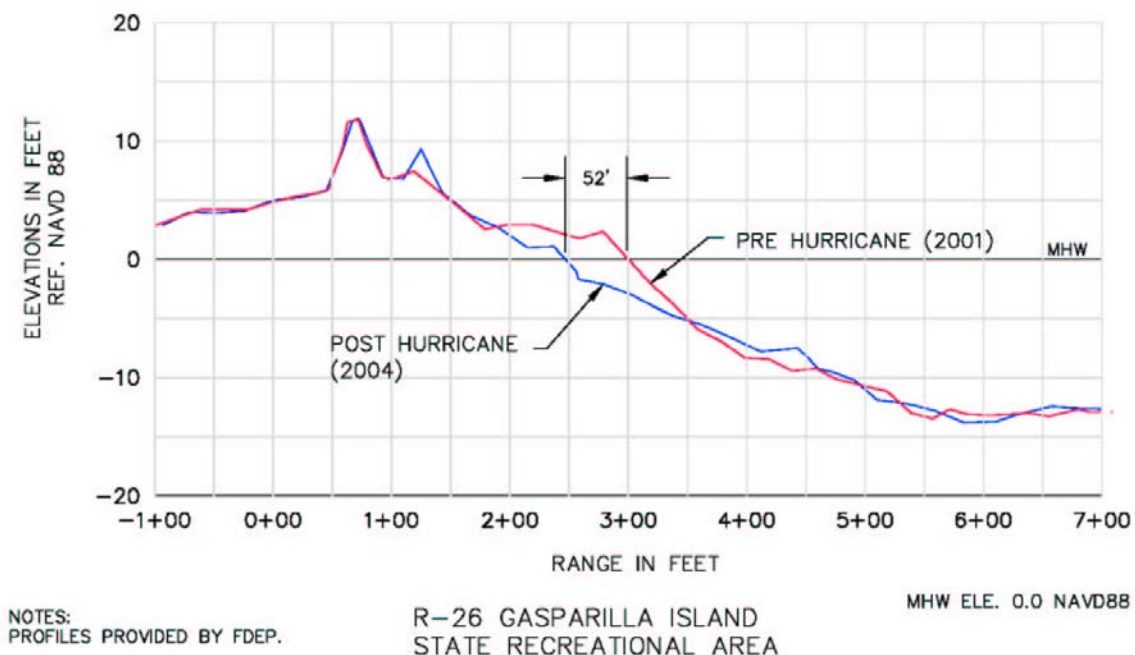
Figure 1 – Gasparilla Island Pre & Post Storm Photographs & Profiles

The southern tip of the island experienced the largest shoreline loss. Approximately 53 feet of shoreline was lost at R-26, located immediately north of Boca Grande Pass in the Gasparilla Island State Recreational Area. Figure 1 shows pre and post storm photographs and profiles, respectively. The figures show 52 feet of shoreline was lost at the Mean High Water line (MHW), but the dune maintained its position. Thus, incoming wave energy was restricted from impacting upland properties.

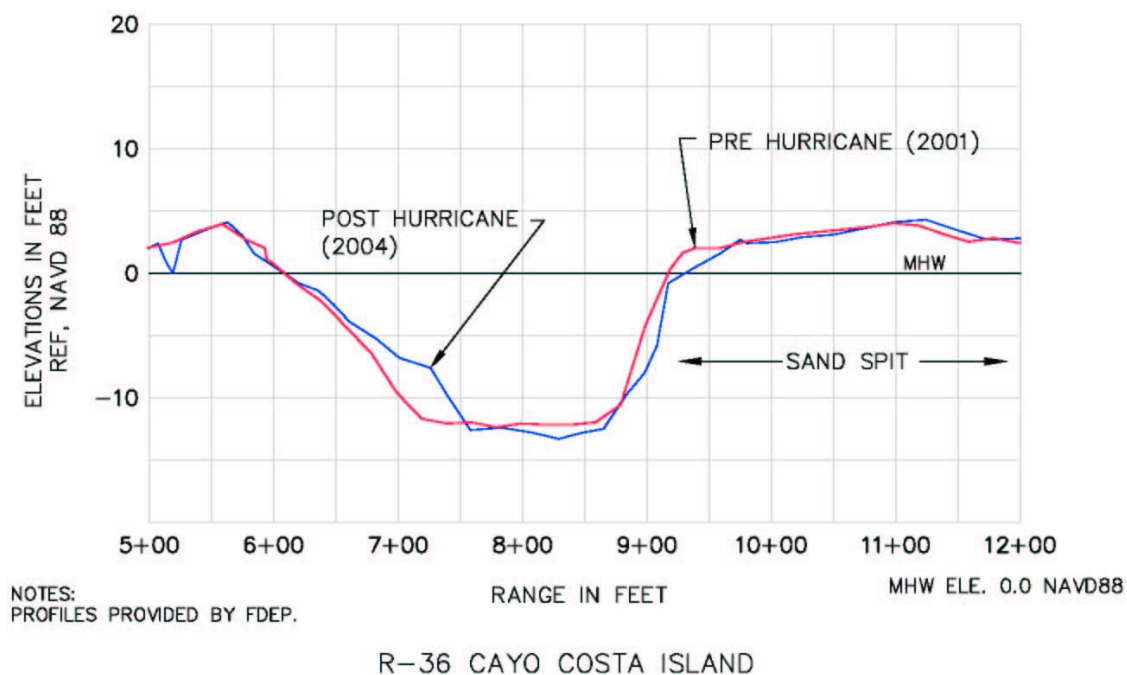
Figure 2 – Pre & Post Storm Profiles for Cayo Costa

Hurricane Charley made landfall on Cayo Costa producing an average of 14 feet of shoreline recession. A sand spit extending from R-32 to R-47 provided protection for the shoreline. Figure 2 shows typical pre- and post storm profiles for the area protected by the spit. As shown, the natural shoreline at approximate range 6+00 is protected from wave action by the sand spit present between range 9+00 to 12+00.

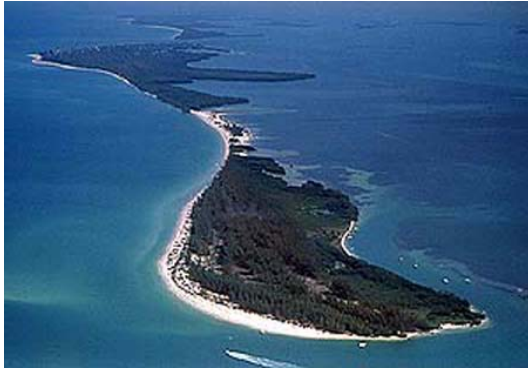
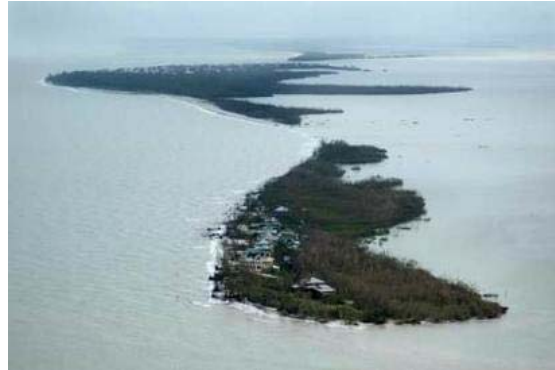
Figure 3 – Pre and Post Storm Photographs of North Captiva Island

North Captiva lost an average of 28 feet of shoreline, with the most significant impact occurring in the undeveloped region near R-78. The overwash from Hurricane Charley

created a 1,600 foot breach in the island, locally referred to as Charley's Cut. This area is part of the geopark, and is managed by the State of Florida Division of Recreation and Parks. Construction projects that may alter the natural existence of the park are discouraged. Thus, with the island's history of overwashing, dating back to Tropical Storm Gabrielle in 2001, the breach was not unexpected. Figure 3 shows pre and post storm photographs of the island.

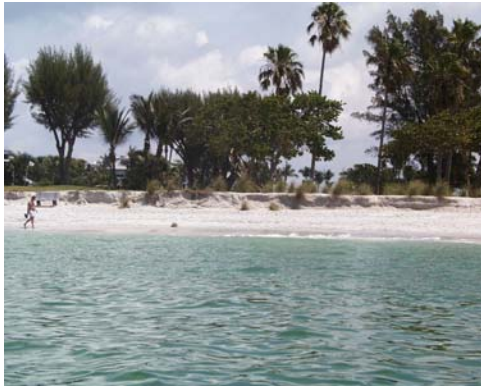
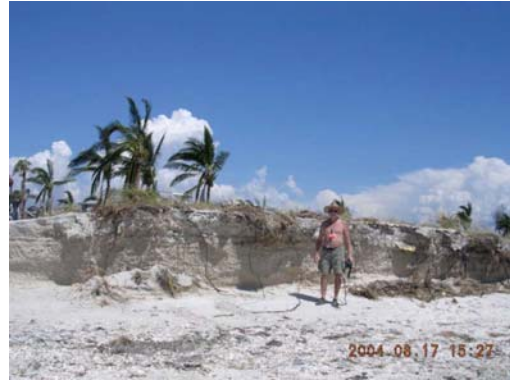
Figure 4 – Pre and Post Storm Photographs of Captiva Island

The island lost an average of 13 feet of shoreline, with the majority occurring at the southern end. Escarpments existing prior to Hurricane Charley of 2 to 3 feet were increased to 5 or 6 feet during the storm. Storm surge on Captiva was recorded as high as 8 feet and 118,000 cubic yards of material were lost (CPE, 2004). Figure 4 below shows the escarpment formation on the north end of the island pre- and post storm.

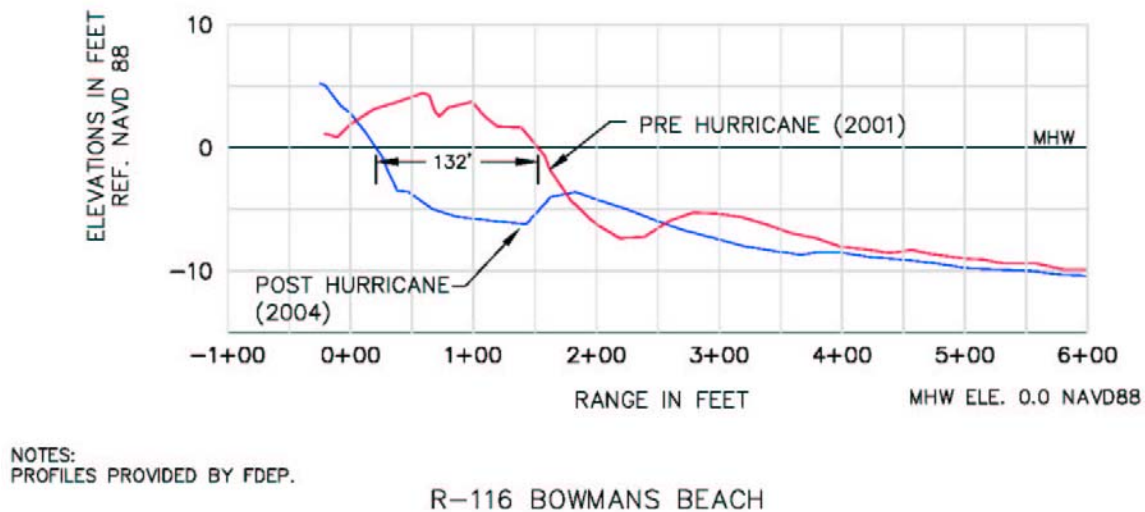
Figure 5– Shoreline Loss at Bowman's Beach

Sanibel's average shoreline loss was approximately 7 feet. Storm surge levels also reached 7 feet. Although the average shoreline loss appears minimal, portions of Sanibel lost more than 100 feet. The largest impact occurred in Bowman's Beach, a county park located at R-118 to R-115. Figure 5 below shows the loss at R-116 reaching 132 feet. This area does not contain major upland structures, but the erosion experienced reinforces the potential for devastation during a storm event.

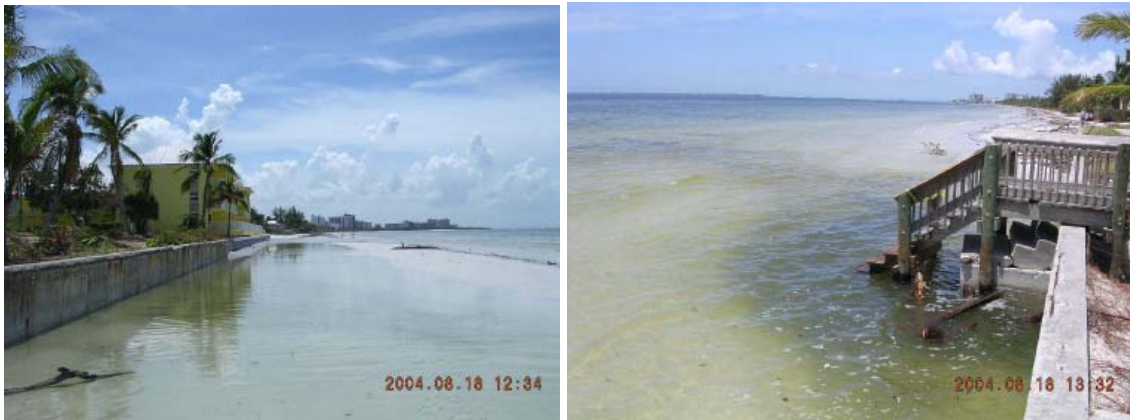
Figure 6 – Scour at Coastal Structures on Estero Island

A sand spit that has migrated from the north protects the southern tip of Estero Island. Seawalls and rock revetments protect many other areas. Figure 6 below shows significant scour occurring at the base of these armaments. Without future maintenance, the wave action may undermine the structures and cause them to fail.

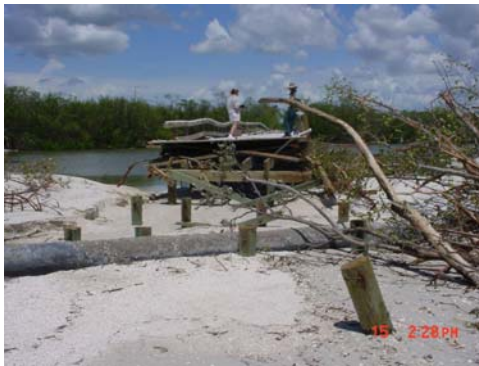
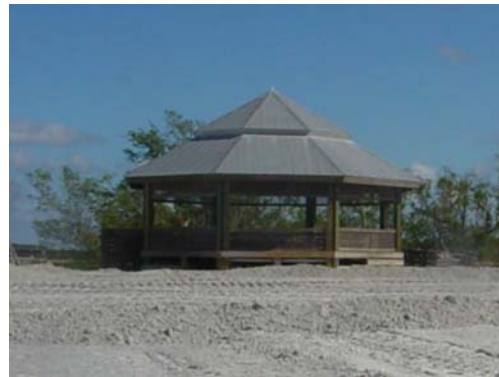
Figure 7 – Post Storm Photograph of Pedestrian Bridge at Lovers Key

Lovers Key provides a viable example of the storm protection provided by a healthy beach. A restoration project was in progress during Hurricane Charley. The impact from the storm resulted in an average shoreline loss of 58 feet. Although this may be a significant loss, the shoreline that had been nourished substantially buffered the incoming wave energy as opposed to the non-nourished shoreline. Figure 7 below shows a pedestrian bridge and pavilion that exist in close proximity of each other. The beach in

front of the pavilion received nourishment prior to the storm, while the beach fronting the bridge did not. As seen in the photographs, the bridge suffered major wave damage while the pavilion was not impacted. The pavilion did incur damage from construction equipment, but the storm did not directly impact the structure. The varying damage to structures on nourished and non-nourished shorelines serve as a visible indication of the benefit provided by nourished beaches.

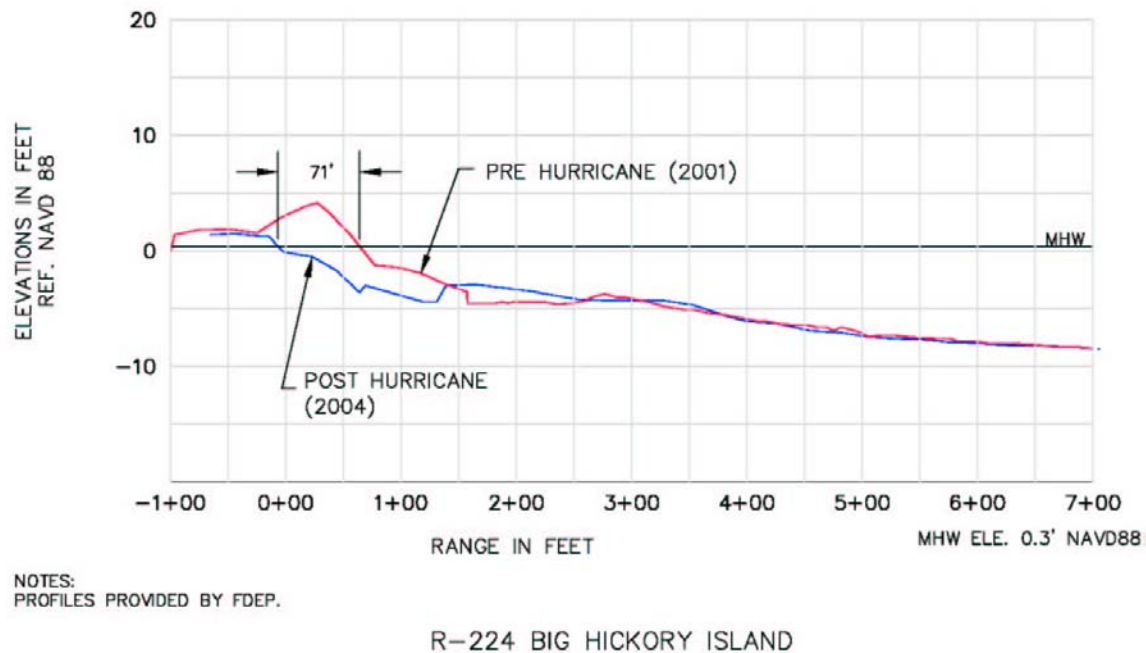
Figure 8 – Pre and Post Storm Profile of Big Hickory Island

The shoreline however, suffered major beach and dune erosion. Losses averaged 91 feet for the island. Figure 8 below shows a typical profile where the dune was completely washed out and 71 feet of shoreline was lost. A sand bar is also evident in the figure. This bar may represent the shorelines natural recovery as it migrates back to land. The recovery process is expected to provide partial restoration, however full recovery is not anticipated without nourishment.
