Hurricane Dennis

Before and After Photo Comparisons: Santa Rosa Island, FL

On Tuesday July 12, 2005, scientists from the U.S. Geological Survey (USGS) conducted an aerial photographic survey of Santa Rosa Island, Florida that was impacted by Hurricane Dennis. The photographs have been compared to pre-Dennis photographs taken by USGS to illustrate extreme coastal change.

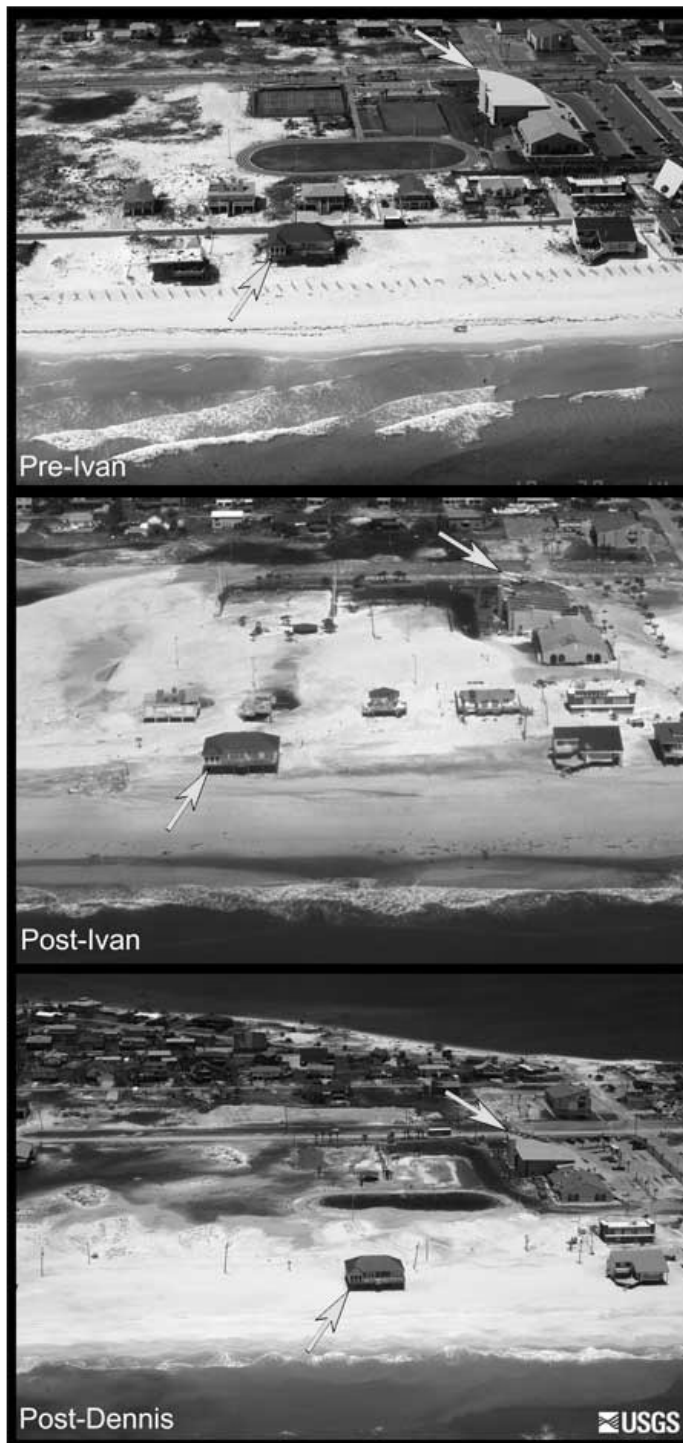
Overwash, Pensacola Beach, FL: Overwash during both Hurricane Ivan and Hurricane Dennis extends landward of the Gulf-front road, but only Ivan overwash deposits reach the next road landward. (Note: Some of the houses present after Ivan but missing after Dennis were likely condemned and demolished sometime between the two storms.) [\[larger version\]](#)

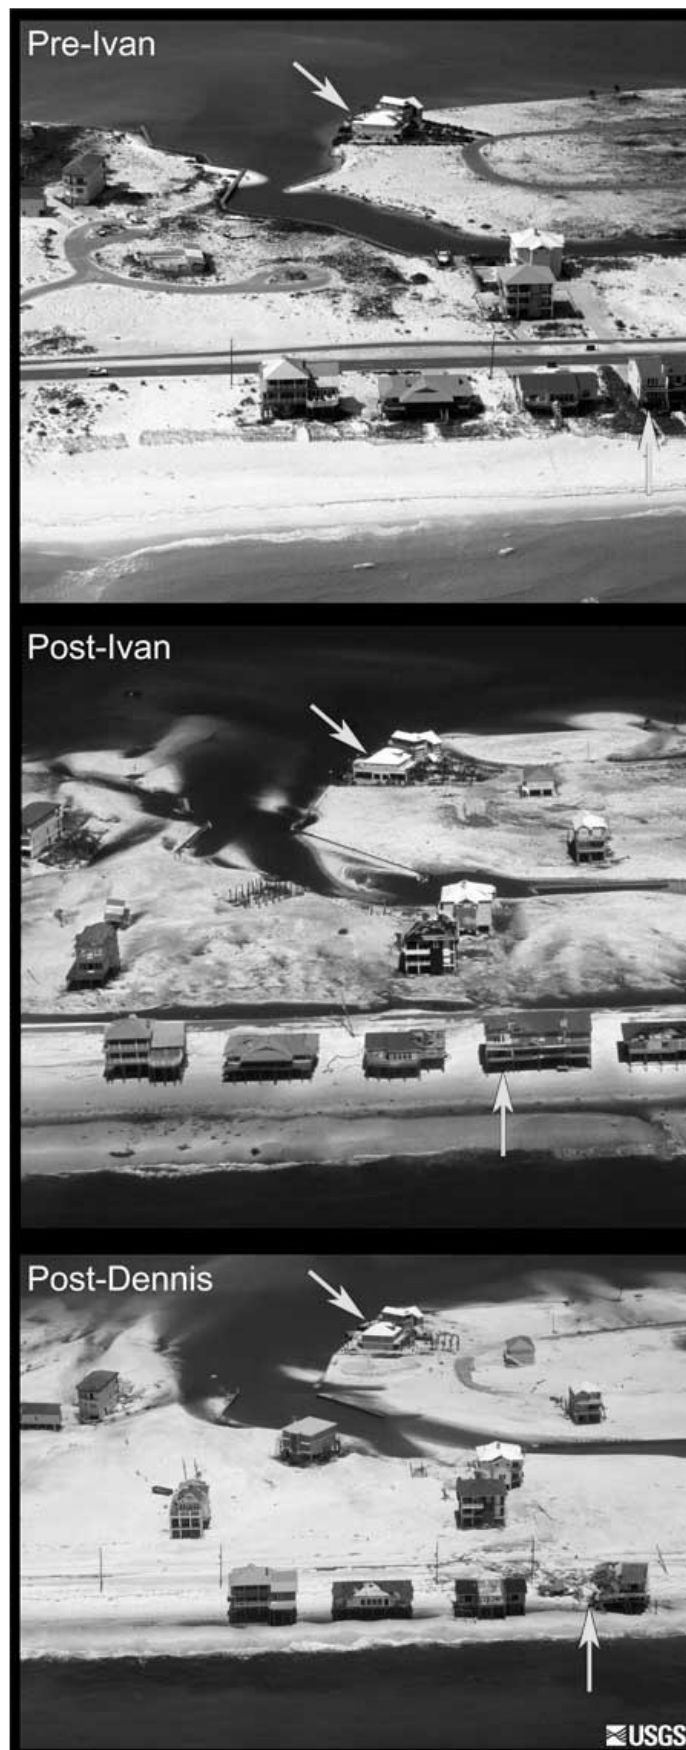
Building Damage and Overwash, Navarre Beach, FL: Overwash deposits resulting from both Hurricane Ivan and Hurricane Dennis cover the main road with sand and extend landward into the back bay. Note the bottom right arrow showing where one half of a house is missing following Dennis. [[larger version](#)]

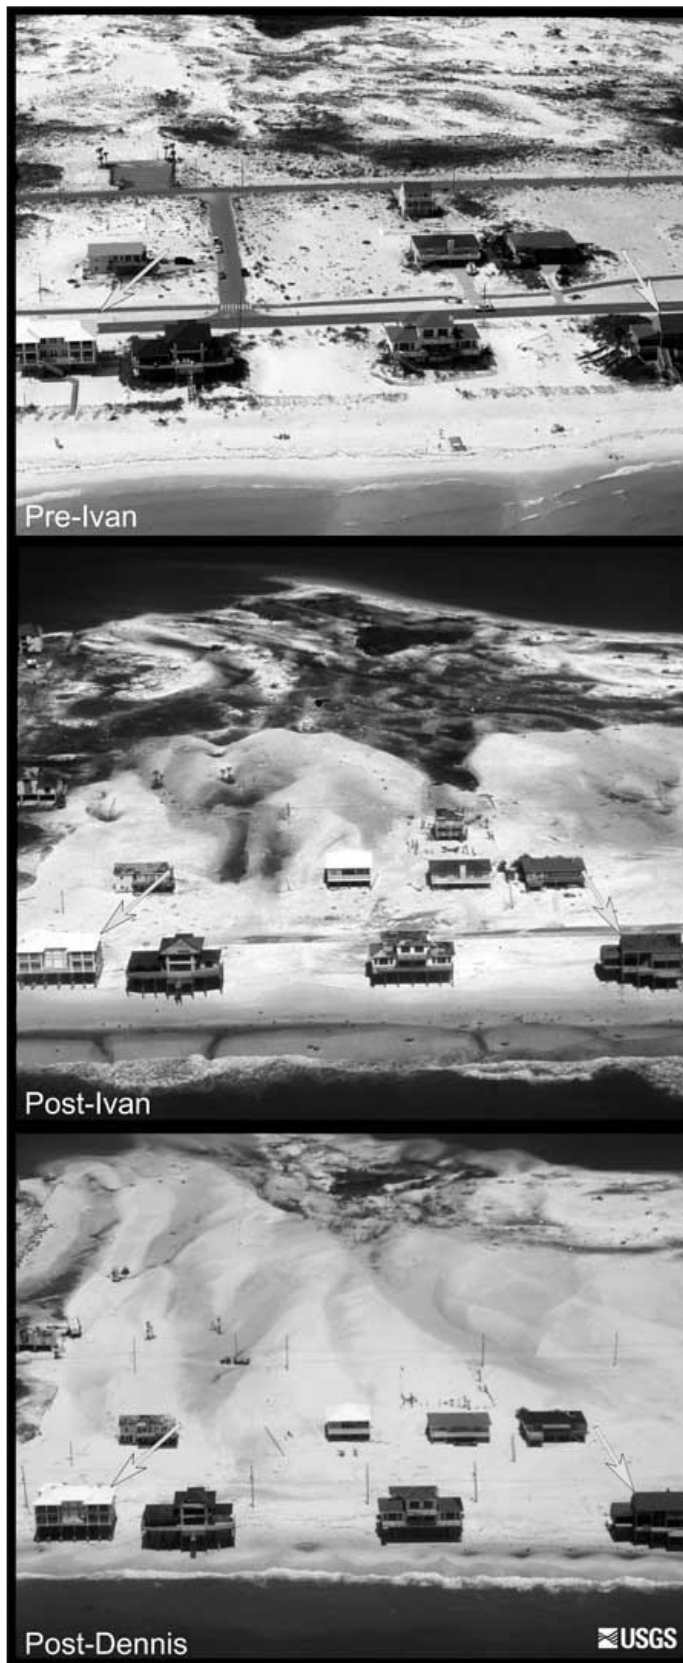
Overwash, Navarre Beach, FL: On this part of Navarre Beach, overwash deposits from Hurricane Dennis extend farther landward than overwash deposits from Hurricane Ivan. Both storms cover the two coast-parallel roads with overwash deposits. [[larger version](#)]

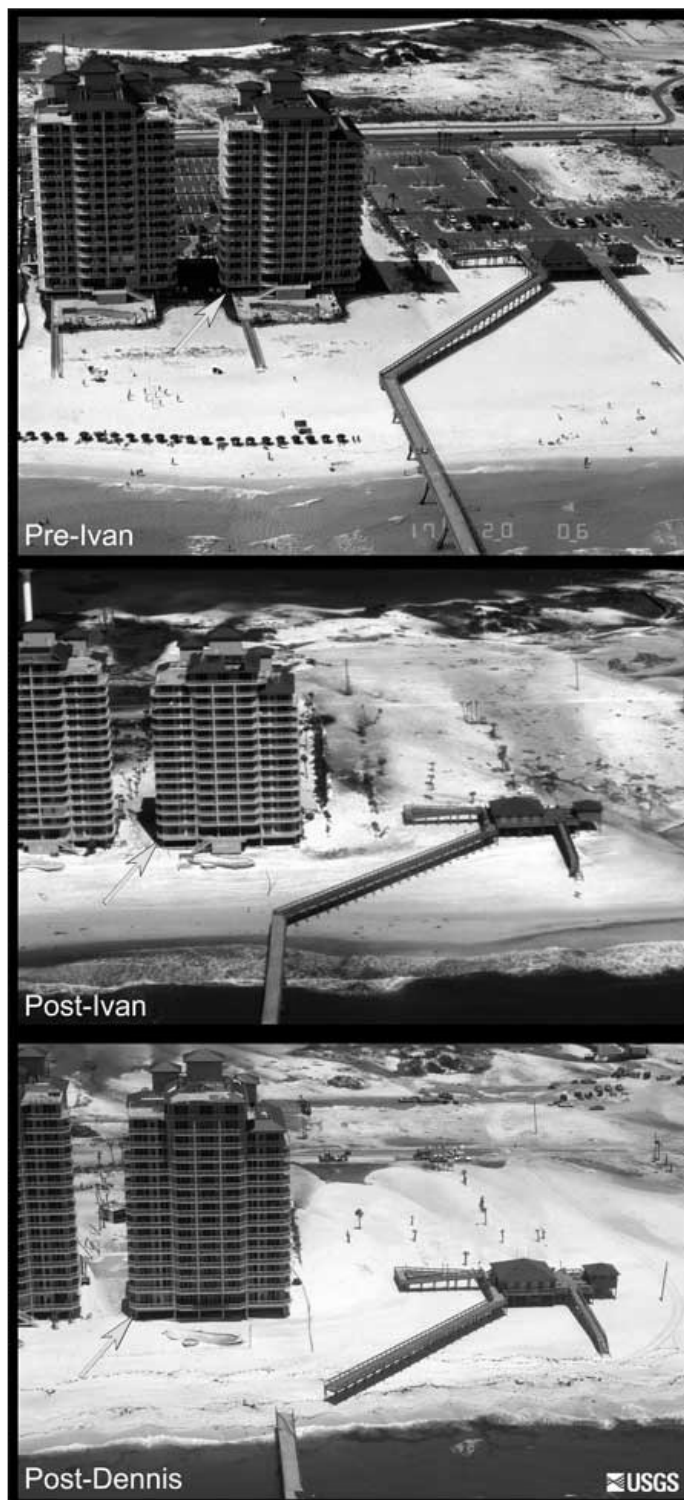
Overwash and Walkover Damage, Navarre Beach, FL: Overwash during Hurricane Ivan covers the parking lot and road with sand. Overwash from Hurricane Dennis again covers the parking lot with sand, but does not extend as far inland here as did the overwash during Ivan. A section of the pier is missing following landfall of Dennis. [\[larger version\]](#)

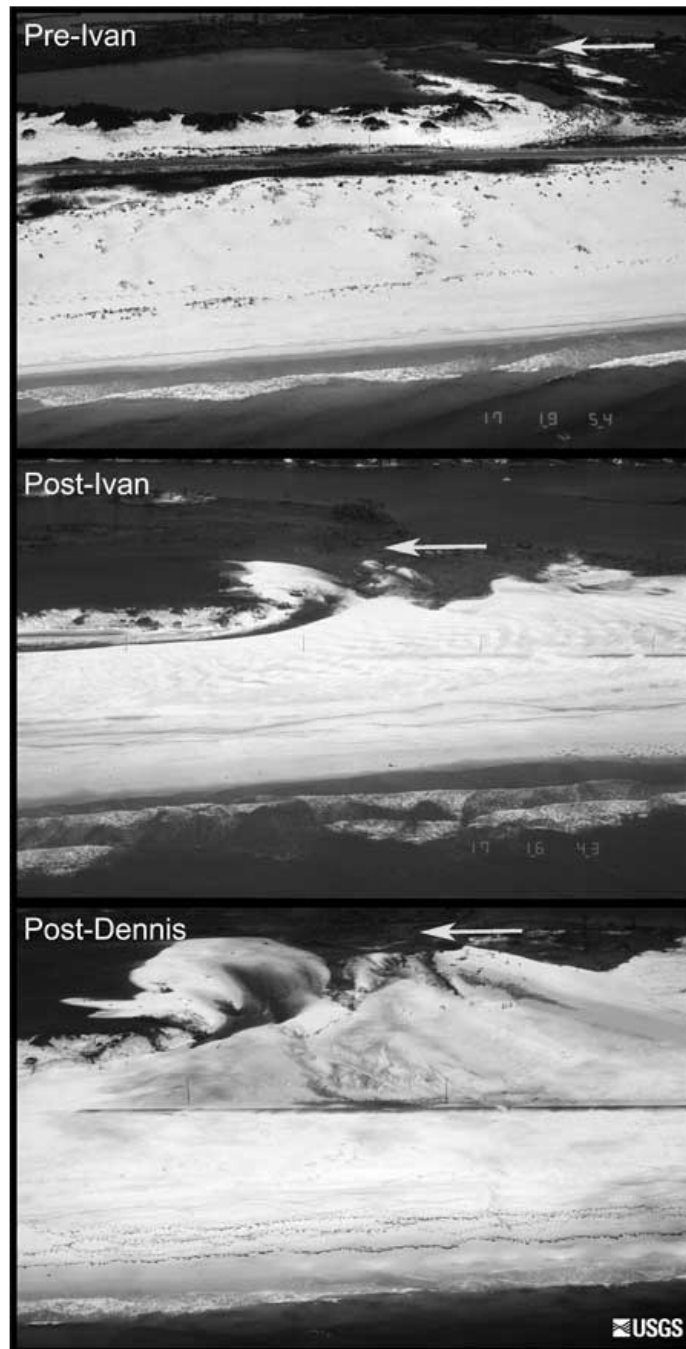
Road Overwash, East Santa Rosa Island, FL: Hurricane Dennis overwash deposits extend farther landward than Hurricane Ivan deposits. (Compare the landward extent of sand in each photograph to the arrow position.) [[larger version](#)]
