# GEOTUBES ALONG THE GULF SHORELINE OF THE UPPER TEXAS COAST: OBSERVATIONS DURING 2001

**A Report of the Texas Coastal Coordination Council pursuant to National Oceanic  
and Atmospheric Administration Award No. NA97OZ0179  
GLO Contract Number 01-597 R**

**Bureau of Economic Geology  
Scott W. Tinker, Director  
The University of Texas at Austin  
Austin, Texas 78713-8924**

**March 2002**

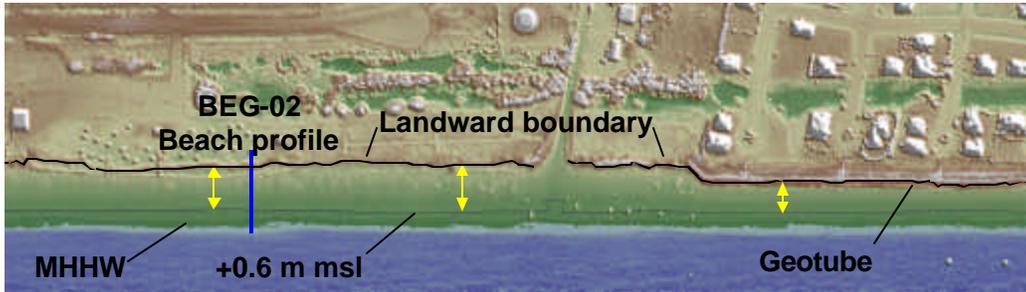
Figure 8. Lidar topographic image of the southwest end of the Pirates Beach geotube project and the northeast end of Galveston Island State Park. Double-ended arrows demonstrate beach width measurement between the 0.6 m level and the landward boundary.

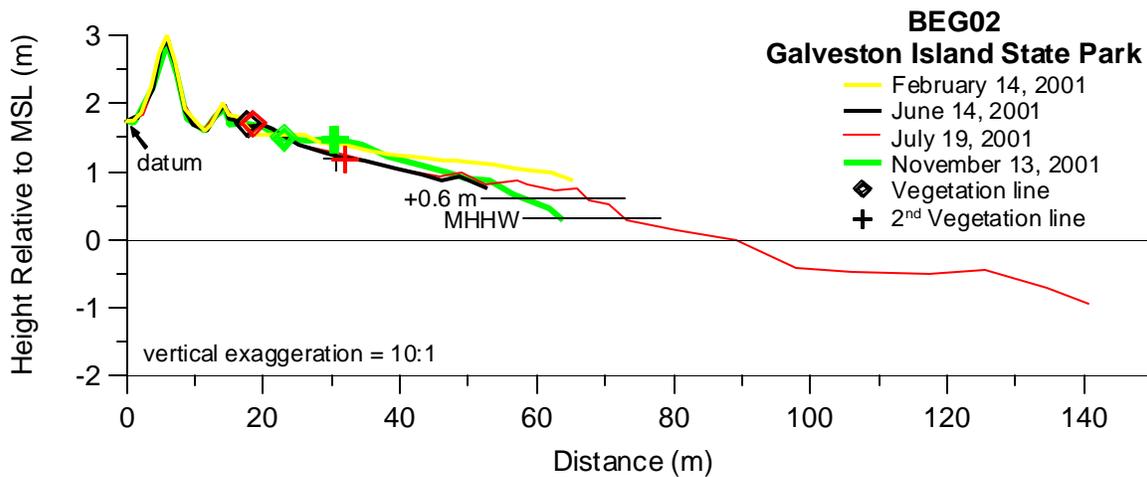
**Figure 11.** Beach profiles at Galveston Island State Park, location BEG02 (see Fig. 6 for location). The foredune and incipient dune seaward of the foredune survived Tropical Storm Allison in early June, 2001.

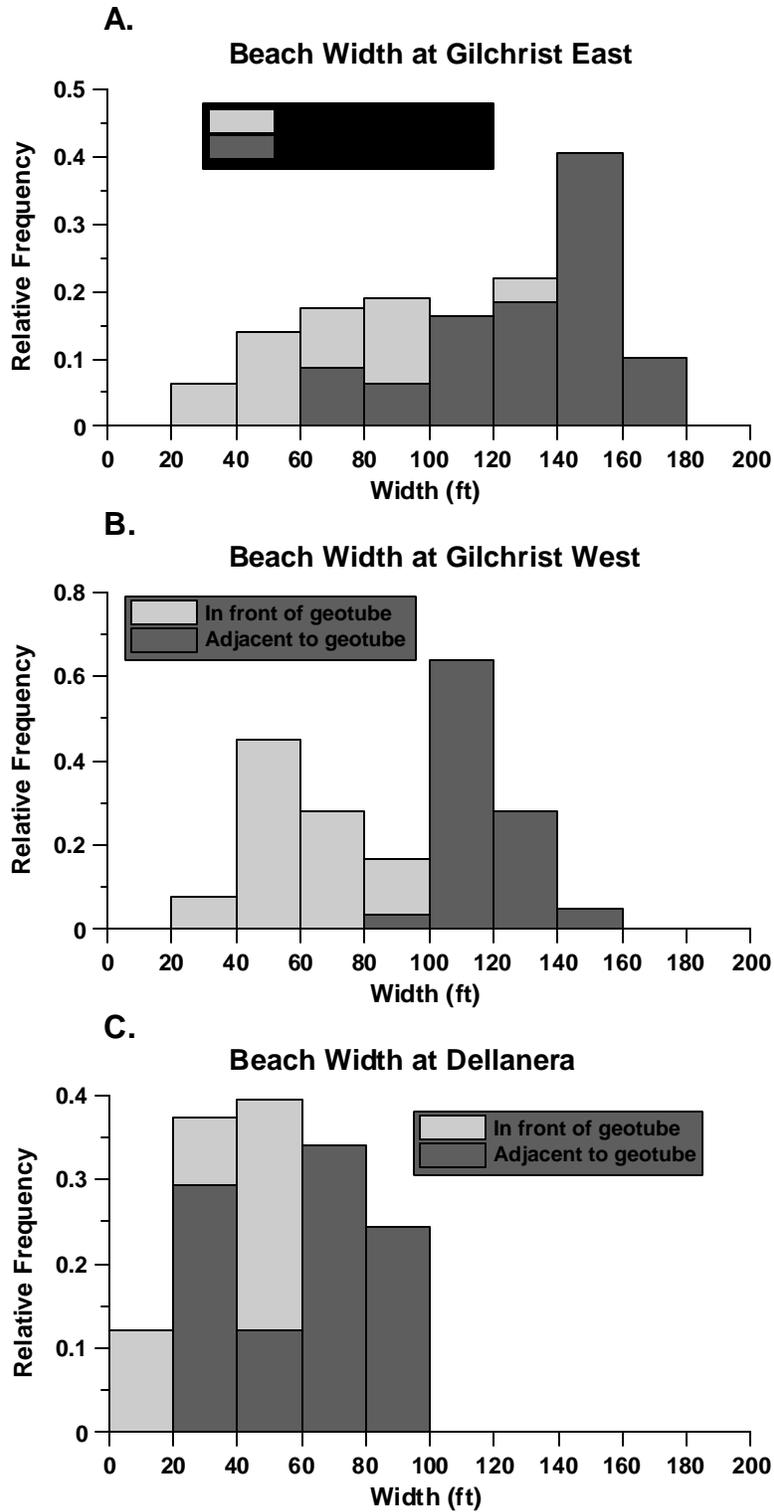
Figures 12 and 13 are histograms that compare beach widths adjacent to and in front of each project except the Treasure Island projects. The histograms are shown in relative frequency of locations spaced 16.40 ft (5 m) alongshore. For example, figure 12A shows that approximately 40 % (0.4 relative frequency) of the length of the beach is 140 to 160 ft (42.7 to 48.8 m) wide adjacent to the geotubes. The histograms show that beaches in front of geotubes are generally narrower than beaches adjacent to them. There are, however, portions of the beaches in front of the geotubes that are as wide as the narrower portions of the adjacent beaches. Table 3 gives the minimum and average beach widths. Average beach widths are narrower in front of the geotubes than adjacent to them by 21 to 83 ft (6.4 to 25.3 m) with the Pirates Beach project showing the greatest difference. Except for the Riviera and Pocket Park II projects, the beaches in front of the geotubes have minimum beach widths narrow enough to prevent passage during water levels of 1 to 2 ft (0.30 to 0.61 m) above MHHW.

Figure 12. July 2001 beach width comparison shown as relative frequency of transects spaced every 16.4 ft (5 m) alongshore in front of and adjacent to the designated geotubes: (A) Gilchrist east; (B) Gilchrist west; (C) Dellanera.

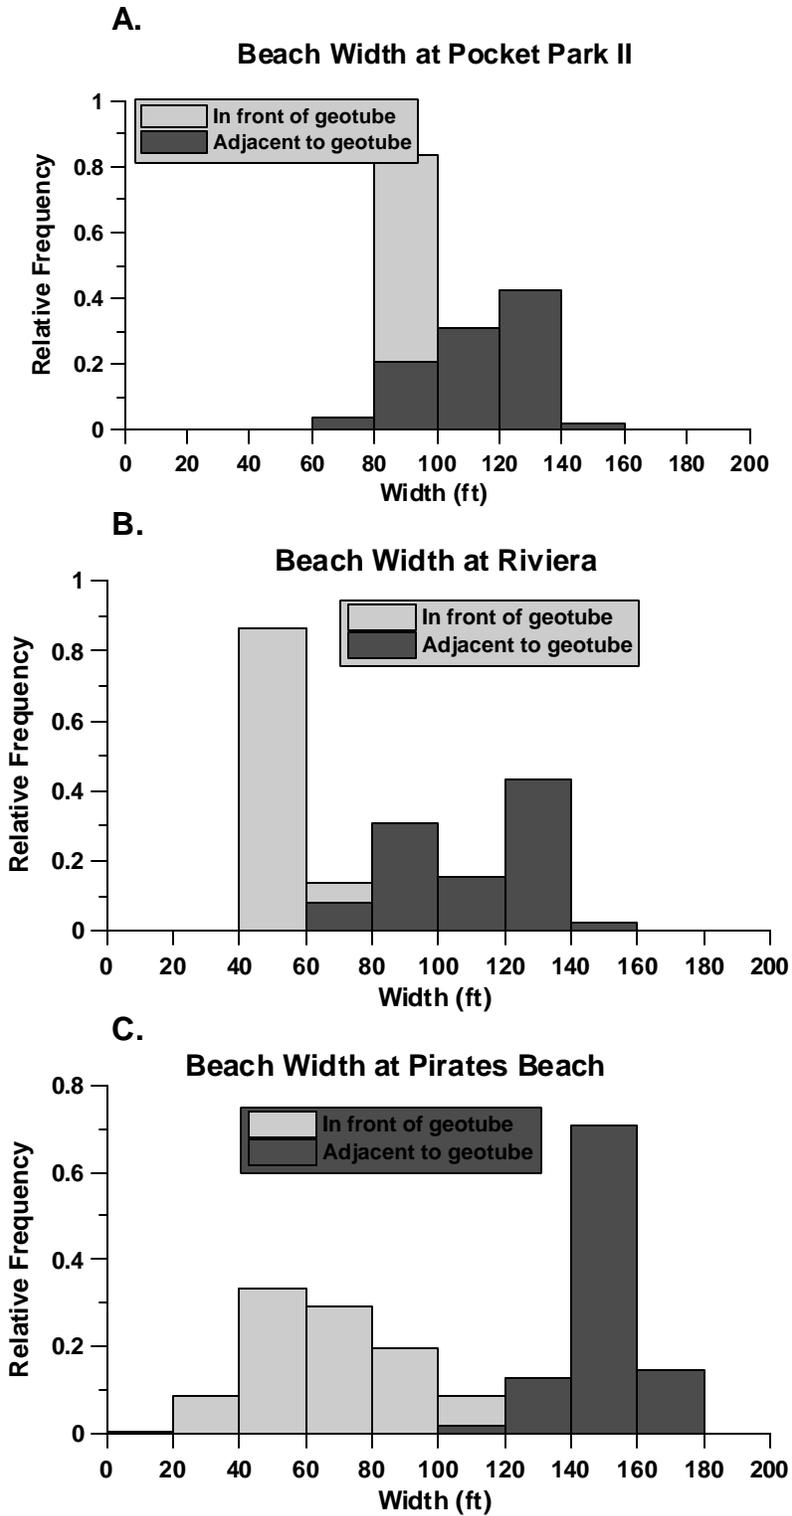
Visual inspection of the 1.97 ft (0.6 m) MSL contour line and back beach elevation on the topographic lidar images (Plates 1 and 2) show that the geotubes have not affected the erosion rates of adjacent beaches. If adjacent beaches were being affected, we would expect to see a decrease in the effect with distance from the geotubes. The morphologies and elevations of the back beach and fore beach portions of the beach profile, however, are similar for sections immediately adjacent to the geotubes and for beaches more distal to the geotubes.

Figure 13. July 2001 beach width comparison shown as relative frequency of transects spaced every 16.4 ft (5 m) alongshore in front of and adjacent to the designated geotubes: (A) Pocket Park II; (B) Riviera; (C) Pirates Beach.
