Geotubes for Temporary Erosion Control and Storm-Surge Protection along the Gulf of Mexico Shoreline of Texas

James C. Gibeaut, Tiffany L. Hepner, Rachel Waldinger, John R. Andrews, Rebecca C. Smyth, and Roberto Gutierrez

BUREAU OF ECONOMIC GEOLOGY, JOHN A. AND KATHERINE G. JACKSON SCHOOL OF GEOSCIENCES, THE UNIVERSITY OF TEXAS AT AUSTIN

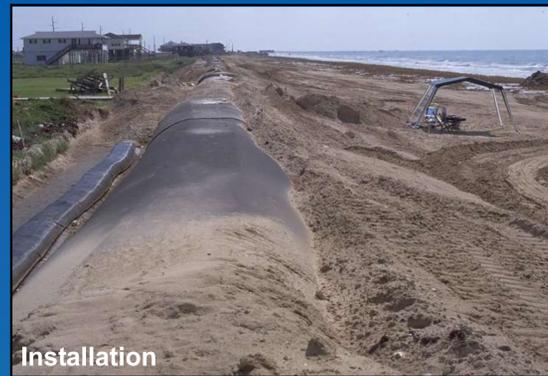
Installation

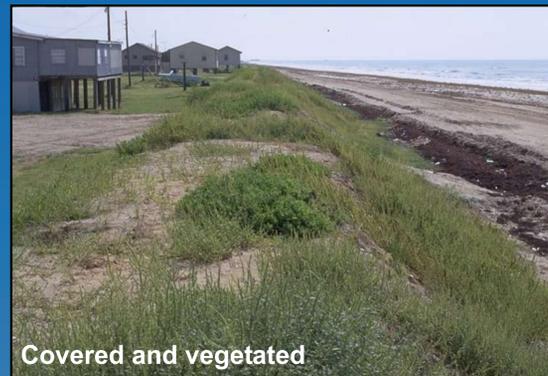
Covered and vegetated

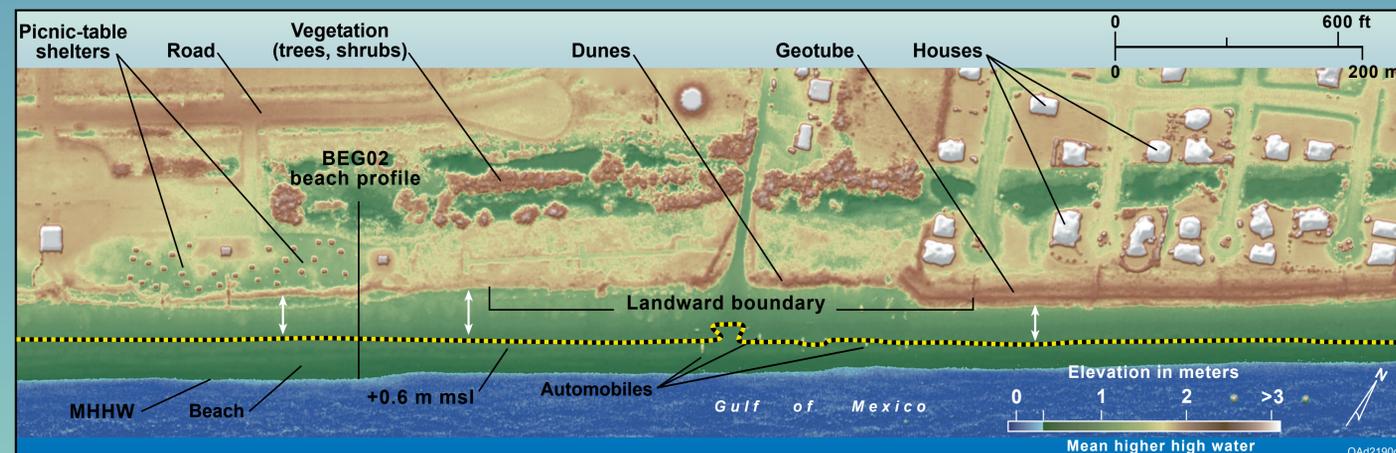
Lidar topographic image of the southwest end of the Pirates Beach geotube project and the northeast end of Galveston Island State Park. Double-ended arrows demonstrate beach width measurement between the 0.6-m level and the landward boundary. These measurements were taken every 16.4 ft (5 m) along shore.

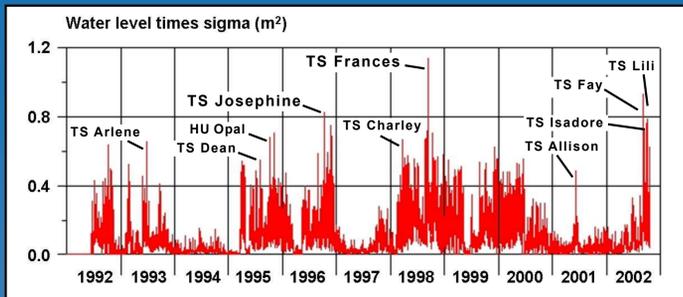
Hourly time-series plot of mean water level multiplied by the standard deviation (sigma) of 180, 1-second readings of water level at the open-coast Pleasure Pier tide gauge on Galveston Island. High sigma values correspond to high waves arriving at the gauge; high values in this plot thus indicate times of simultaneous high water level and high waves. TS Frances occurred before the geotube projects were installed and is the only storm that washed over foredunes. Subsequent storms have not tested the storm-surge protection function of the geotubes.

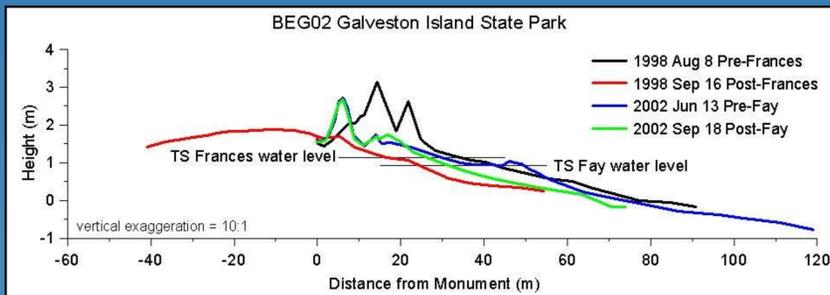
Beach profiles at a location without geotube installed. TS Frances caused complete erosion and washover of the foredune and was the impetus for geotube installation on adjacent beaches. Erosion by subsequent storms has been moderate at this relatively natural setting.

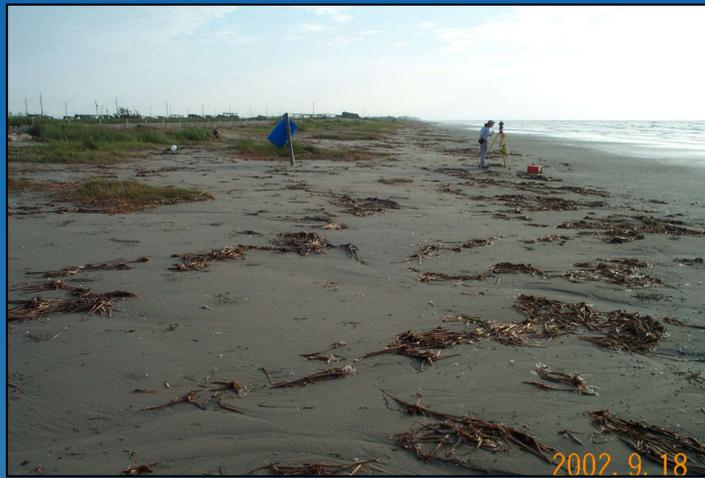
Coppice mounds at GLO06 profile location in Galveston Island State Park on September 18, 2002. This subenvironment of wind-blown sand and sparse vegetation was eroded but survived Tropical Storm Fay.
