EPA/OSHA JOINT CHEMICAL ACCIDENT INVESTIGATION REPORT

**Shell Chemical Company
Deer Park, Texas**

Shell Chemical Company, Deer Park, TX, June 22, 1997

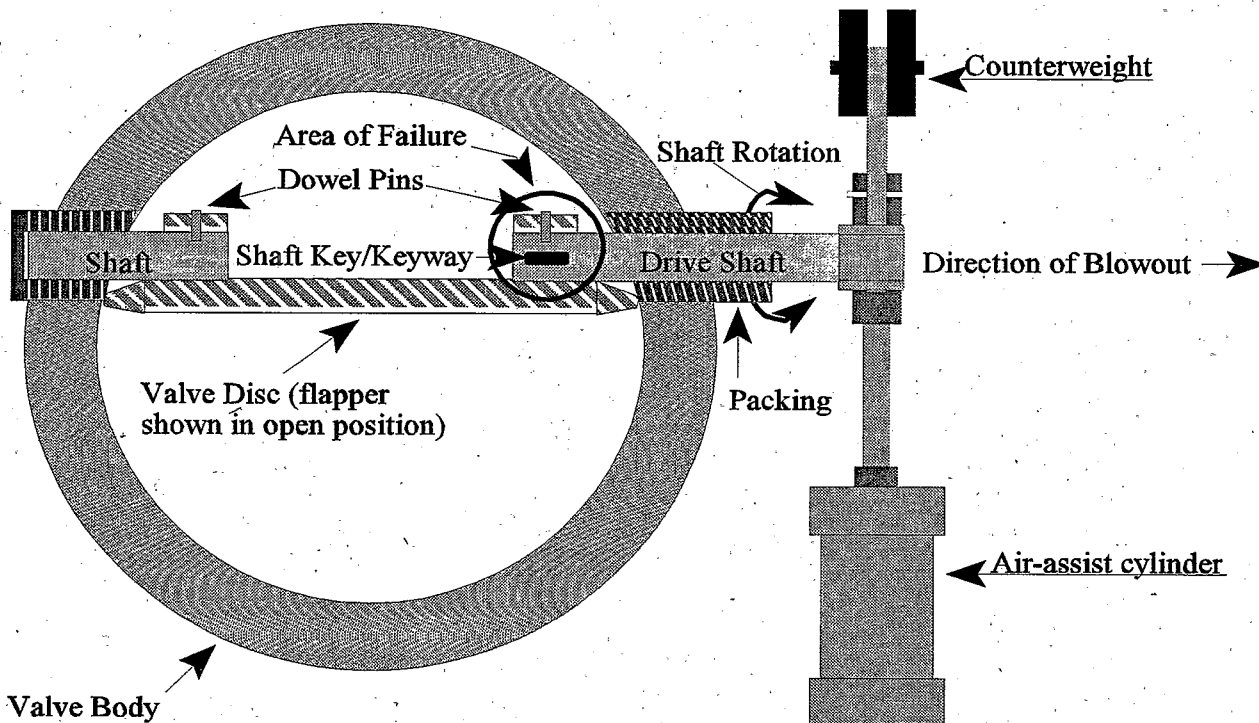
Figure 2: Clow Model GMZ Pneumatically-Assisted Check Valve

Analysis of sample number 5, the 36-inch diameter Clow Model GMZ check valve (and its internal components), revealed that it had suffered little or no heat damage. Analysis also indicated the following (see Figures 2 and 3 on pages 25-26 for an illustration of the valve):

Clow Model GMZ check valves (see Figure 2) contain a two-piece stem in which one

stem piece functions as a drive shaft and connects the internal valve disk to an external air-assist cylinder and flapper counterweight assembly. The other stem piece, or idler shaft, simply functions as a hinge for one side of the flapper. The drive shaft penetrates the pressure boundary through a stuffing box. The exterior portion of the drive shaft is connected to the pneumatic piston and counterweight, and the interior portion of the shaft is coupled directly to the valve disk using a cylindrical hardened steel dowel pin and a steel rectangular bar key (see Figure 3). This arrangement provides a counter weight to partially balance the weight of the valve disk, and provides the pneumatic power assist to maintain the valve closed as described above.

The Clow Model GMZ check valve installed as the PGC fifth stage suction check valve had an internal diameter of 36 inches and weighed 3.2 tons. The valve had a design limit pressure of 480 psig, and a design limit temperature of 115 degrees Fahrenheit. The JCAIT found no evidence that these limits were exceeded at any time prior to or during the accident.

- Prior to restarting OP-III, Shell Chemical Company should replace all Clow Model GMZ check valves installed in the unit with valves not susceptible to shaft blow-out. Other Shell facilities and other companies as appropriate should review their process systems to determine if they have valves installed that may be subject to this hazard, and modify or replace those valves as necessary to prevent shaft blow-out. Companies should consult valve manufacturers or other appropriate design authorities to ensure any modifications made are safe. [Editor's note: Prior to this report being published, Shell Chemical Company replaced all Clow Model GMZ check valves installed in OP-III with valves not susceptible to shaft blow-out.]

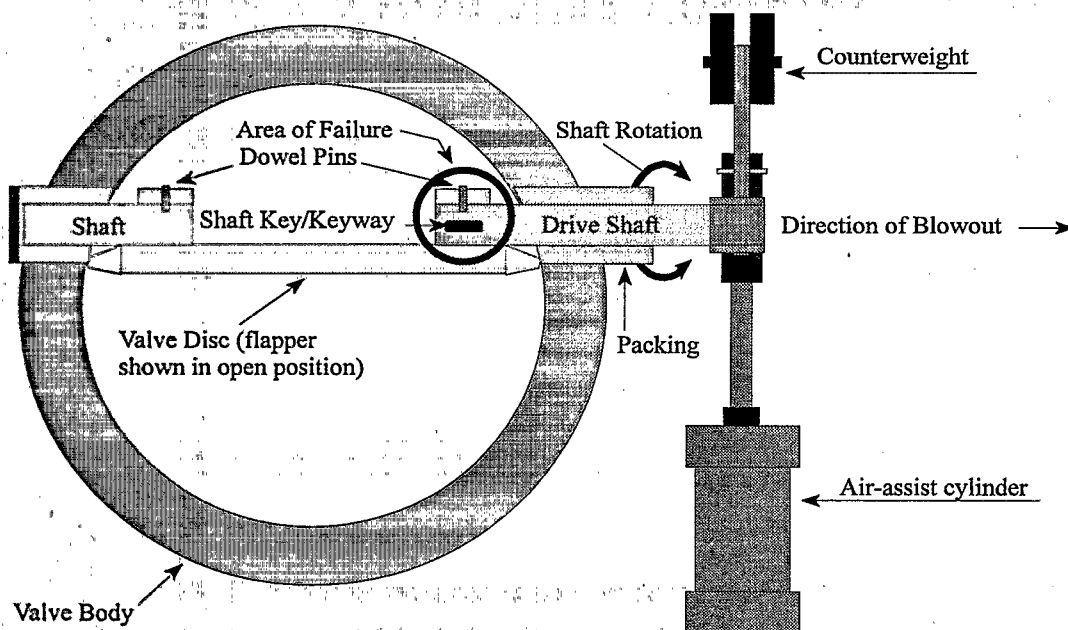
Valves subject to this hazard may be designed with a two-piece valve stem (sometimes referred to as a "stub-shaft" design). In each of the cases described above, the malfunctioning component was a Clow stub-shaft Model GMZ pneumatically assisted swing check valve (see diagram below). In these check valves, one stem piece functions as a drive shaft that connects the internal valve disk to an external air-assist cylinder and counterweight assembly. The drive shaft penetrates the pressure boundary through a stuffing box. The exterior portion of the drive

shaft is connected to a pneumatic piston and counterweight, and the interior portion of the shaft is coupled directly to the valve disk using a cylindrical hardened steel dowel pin and a rectangular bar key. This arrangement provides a power-assist to close the valve during compressor shut down, preventing reverse flow of compressed gases. These particular valves have probably not been produced since 1985, but still exist in some process facilities constructed before that date. Similar valves currently or previously produced and sold by other valve manufacturers may also be subject to this hazard.
