TECHNICAL REPORT CERC-90-7

# KING HARBOR, REDONDO BEACH, CALIFORNIA, BREAKWATER STABILITY STUDY

## Hydraulic Model Investigation

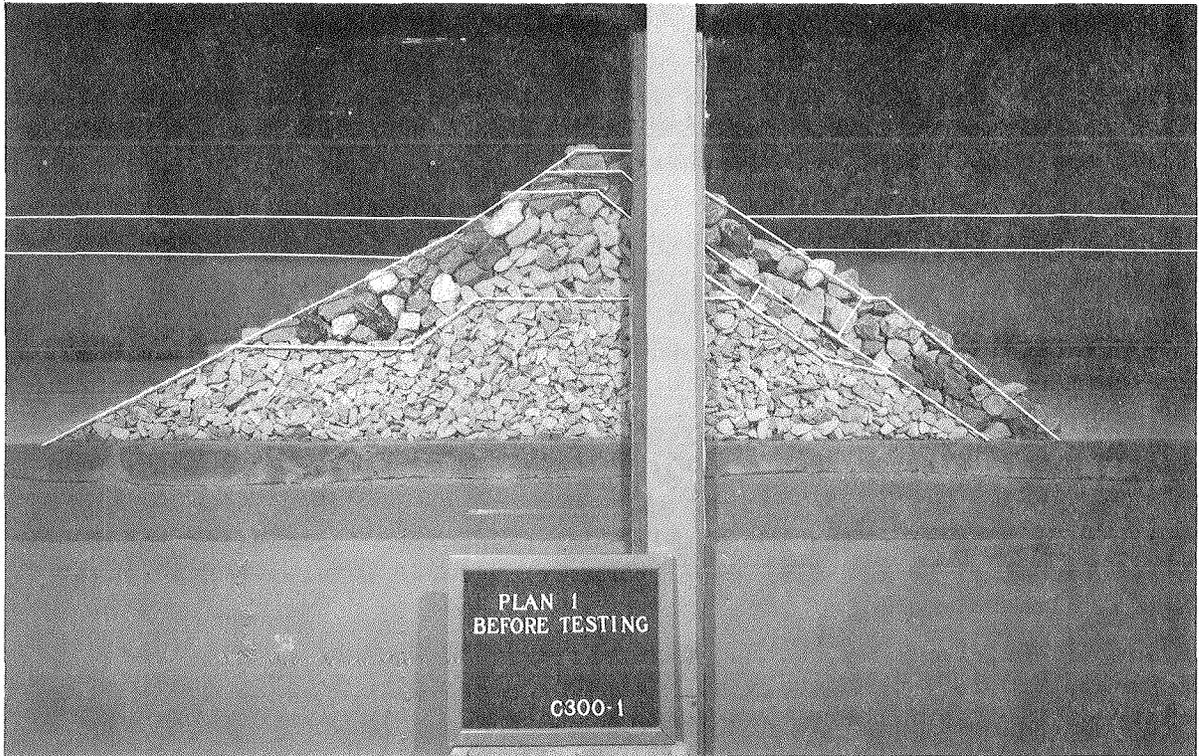
Photo 1. Plan 1, before testing, side view

23. Plan 1 (Figure 4, Photos 1-6), proposed by SPL, consisted of raising the crest elevation to +20 ft mllw by adding one layer of 11- to 19-ton stone ("A" Stone) to the existing crest, adding two layers of "A" Stone to the harbor side slope from -10 ft mllw to the crest, and placing 3- to 8-ton stone ("A-2" Stone) to -10 ft mllw from the base of the breakwater on the harbor side to form a toe buttress. Placement of armor units on the harbor side at King Harbor is more economical because shallower water depths result in less armor stone required and armor stone placement by ocean-borne construction equipment is protected by the breakwater.

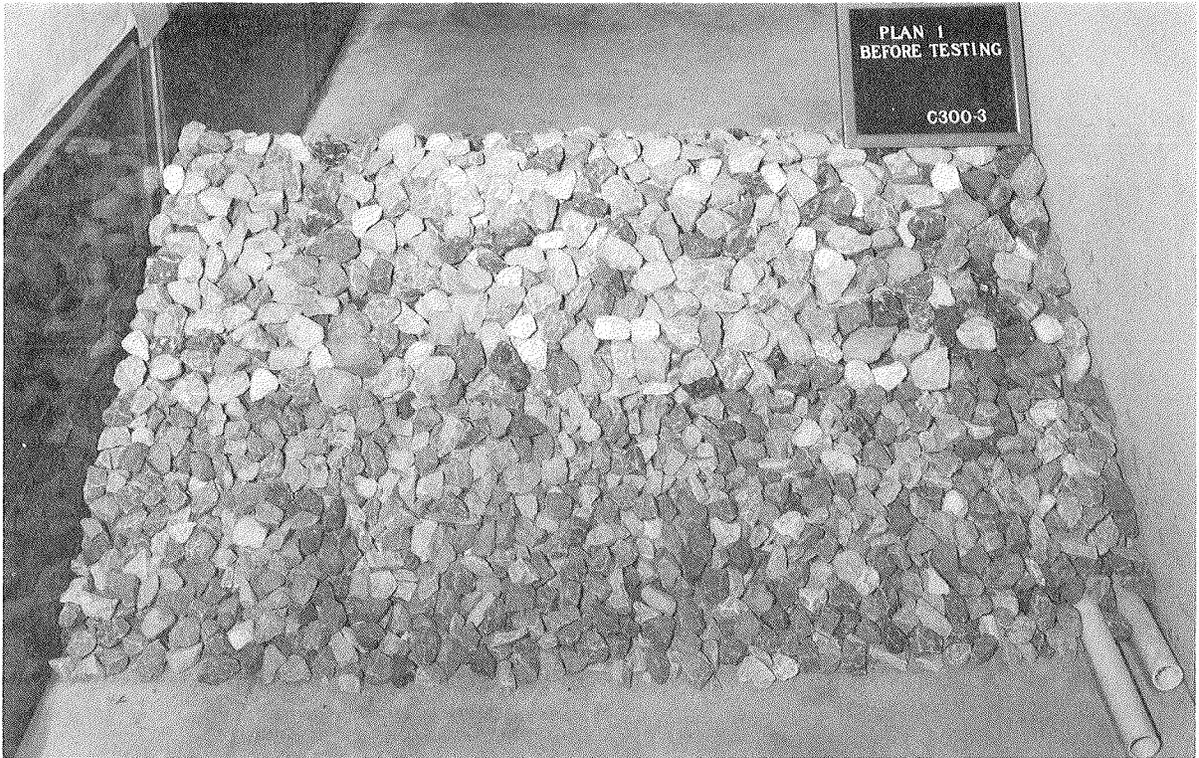
Photo 3. Plan 1, before testing, harbor-side view

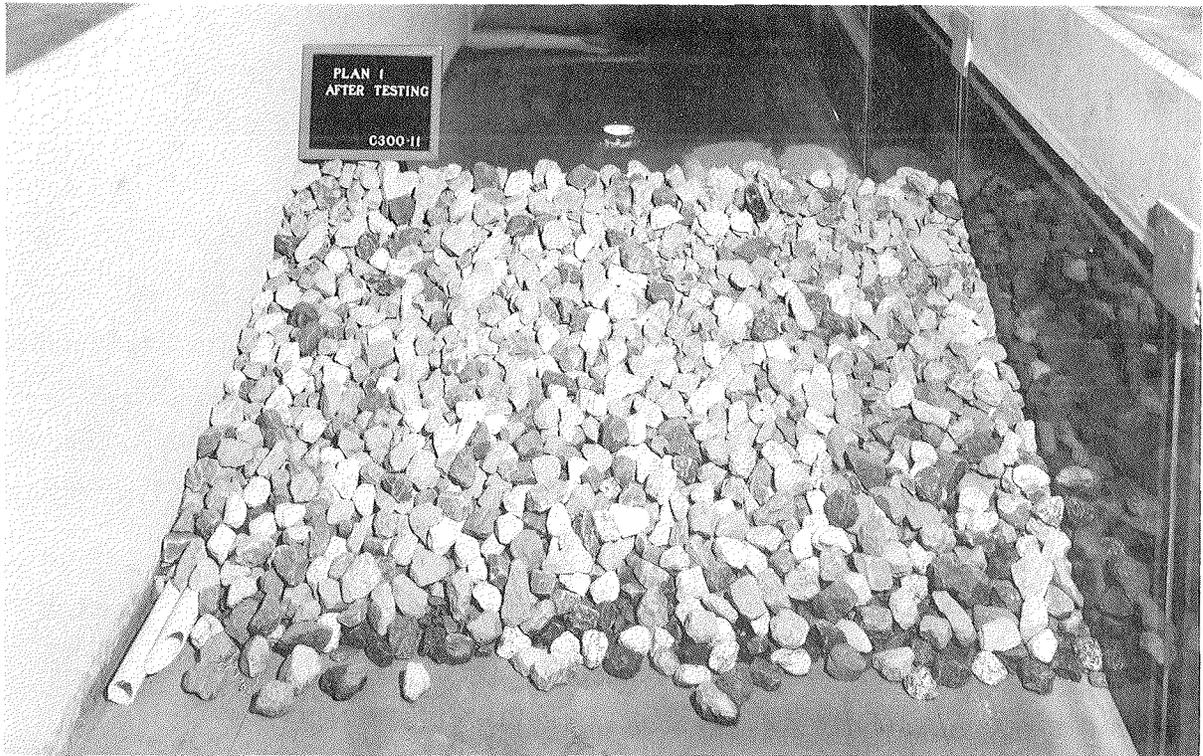
Photo 5. Plan 1, after testing, sea-side view

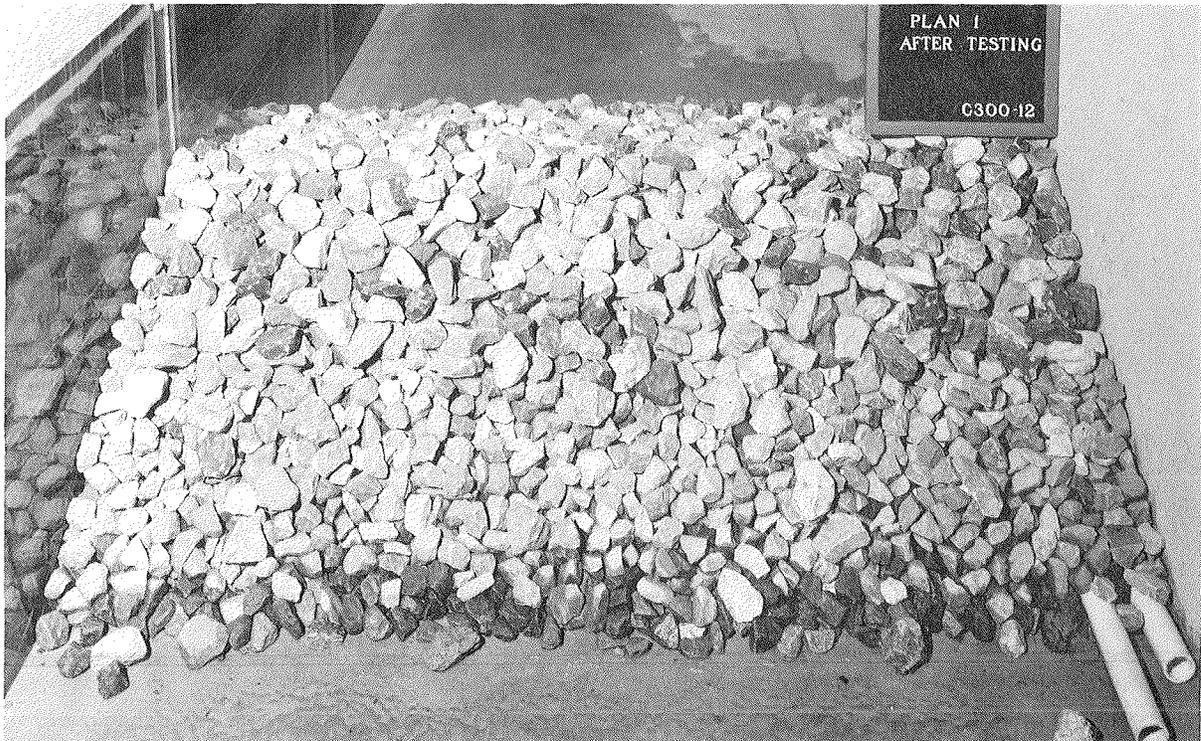
Photo 6. Plan 1, after testing, harbor-side view

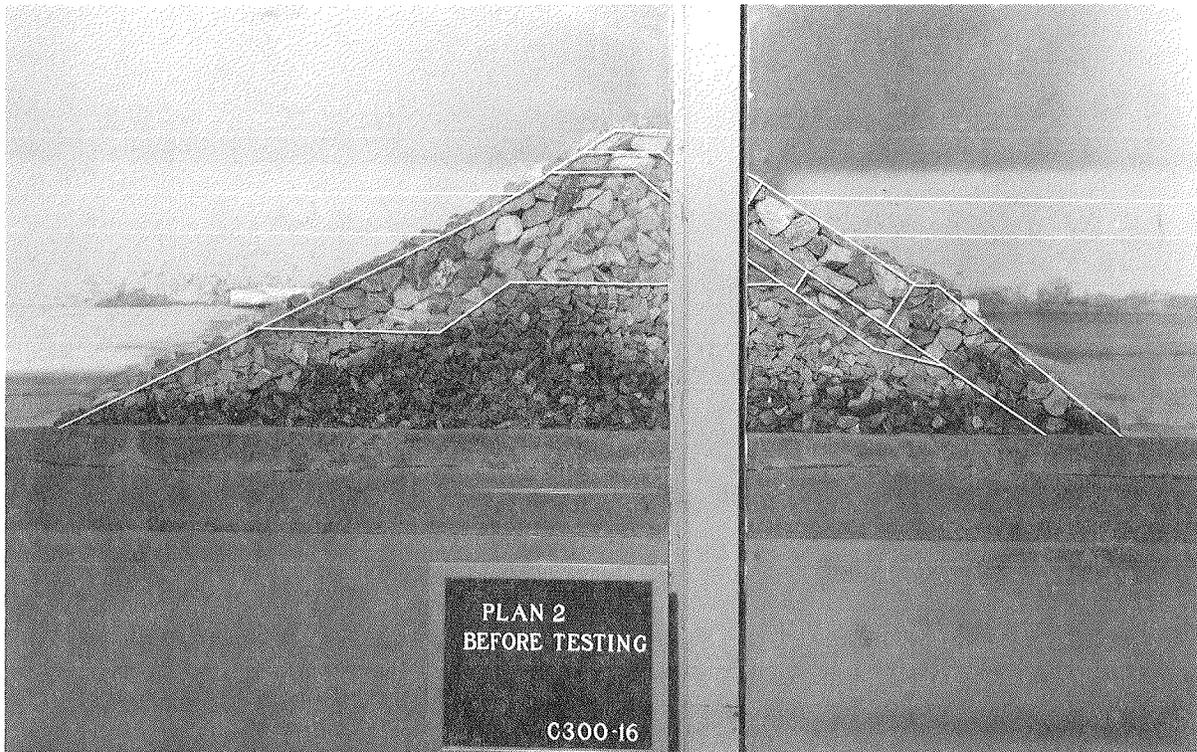
Photo 7. Plan 2, before testing, side view

27. Plan 2 consisted of the same geometric cross section as Plan 1, but 6- to 11-ton armor stone ("A-1" Stone) was placed from +10 ft mllw to -10 ft mllw, with "A" Stone placed from +10 ft mllw to the crown on the harbor side (Figure 8, Photos 7-12). "A-1" Stone was chosen by SPL as the most economical armor size to replace the larger armor units. The toe buttress was composed of "A-2" Stone, identical to Plan 1.

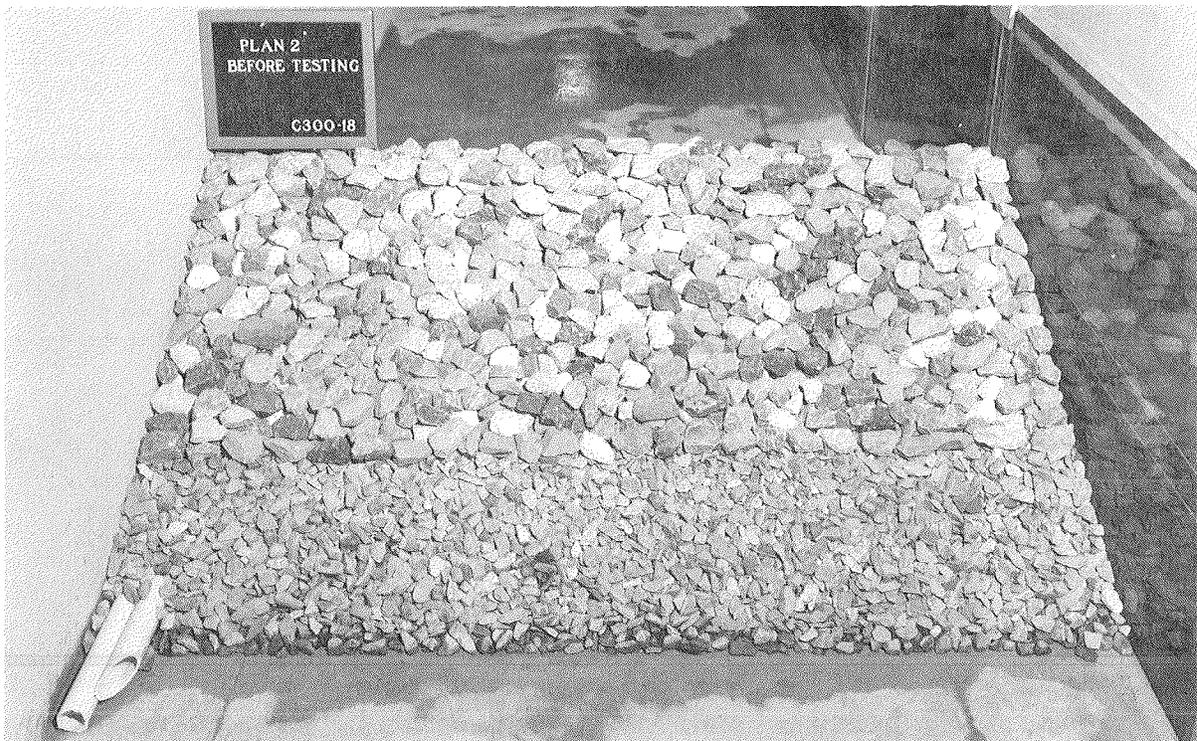
Photo 8. Plan 2, before testing, sea-side view

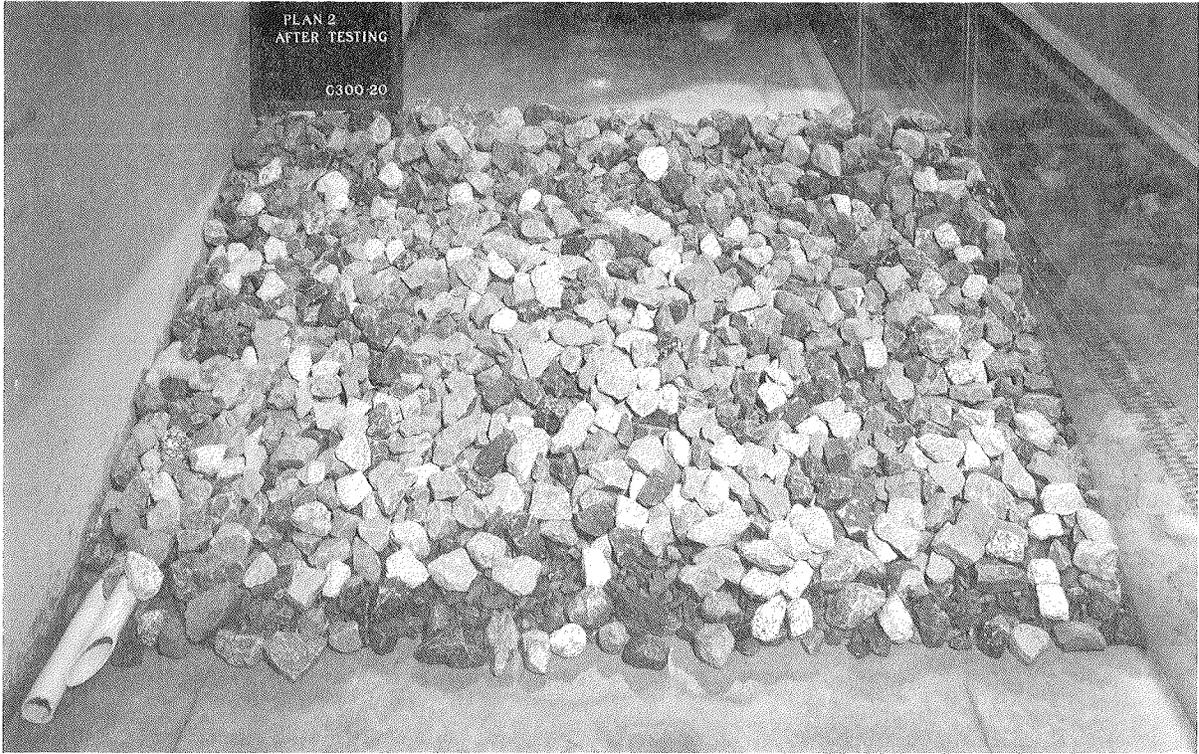
Photo 11. Plan 2, after testing, sea-side view
