Navigation Study, Colorado Locks, Colorado River, Matagorda, Texas

Final report

Prepared for U.S. Army Engineer District, Galveston
P.O. Box 1229
Galveston, TX 77553-1229

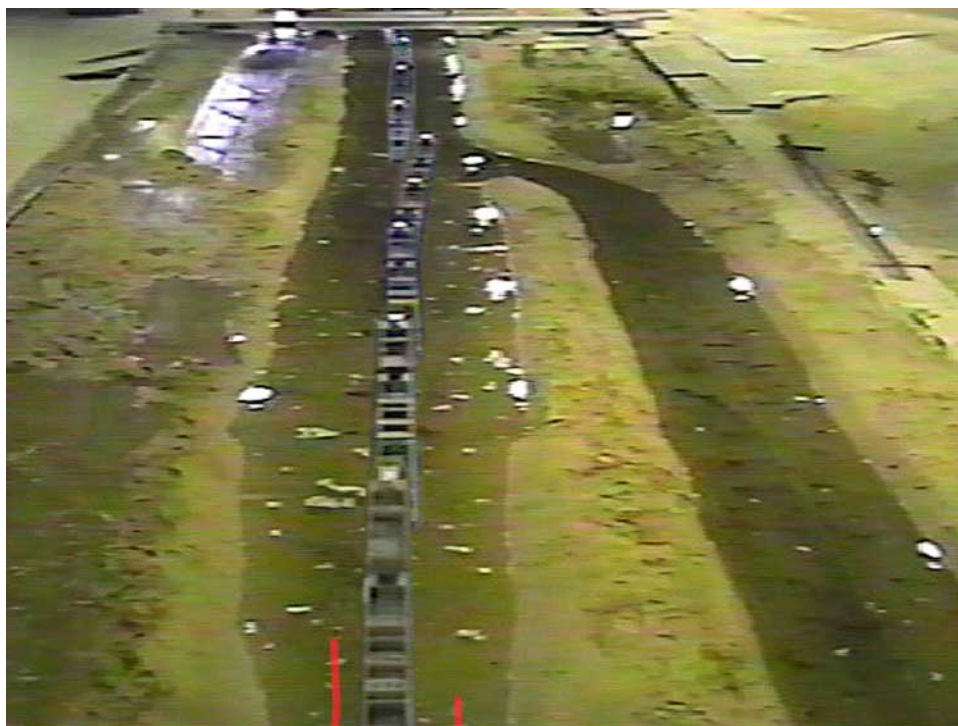
Figure 19. Flow east to west with bridge three tow lengths from confluence, tow moving east to west

Ebb Tide, tows moving east to west. With the bridge at three tow lengths from the Bypass Channel (Figure 19), the tow was set well toward the Bypass Channel as it passed, but the tow recovered and was in alignment to pass through the bridge approximately two tow lengths eastward of the bridge. With the bridge at two tow lengths (Figure 20), again the tow had a strong set toward the Bypass Channel but was able to come into alignment with the bridge about one tow length eastward of the bridge. With the bridge at one tow length (Figure 21) the tow was set toward the Bypass Channel, but the head of the tow was almost at the bridge fenders before the stern of the tow passed clear of the current set going out the Bypass Channel. Although the bridge fender was not struck, the maneuvering to avoid colliding was difficult.

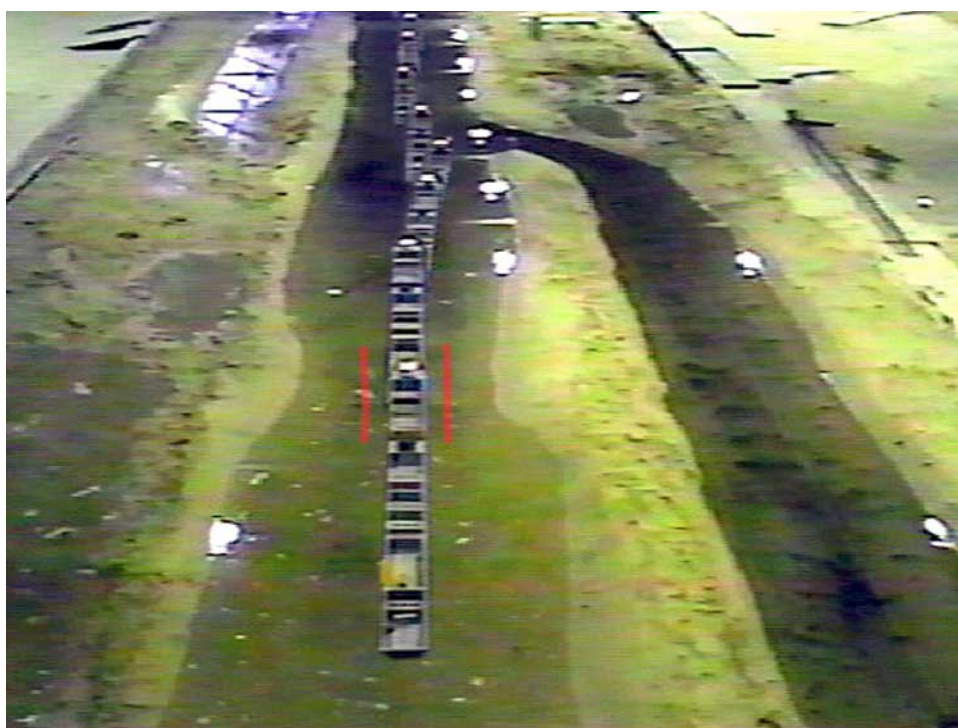
Figure 20. Flow east to west with bridge two tow lengths from confluence, tow moving east to west

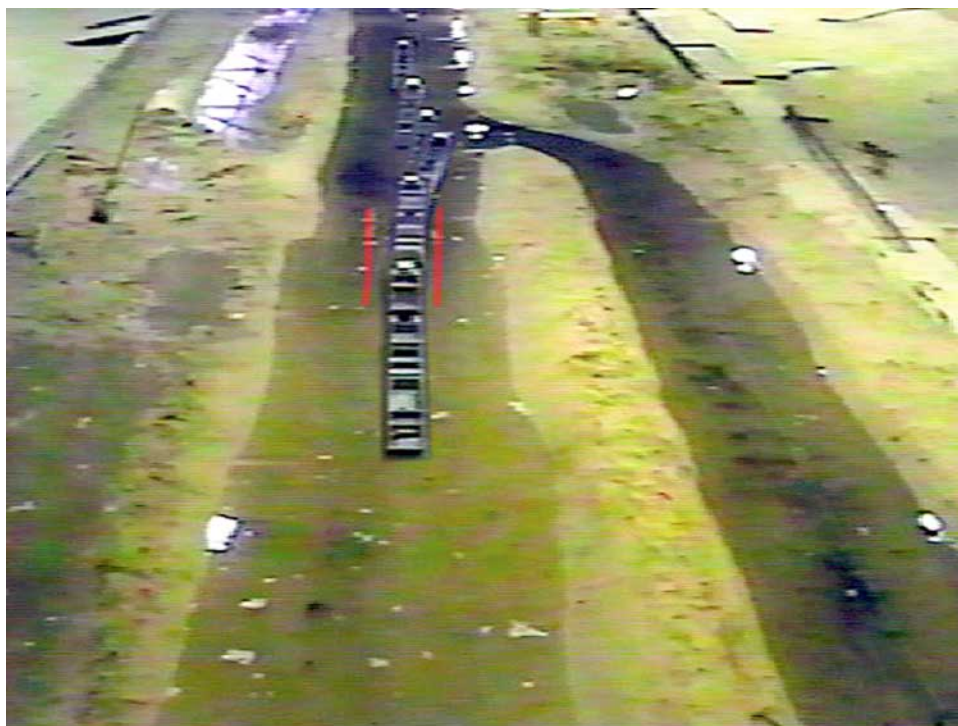
Figure 21. Flow east to west with bridge one tow length from confluence, tow moving east to west

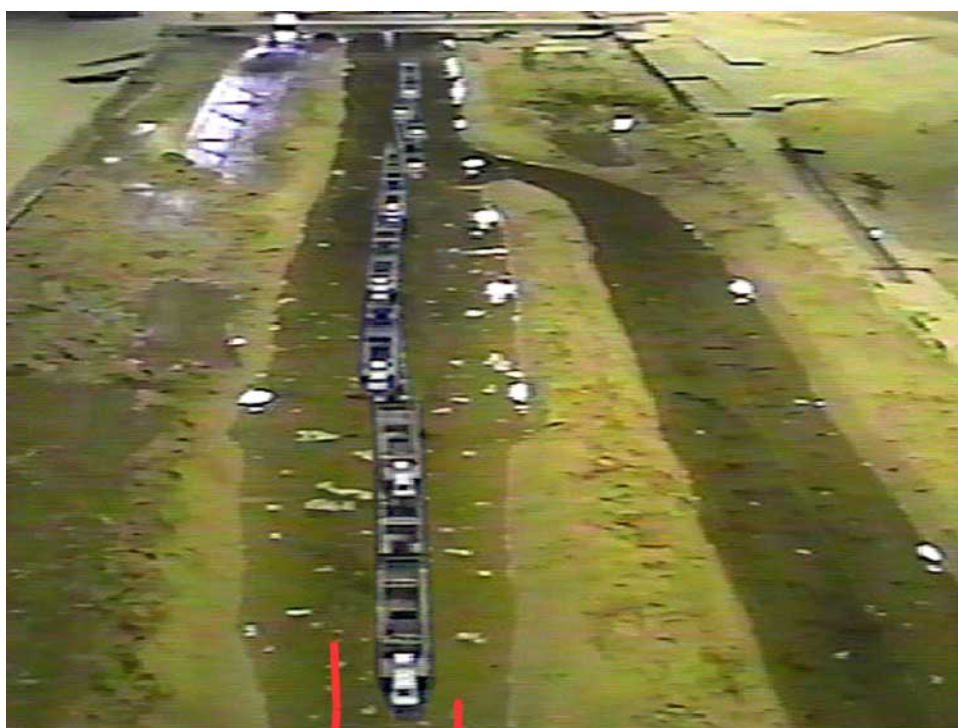
Figure 22. Flow east to west with bridge three tow lengths from confluence, tow moving west to east

Ebb Tide, tows moving west to east. With the bridge at three tow lengths from the Bypass Channel (Figure 22) the tow passed through the bridge with no difficulty and had plenty of room to prepare for the set toward the Bypass Channel. The set on the stern of the tow was not extremely difficult to control and passage eastward of the Bypass Channel was not difficult. With the bridge at

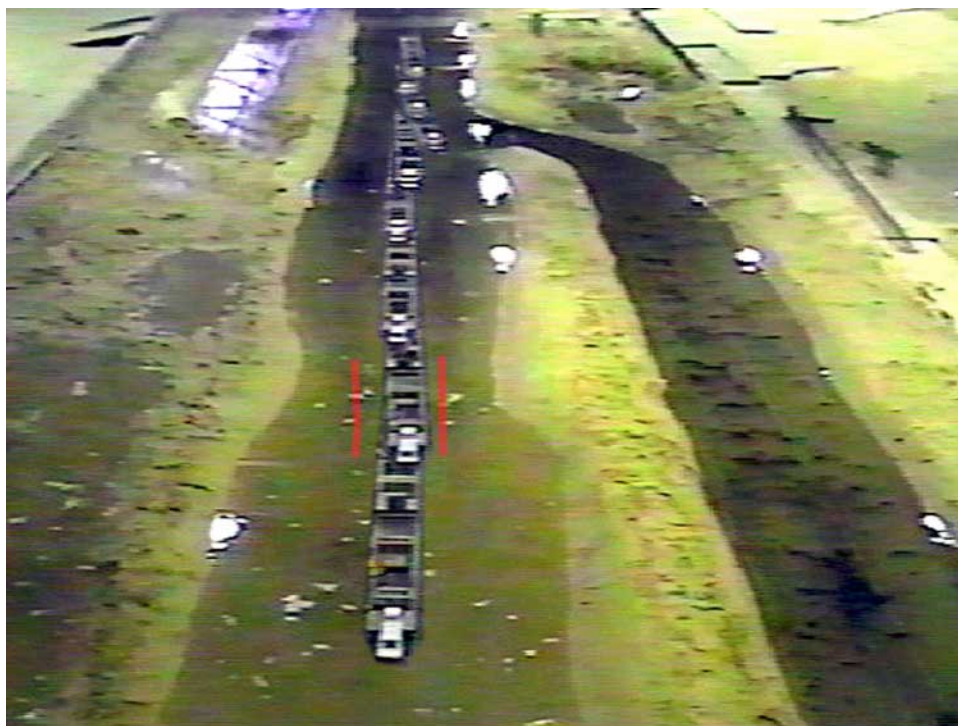
Figure 23. Flow east to west with bridge two tow lengths from confluence, tow moving west to east

two tow lengths (Figure 23), the tow still had sufficient room to come through the bridge, then maneuver in preparation of the anticipated set into the Bypass Channel. With the bridge at one tow length from the Bypass Channel (Figure 24), the tow could pass safely through the bridge, but as the stern cleared the bridge fenders, the head of the tow was subjected to set from current passing down the Bypass Channel. Holding the head of the tow, then the stern of the tow against the current set was not dangerously difficult, but was more difficult than with the bridge being two tow lengths from the Bypass Channel.

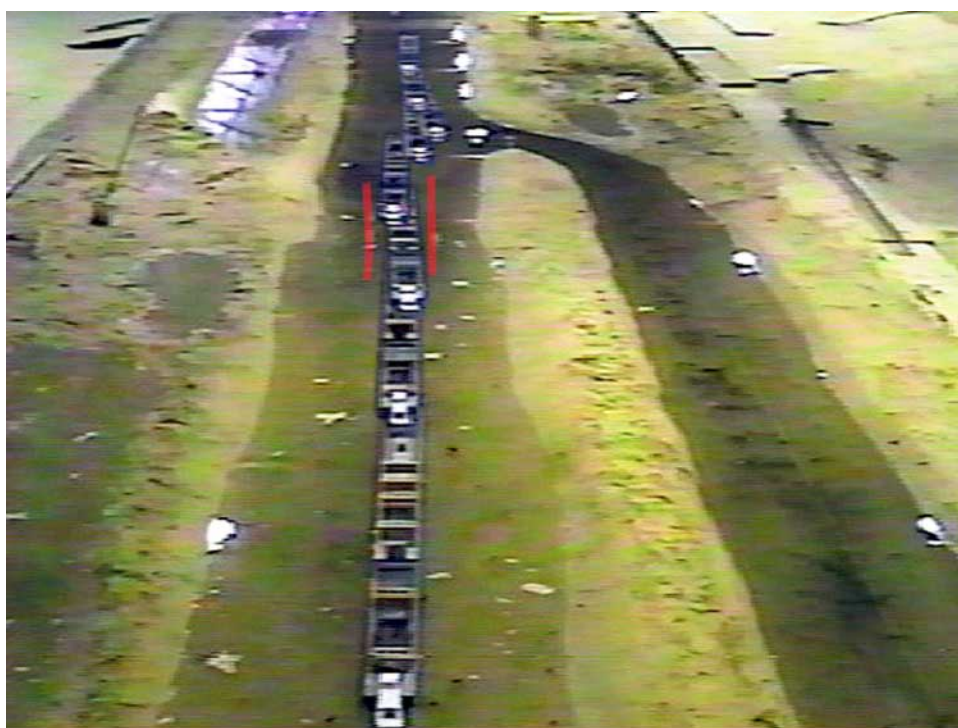
Figure 24. Flow east to west with bridge one tow length from confluence, tow moving west to east

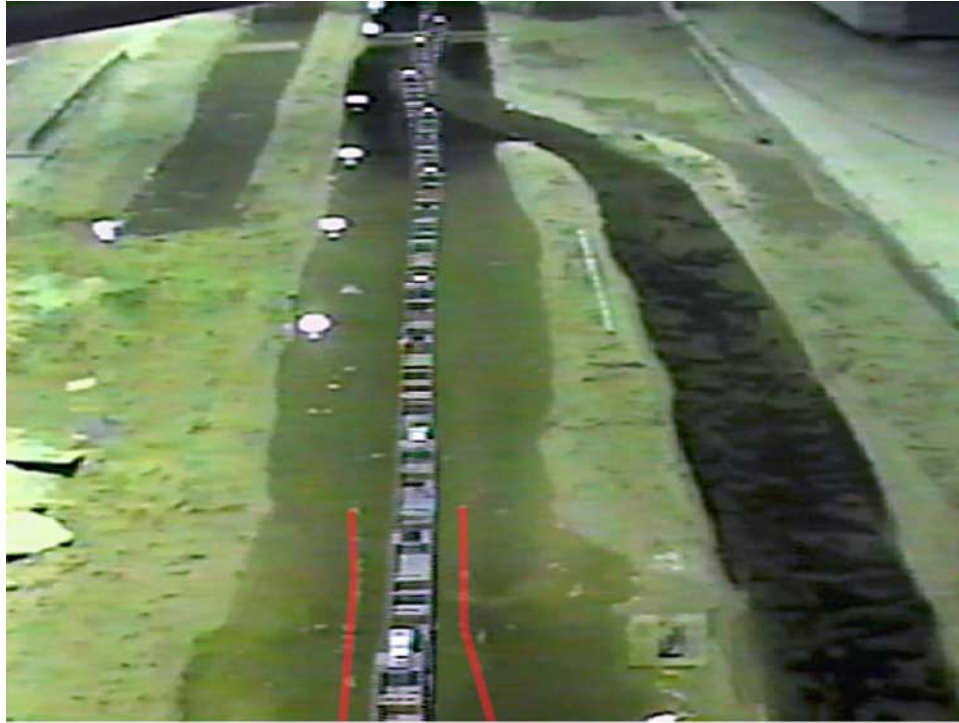
Figure 25. Flow west to east with bridge three tow lengths from confluence, tow moving east to west

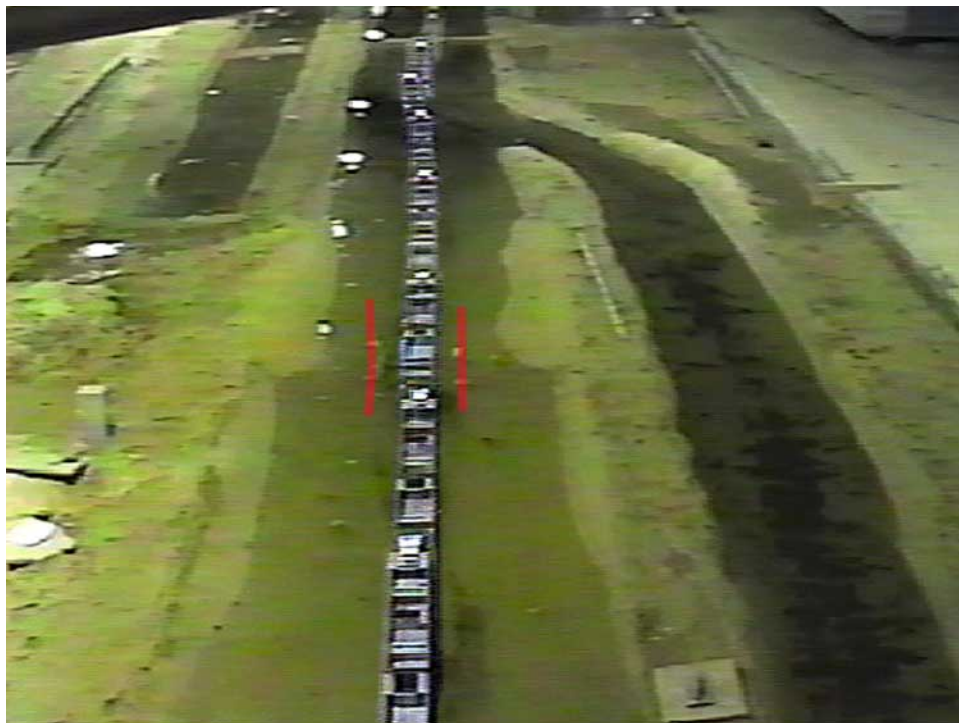
Figure 26. Flow west to east with bridge two tow lengths from confluence, tow moving east to west

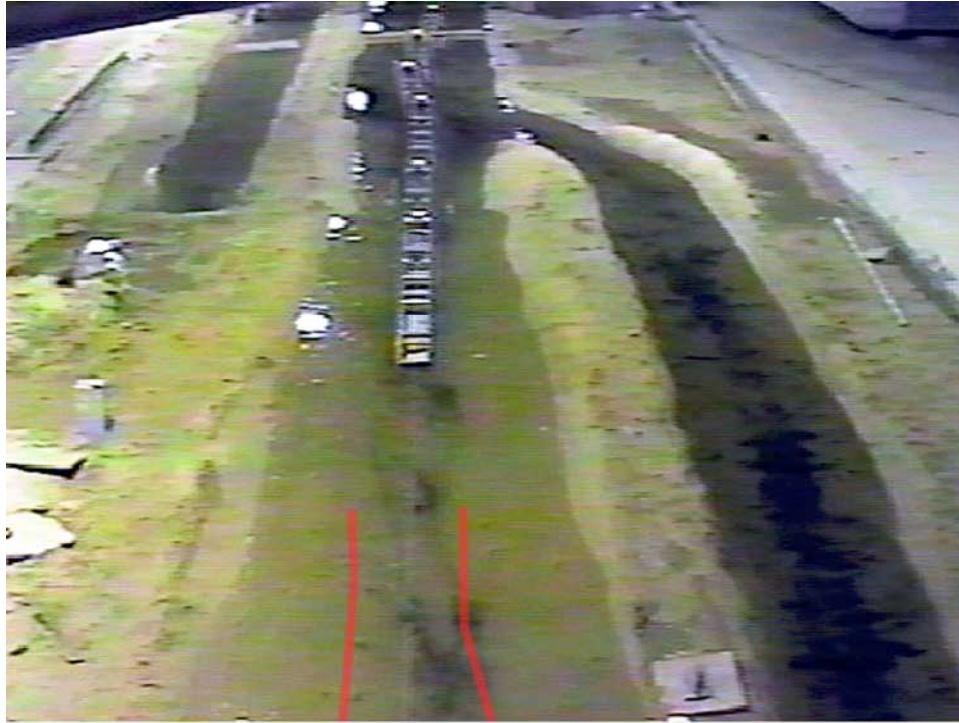
Figure 27. Flow west to east with bridge one tow length from confluence, tow moving east to west

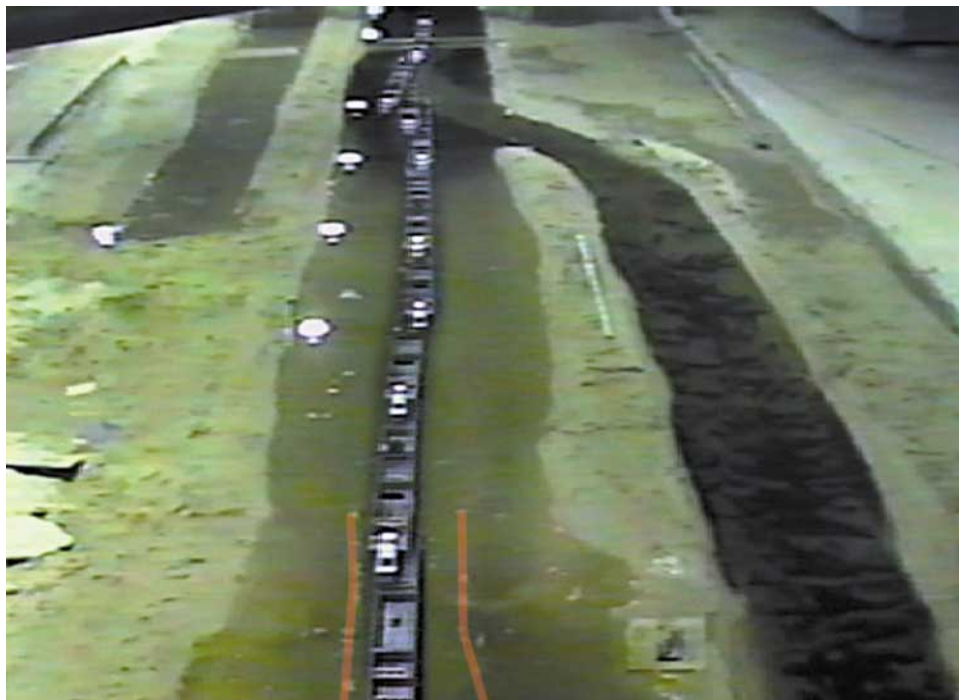
Figure 28. Flow east to west with bridge three tow lengths from confluence, tow moving west to east

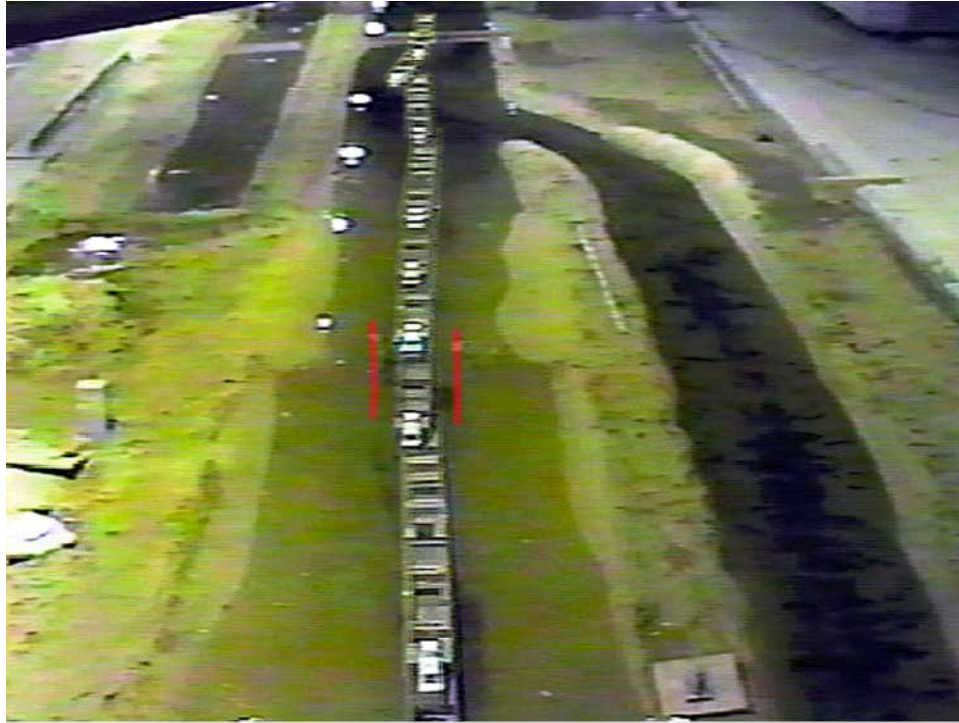
Figure 29. Flow east to west with bridge two tow lengths from confluence, tow moving west to east

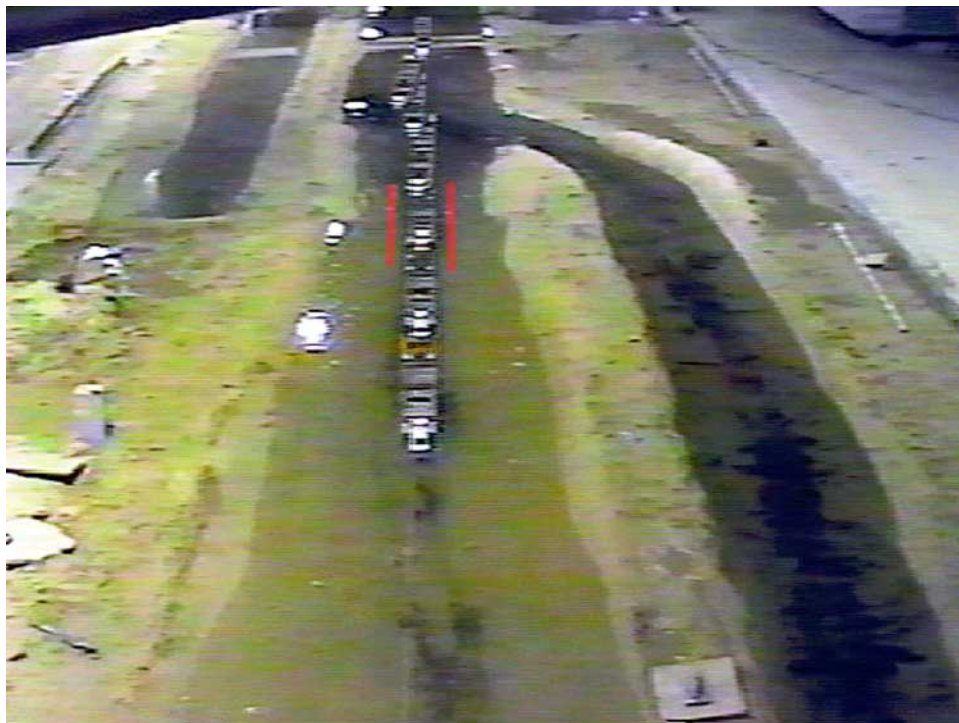
Figure 30. Flow east to west with bridge one tow length from confluence, tow moving west to east
