application **Sand Dune Construction**  
location **Bolivar Peninsula, Texas**  
products **Geotube® Structures**

JOB OWNER:  
**Galveston County, Texas**  
ENGINEER:  
**Shiner Moseley & Assoc.**  
CONTRACTORS:  
**DRC Inc.**  
**Reama Contractors**

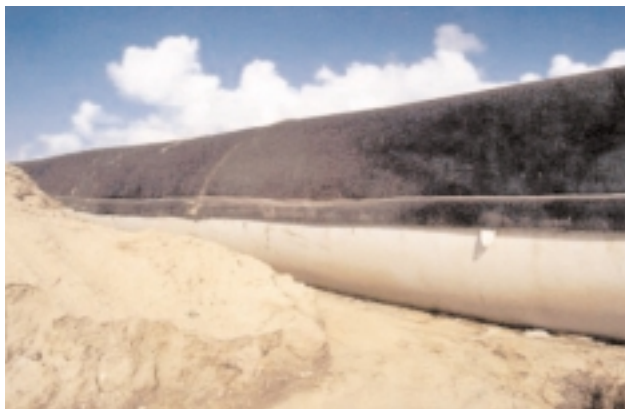
Mirafi® 1120N was used as a UV resistant shroud for the Geotube® structure.

white polyester woven geotextile. The scour apron with anchor tubes, which serves to prevent erosion underneath the tube as well as to anchor the structure, was constructed of black Mirafi® GT 500 fabric. Mirafi® 1120 N was fabricated to the top of the Geotube® structure. This nonwoven geotextile would serve as a shroud for increased UV protection in the event that a Geotube® container was uncovered for long periods of time (Figure 1, 2). The tubes were filled by the use of a hopper method using imported sand (Figure 3, 4). The Geotube® structures were first held in place by pumping sand into the anchor tubes. The main geotextile tube body was then filled by pumping sand through injection ports that were located on 25-foot centers. The tubes were then covered with a layer of sand and vegetated (Figure 5). According to Hauske, contractors are able to install one tube per day.

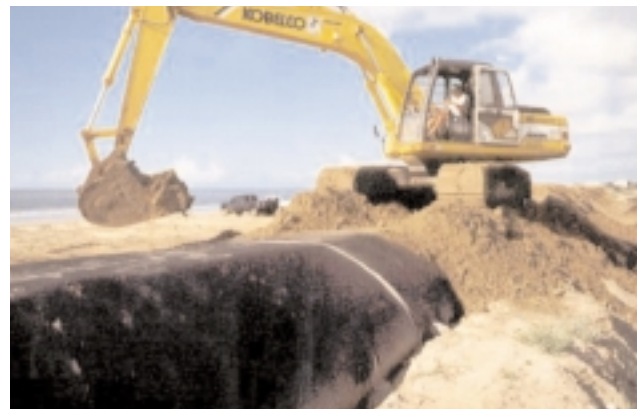
Each Geotube® container was covered and vegetated to take on the appearance of a natural dune.

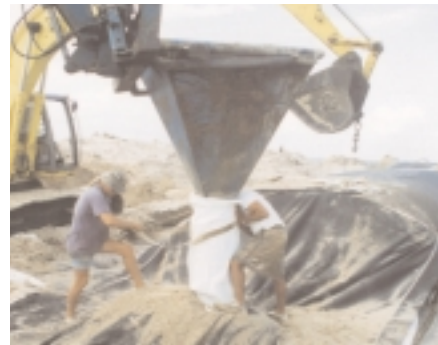
Each Geotube® structure was filled by attaching a hopper to the container injection ports and filling the tubes with imported sand.

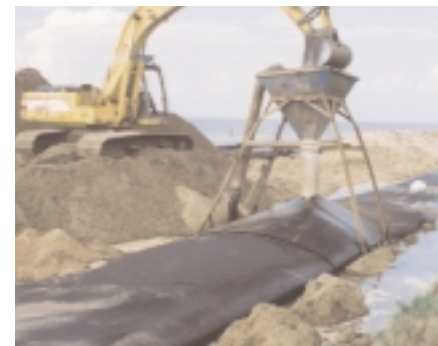
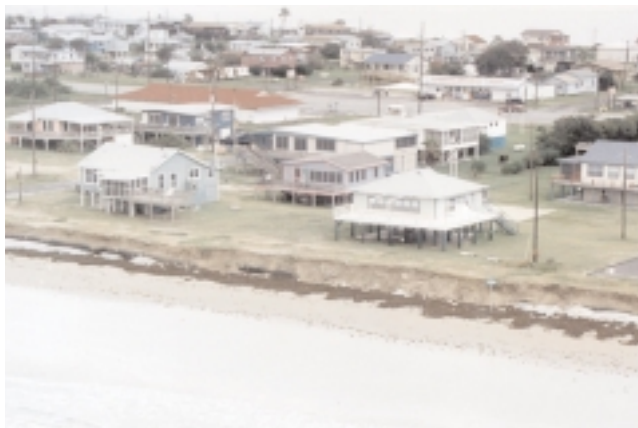
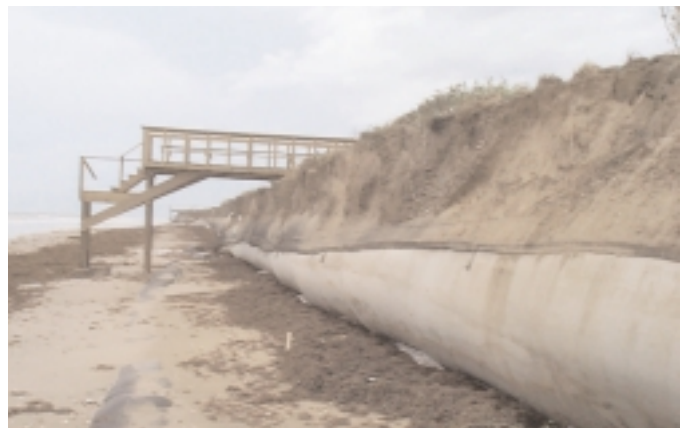
No damage could be reported in areas protected by Geotube® structures after Tropical Storm Allison. However, some erosion was reported in front of the containers, in some cases exposing the structure.

County 1 to 2 million dollars in clean up cost, according to Duffey. She continued saying, "With this last event (Tropical Storm Allison) we estimated that we had about 50 homes on the Bolivar Peninsula that would have been on the public Beach (due to erosion) and subject to removal if it had not been for this project." Oehlers echoed Duffey's response saying, "Not one dollar of damage or debris could be reported past the Geotubes." Some erosion was reported in front (surf side) of the tubes in some cases exposing the sand-filled containers. But no damage to the tubes themselves was reported (Figure 6,7)
