# TORNADO PROTECTION

SELECTING and DESIGNING

SAFE AREAS in BUILDINGS

TR-83B / JANUARY 1980

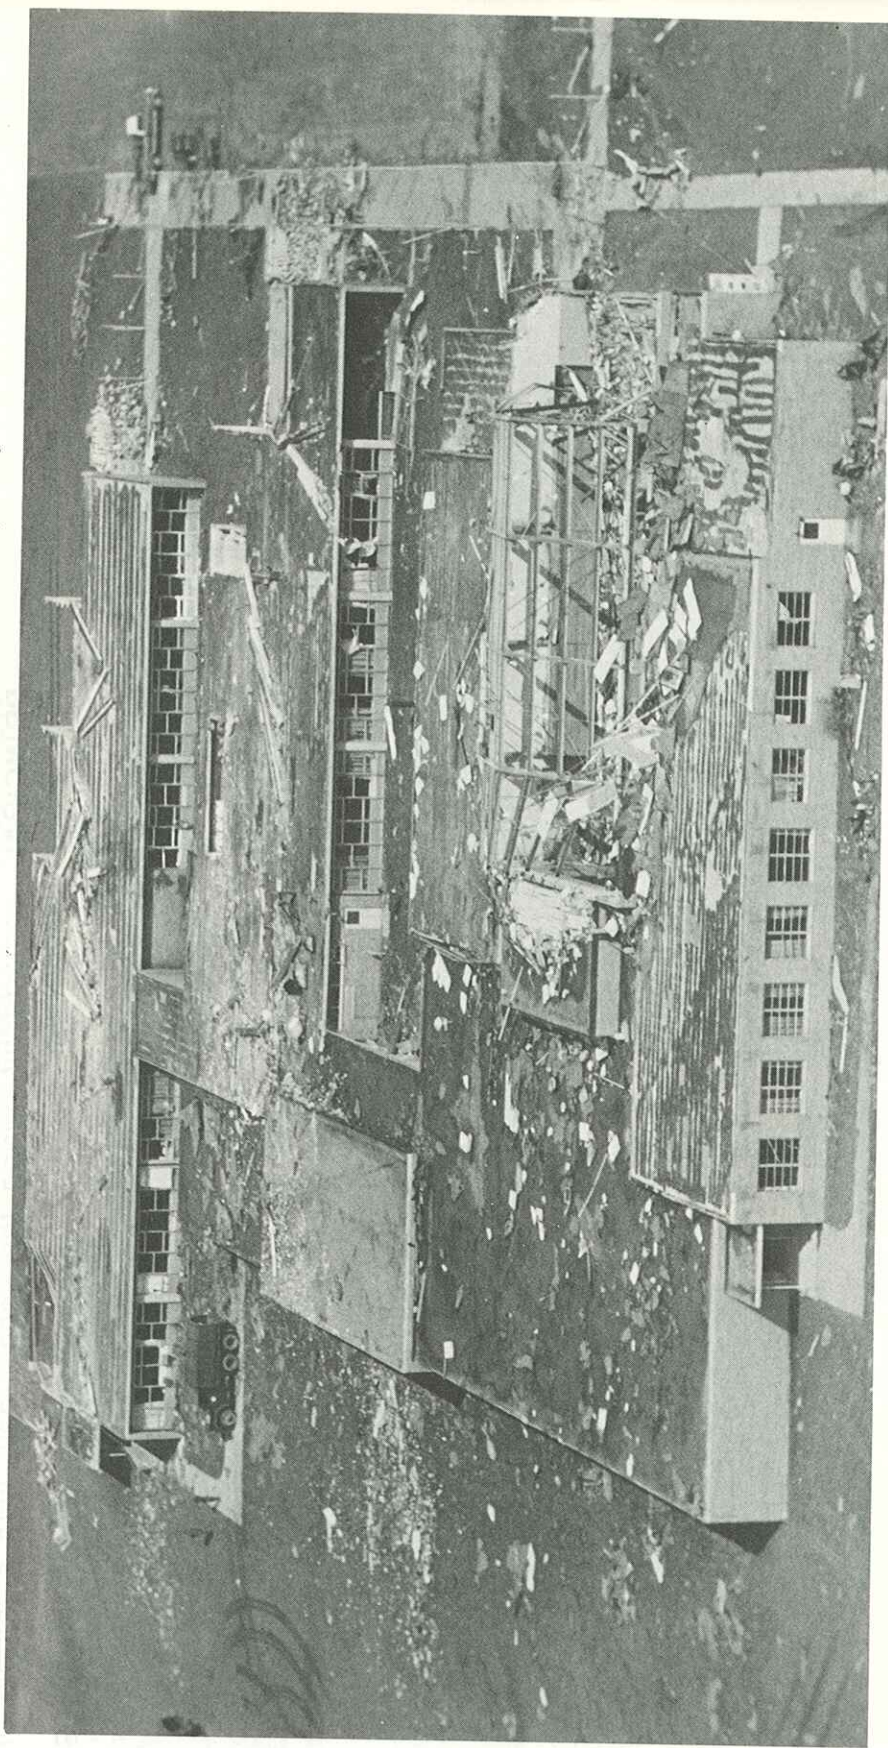
## **MONROE CENTRAL SCHOOL PARKER, INDIANA**

The tornado center passed slightly to the right of the center of the building, and caused major damage to all three wings. The enclosure walls failed, allowing the winds to enter interior spaces, lift roofs, and toss debris throughout the building.

Winds entering the room caused a ballooning effect. The lightweight roof deck was blown off. Some of the deck and the steel bulb tees fell on the floor; and the remainder blew onto adjacent roofs and open spaces.

The high leeward (north) wall of the multipurpose room **COLLAPSED** onto the locker room roof below.
