Job Report

Project No. MO-1-D-2 Date 1 August 1960.

Project Name: Oyster Reef Development and Protection.

Management of the Mudshell Industry

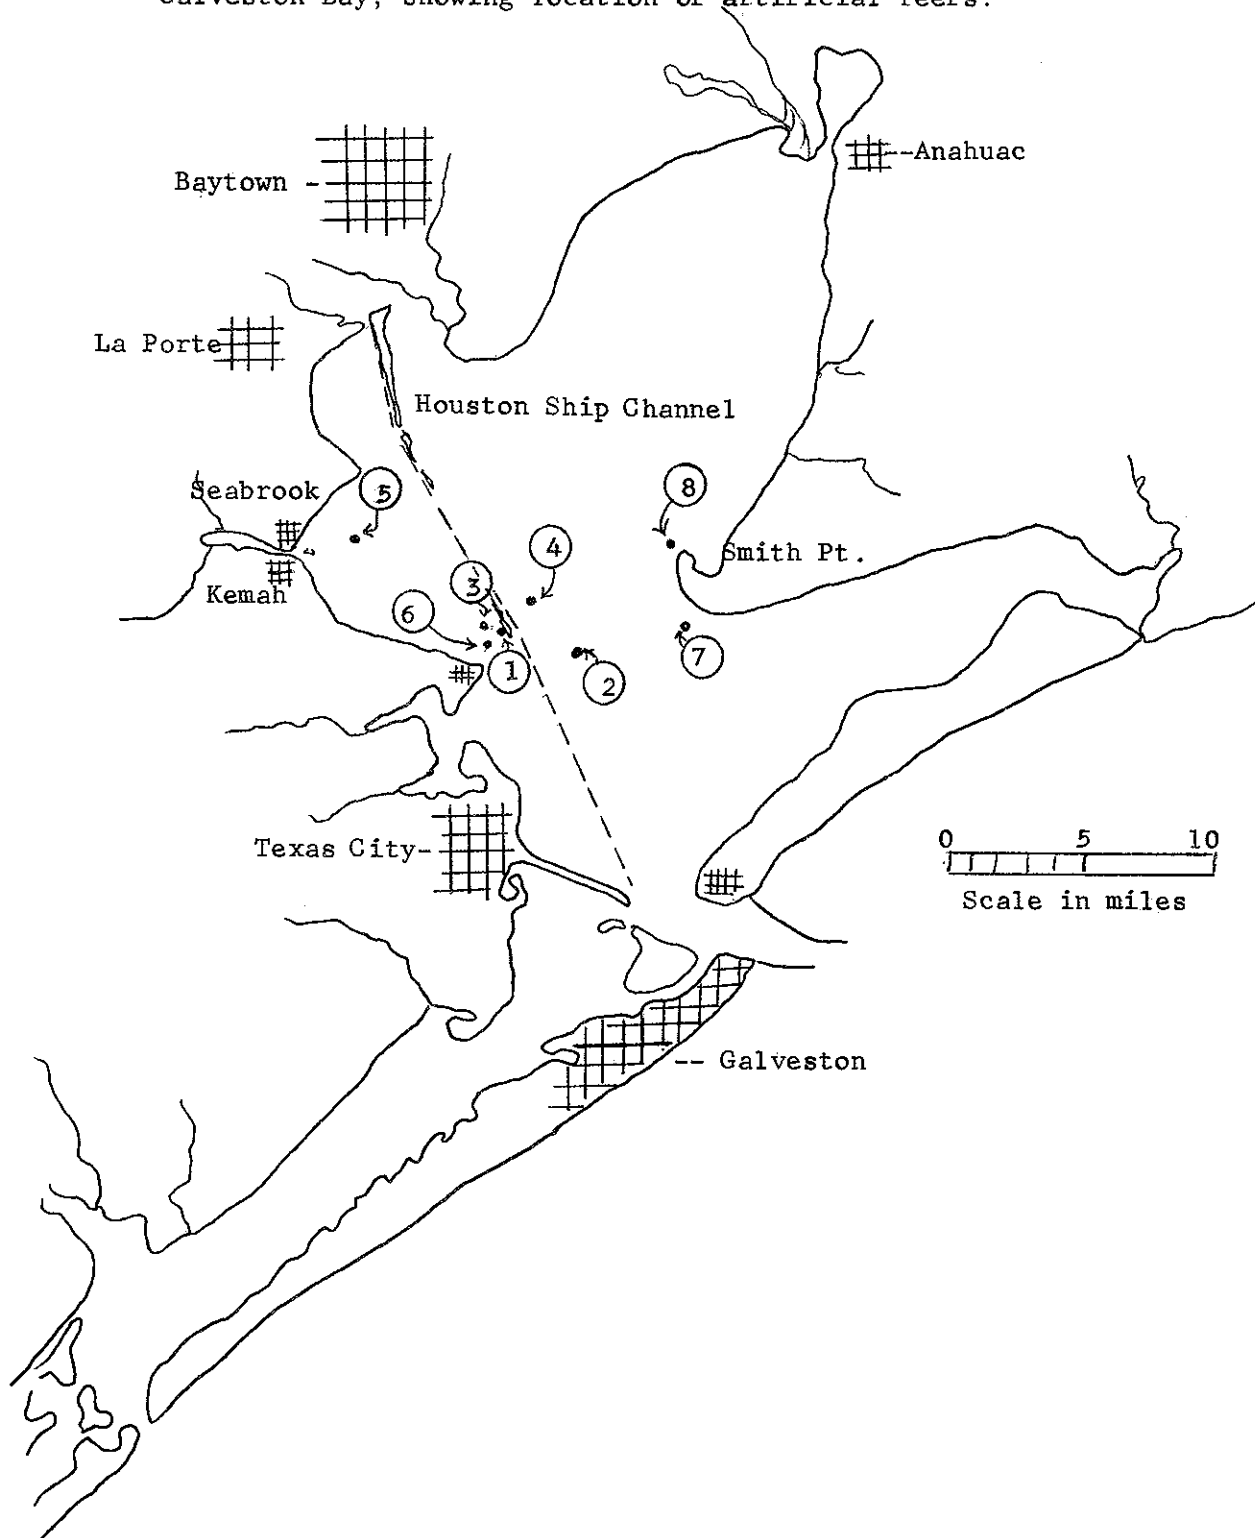
Figure I

Galveston Bay, showing location of artificial reefs.

Eight reefs have been constructed, or are under construction, in Galveston Bay. Their locations are shown in Figure I. Summaries of oyster and shell plantings are given in Tables 1, 2, and 3.
